Aviation Investigation Final Report

Location:	Colbert, Oklahoma	Accident Number:	CEN15FA316
Date & Time:	July 26, 2015, 15:13 Local	Registration:	N252G
Aircraft:	Beech V35B	Aircraft Damage:	Substantial
Defining Event:	Loss of engine power (total)	Injuries:	2 Fatal
Flight Conducted Under:	Part 91: General aviation - Personal

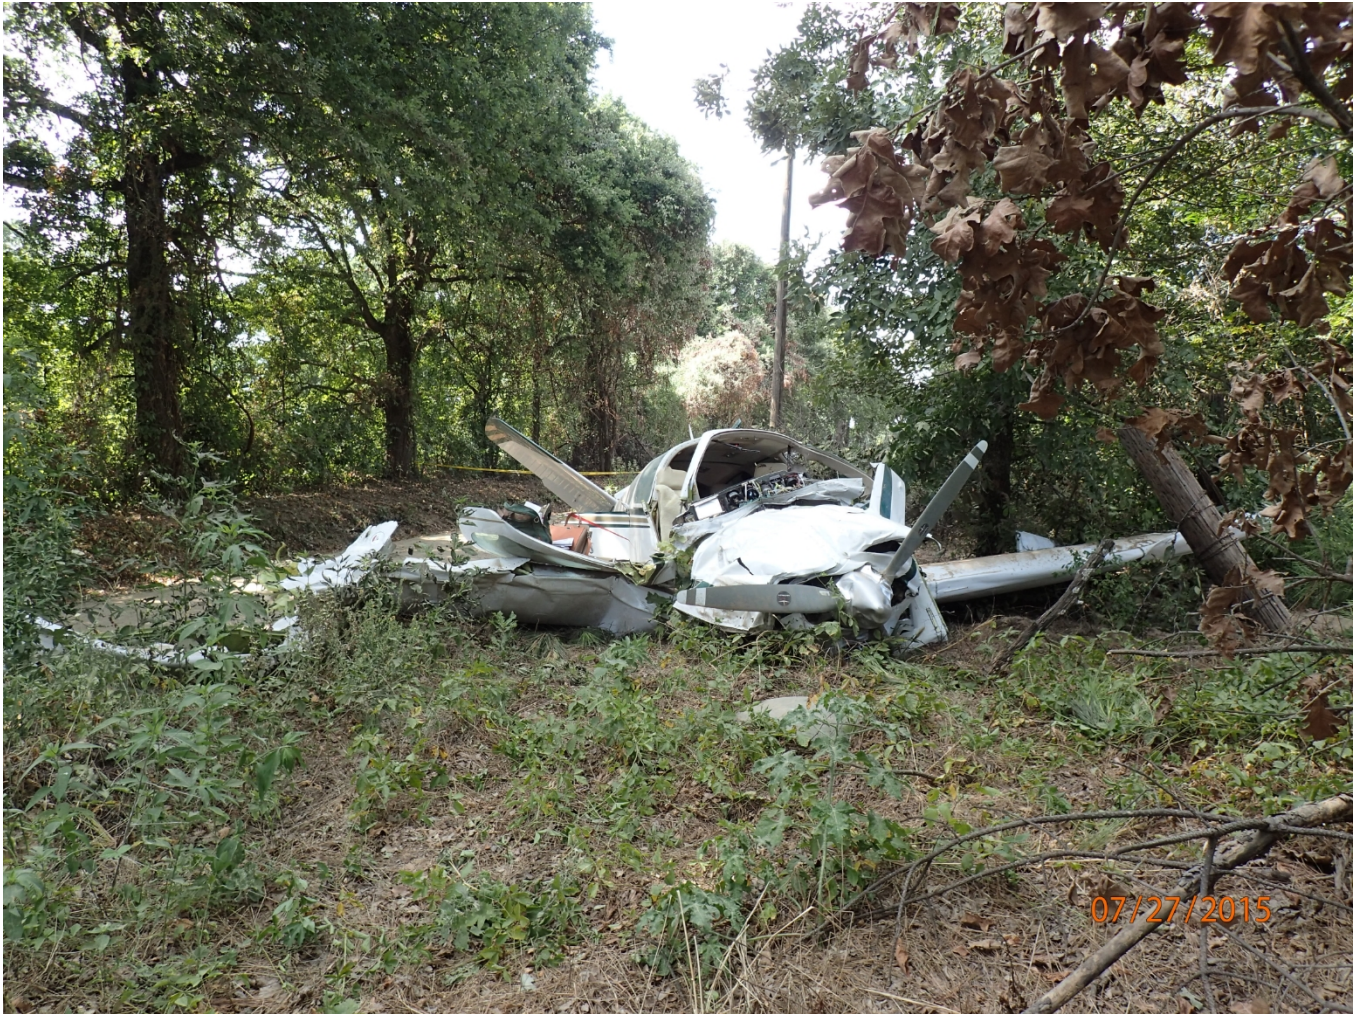
The accident site was located in a wooded area along the east side of a road about 5 miles southeast of Colbert. The site was surrounded by fields suitable for a forced landing. The airplane came to rest upright and was oriented on a south-south westerly heading. The airplane initially impacted some pine trees about 100 ft. east-northeast of the wreckage. Several tree branches in the immediate vicinity of the airplane were broken and showed marks consistent with impact marks on the airplane's wings and fuselage. The debris path was on a bearing of about 200° from the initial tree impact. About 40 ft. east of the airplane was an impact crater that measured about 25 ft. wide and 20 ft. long. Airplane debris and dirt fanned out from the crater toward the airplane wreckage.

The main wreckage consisted of the cabin, fuselage, engine, propeller, left and right wings, and empennage. (See Figure 1 for a photograph showing the accident site and main wreckage.)

Figure 1. A photograph showing the accident site and main wreckage.

The cowling, engine, and engine mounts were broken downward and twisted right 15° . The nose gear was in the retracted position. The nose gear wheel well and nose gear doors were crushed upward. The front cabin floor and front seats were broken downward and canted right about 10° . The instrument panel, control yoke and glareshield were broken forward and down. The front windscreen was broken out and fragmented. The rear cabin, baggage compartment and aft fuselage showed upward crushing. The empennage showed minor damage.
