Preliminary Report on the Bhuj Earthquake, January 26 2001, in India

Takashi KAMINOSONO¹⁾

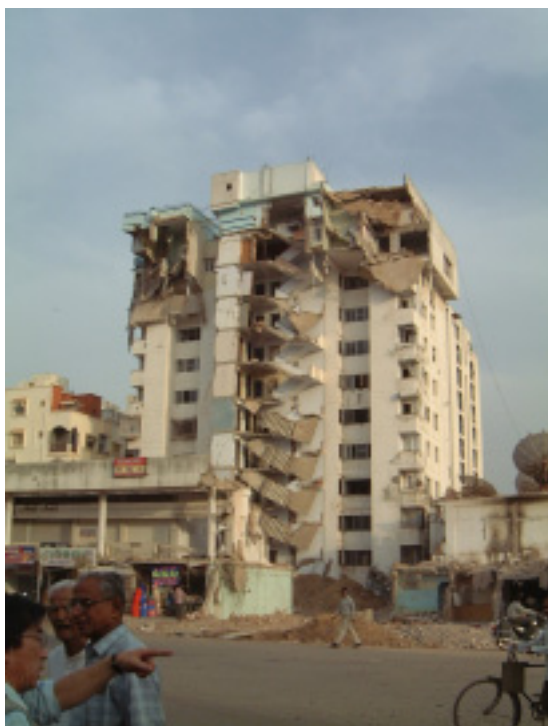
Photo 1 Manasi Tower apartment building

There was a part of building on this side that has the same structural system as the back side of the remaining building. The part of building was totally collapsed.

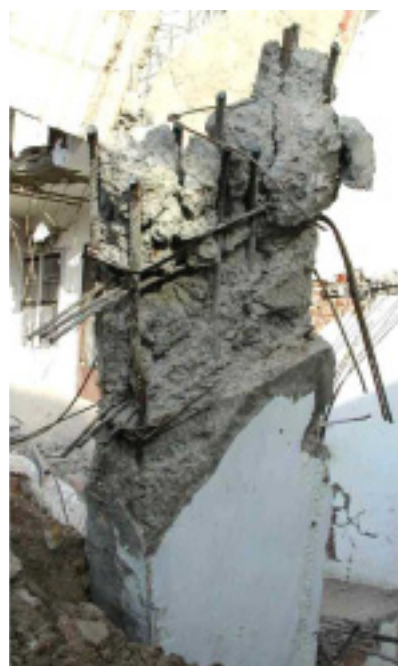
Photo 3 Damaged column

This column has small thickness. If the column suffers damage in thickness direction, the column will lose the weight support capacity easily.

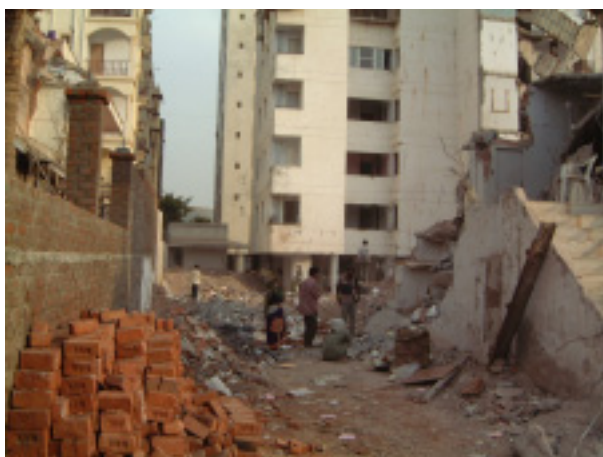
Photo 2 Manasi Tower apartment building

This building has a soft first story.

At first, damage concentrated to columns at the first soft story, the columns lost weight support capacity, and finally the building collapsed totally.

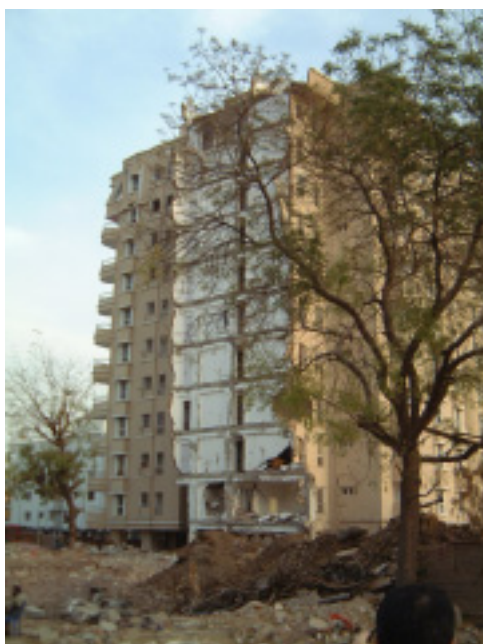
Photo 4 Apartment building
This building has a soft first story.
A part of building on this side
collapsed totally.

After the earthquake, temporary wooden supports were installed, and also columns at the first story were retrofitted by jacketing technique to prevent the total collapse of the remaining building.

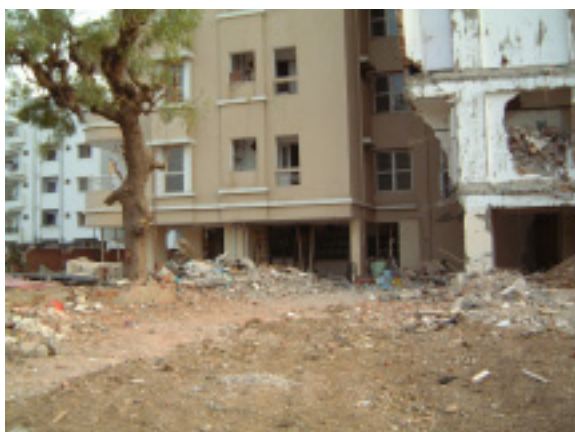
Photo 5 Apartment building
This building has a soft first story.
At first, damage concentrated to
columns at the first soft story, the
columns lost weight support capacity,
and finally the building collapsed
totally.

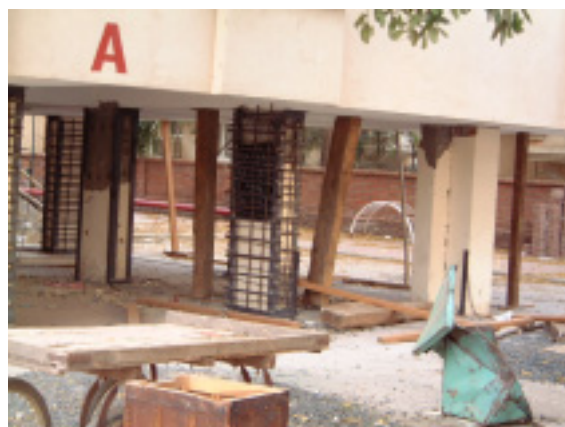
Photo 6 Retrofitted columns
These columns were temporarily
retrofitted using angle and flat steel plates.

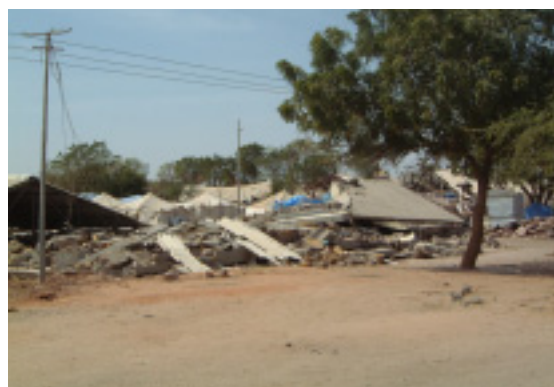
Photo 6 Damage at Bhachau
Most of masonry housings were
destroyed.

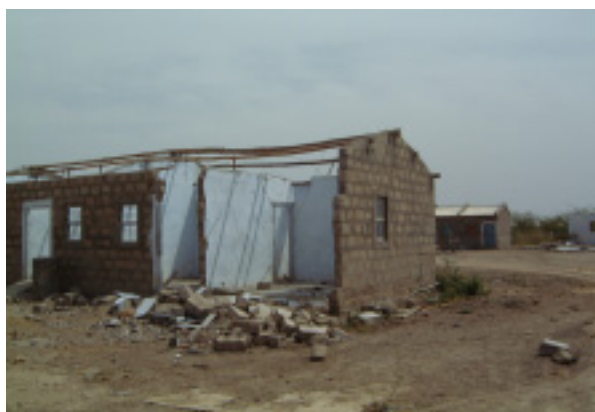
Photo 7 Damage of masonry housing

This building has no reinforcement in walls. Walls fell in out-of-plane direction.

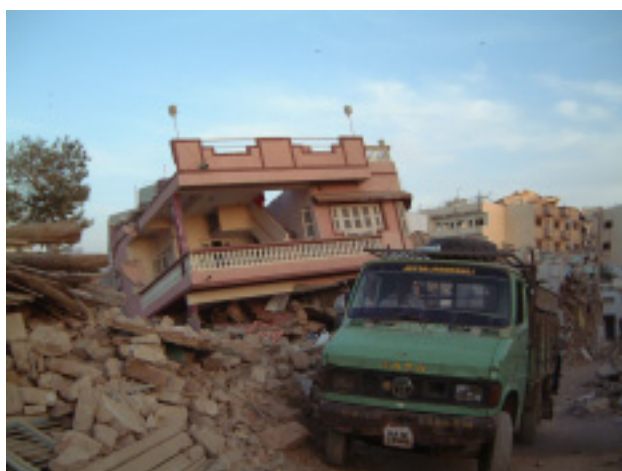
Photo 8 Damage in old city area at Bhuj

Most of traditional masonry housings were destroyed.

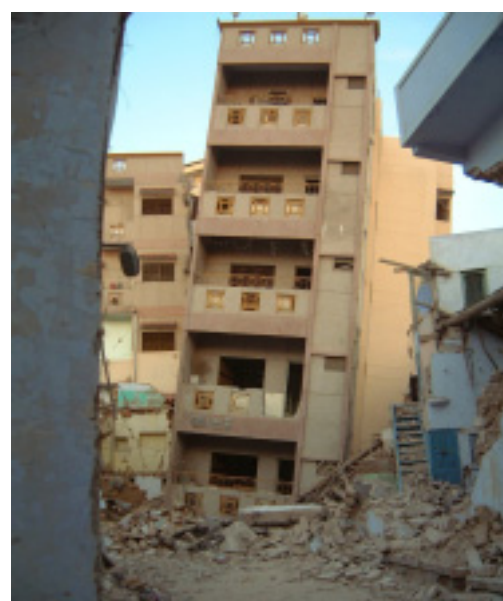
Photo 10 Collapse of soft first story of building

This 6 story building in old city area of Bhuj was collapsed at the soft first story.

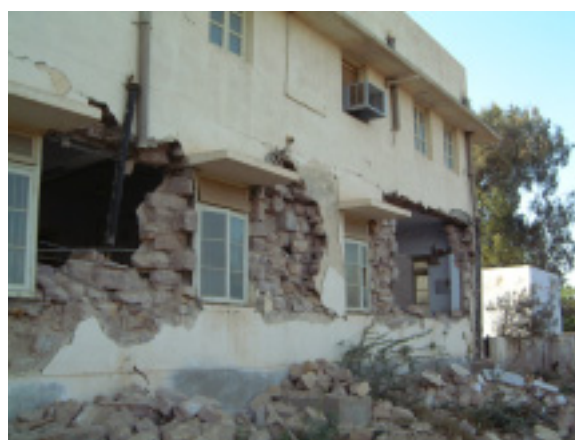
Photo 11 Damage on hospital building

All masonry walls were damaged heavily.

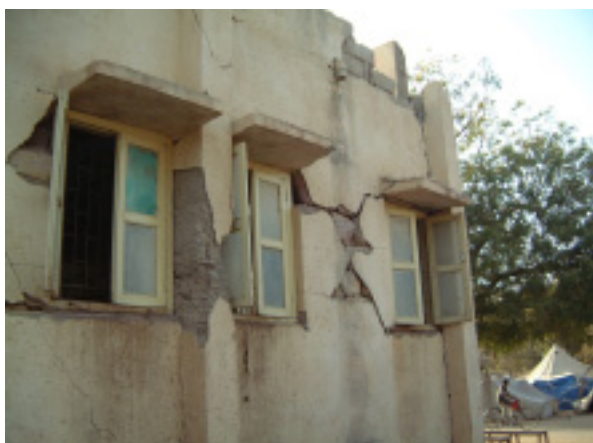
Photo 12 Damage on column
Masonry wall and Short reinforced masonry column were failed in shear.

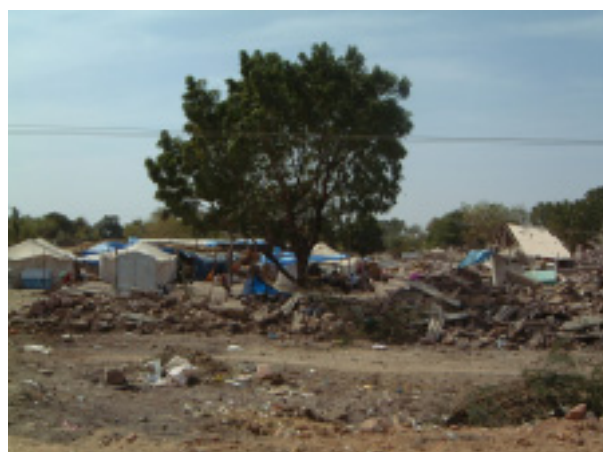
Photo 13 Shelters at Bhachau
Tents or blue sheets were used for shelters for refugees.

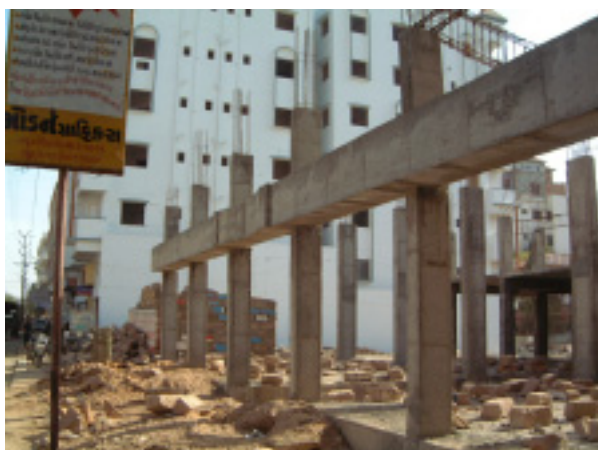
Photo 17 Column and beam
Beams are eccentrically connected to columns.

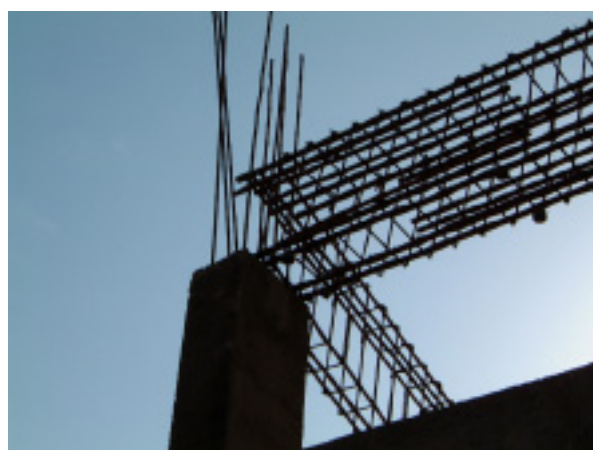
Photo 20 Column, beam and joint details
Anchorage of beam reinforcements is not enough as described in Indian Standard.

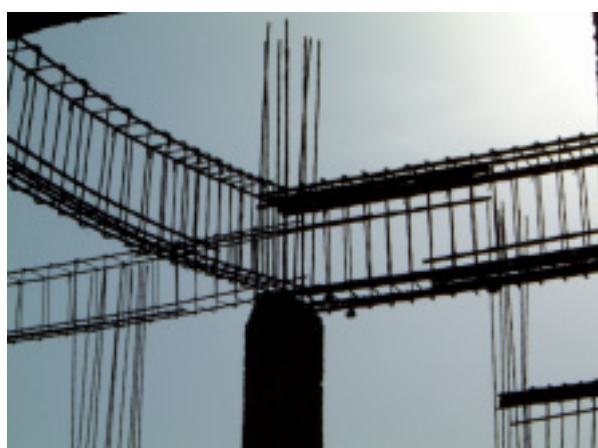
Photo 19 Column, beam and joint details
Anchorage of beam reinforcements is not enough as described in Indian Standard.
