Lightning Damage to Wind Turbine Blades From Wind Farms in U.S.

Lightning Damage to Wind Turbine Blades from Wind Farms in U.S.

Abstract--This paper presents statistical data about lightning damage on wind turbine blades reported at different wind farms in the U.S. The analysis is based on 304 cases of damage due to direct lightning attachment on the blade surface. This study includes a large variety of blades with different lengths, laminate structure and lightning protection systems. The statistics comprises the distribution of the lightning damage along the blade and classifies the damage by severity. In addition, the frequency of lightning damage to more than one blade of a wind turbine after a thunderstorm is assessed. The results of the analysis show that the majority of the lightning damages are concentrated at the tip of the blade. Furthermore, all the blades involved in the study show a great similarity in the distribution of damages along the blade and the characteristics of the damages, even concerning the significant differences in the blades geometry and materials.

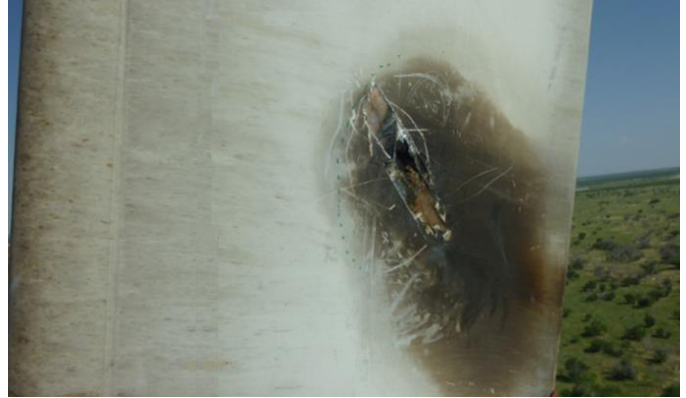
Damage type 1: Delamination. The delamination consists of damage on the blade structure, where the plies of the laminate are detached from each other (Fig. 5 and 6). It is normally caused by local pressure and rapid expansion of the lightning arc column combined with incineration of the resin between the laminate plies due to the temperature of the lightning channel. Usually, delamination is accompanied with punctures and burns on the laminate at and around the point where the lightning struck the blade. The examination of the damaged

Fig. 5 Burn and delamination on the shell at about 3m from the blade tip due to lightning direct strike.

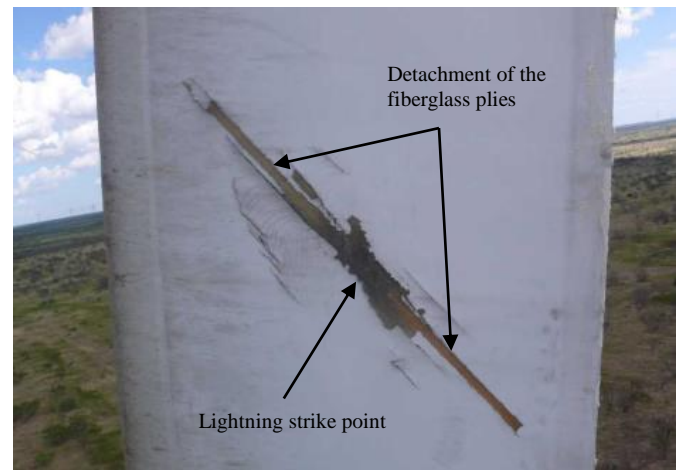
Fig. 6 Delamination on the shell at about 2m from the blade tip due to lightning direct strike. It is observed how the fiberglass plies of the shell are detached around the strike point.

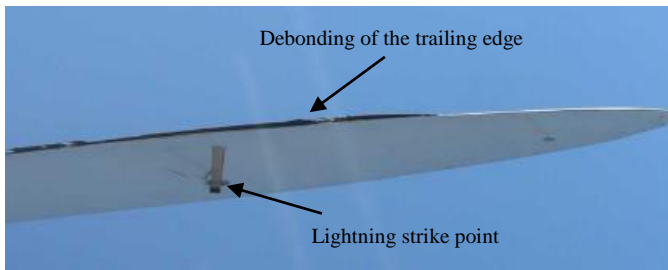
Damage type 2: Debonding. Debonding of the shells consists of a localized separation of the upper and lower shells, usually at the tip of the blade or at the trailing edge in the last few meters of the blade (Fig. 7). The lightning strike point is often located close to but not at the debonded area, which suggests that the cause of the debonding is the expansion of the air inside the blade due to the heat generated by the lightning channel, possibly combined with vaporization of condensed moisture trapped inside the blade. All the examined blades that suffered debonding were accompanied with a certain degree of delamination.

Fig. 7 Delamination on the shell over the cap and debonding of the trailing edge likely due to the expansion of the air caused by the lightning current.

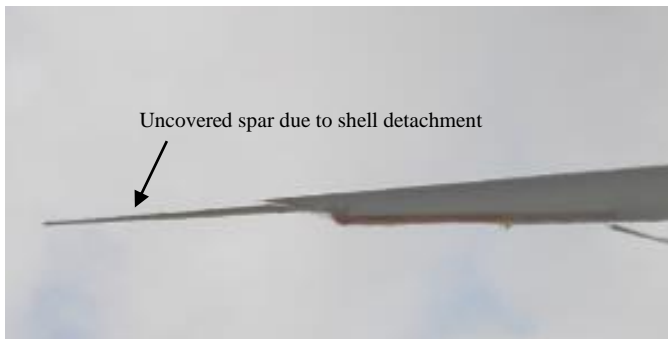
Damage type 3: Shell detachment. The shell detachment consists of several meters of one or both shells completely detached from the load carrying structure (Fig. 8). The examination of the affected blades suggests that the damage started with a shell debonding (damage type 2). The rotation of the blades combined with the strong wind gusts during the thunderstorm generates mechanical forces to the debonded area, eventually causing shell detachment. This type of damage did not occur frequently. It is noted that in the cases of shell detachment analyzed here, the lightning attachment point was located within the last 3m of the blade tip, even if the damage affected several meters of the shell.

Fig. 8 Shell detachment of the last meters of the blade most likely initiated with a shell debonding due to direct attachment to the blade, aggravated by the strong wind conditions.

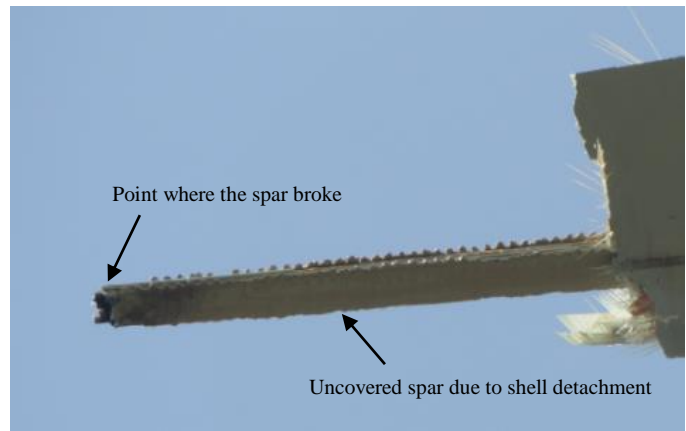
Damage type 4: Tip detachment. The tip detachment is the most critical case of damage, where several meters of the blade tip are detached from the rest of the blade (Fig. 9). This type of damage occurs when the lightning current severely damages the structural laminate, to the extent that the laminate cannot support the mechanical load and breaks. Tip detachment does not occur frequently, and it is mainly associated with blades having a carbon fibre structure. In the case of a direct strike to the carbon fibre, the current can flow through the conductive carbon fiber laminate and extend the damage. In the cases analyzed here, lightning struck the cap laminate a few meters inboard from the blade tip, where the spar cap laminate is relatively thin but supports certain mechanical loads.

Fig. 9 Tip detachment due to direct lightning strike to the carbon fiber laminate of the spar (load carrying structure). The spar broke at several meters from the blade tip and the shells were detached several meters further inboard.
