Law Enforcement and TxDOT Use ONLY. Form CR-3 (Rev. 1/1/2018)		Case ID 223580248		TxDOT Crash ID 19300754.1/2022622599		Page 2 of 2																													
DISPOSITION OF INJURED/KILLED	Unit Num.	Prsn. Num.	Taken To		Taken By		Date of Death (MM/DD/YYYY)		Time of Death (24HR.MM)																										
	1	1	ASCENSION SETON HAYS MEDICAL CENTER		MEDICAL HELICOPTER																														
CHARGES	Unit Num.	Prsn. Num.	Charge						Citation/Reference Num.																										
DAMAGE	Damaged Property Other Than Vehicles				Owner's Name				Owner's Address																										
CMV	Unit Num.	<input type="checkbox"/> 10,001+ LBS.	<input type="checkbox"/> TRANSPORTING HAZARDOUS MATERIAL	<input type="checkbox"/> 9+ CAPACITY	CMV Disabling Damage?	<input type="checkbox"/> Yes <input type="checkbox"/> No	28 Veh. Oper.	29 Carrier ID Type	Carrier ID Num.																										
	Carrier's Corp. Name			Carrier's Primary Addr.						30 Veh. Type

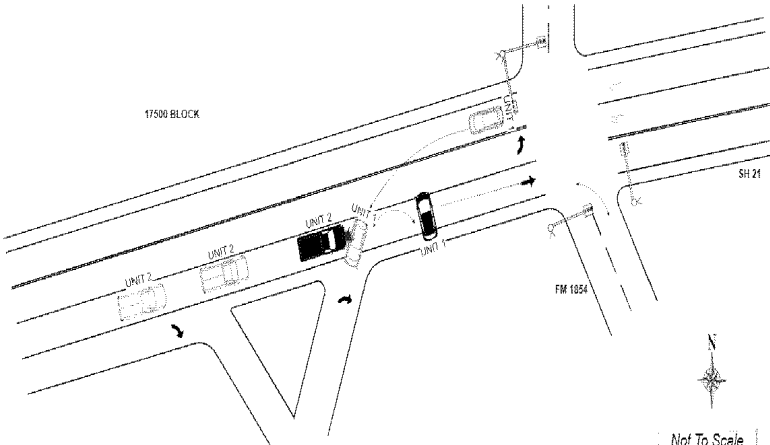
Unit #	Contributing		May Have Contrib.		Contributing		May Have Contrib.		38 Weather Cond.	39 Light Cond.	40 Entering Roads	41 Roadway Type	42 Roadway Alignment	43 Surface Condition	44 Traffic Control																			
	1	37								1	1	4	2	1	1	17																			
NARRATIVE AND DIAGRAM	Investigator's Narrative Opinion of What Happened (Attach Additional Sheets if Necessary)  UNIT 1 WAS TRAVELING WESTBOUND ON CAMINO REAL (SH 21) WHEN AT THE 17500 BLOCK, IT TURNED SOUTHBOUND TO ENTER THE EXXON GAS STATION TRAVELING THE WRONG WAY TOWARD THE EXIT RAMP. UNIT 2 WAS TRAVELING EASTBOUND ON CAMINO REAL (SH 21) WHEN UNIT 1 ENTERED HIS LANE WITHOUT DUE CAUTION AND FAILED TO YIELD THE RIGHT OF WAY TO UNIT 2. UNIT 2 IMPACTED UNIT 1 AT A "T-BONE" ANGLE, MAKING UNIT 1 SPIN 180 DEGREES.										Field Diagram - Not to Scale
