PHOTO REPORT

FIXD Trade Group

Site Contact: Chawakorn Kamnuansil & Podjana Tienmon
Site Address: 243 Franklin Street
Melbourne VIC 3000
Job No: 418092
Order No.:
Project Mngr: Steven Bonfa
Date: 20/05/2025

FRA attended site to complete the required restoration works following reported water damage to the property.

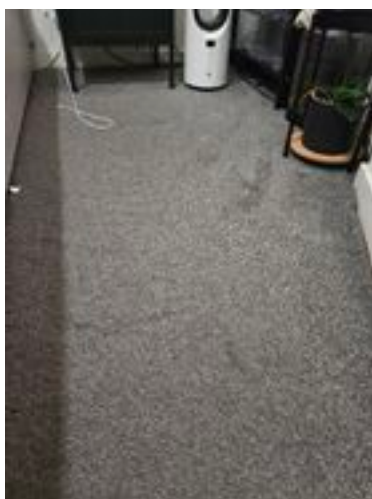
- Visible water stains present on the plaster ceiling and wall lining.
 - Carpet is frayed and wrinkled, it is unlikely that this has been caused by the event.

Carpet Damage

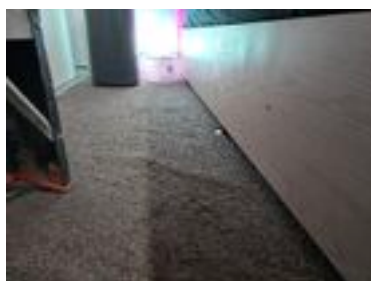
Carpet Damage

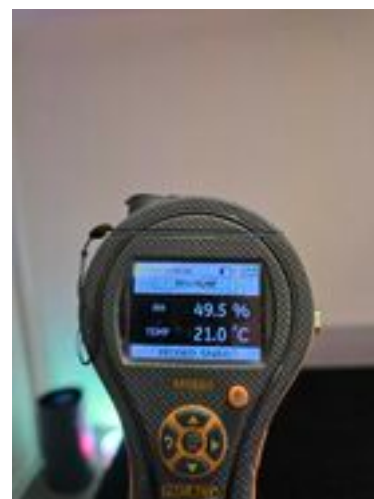
Location	Humidity (Percentage)	Temperature
Internal	49.5%	21.0°C

Internal RH Temp

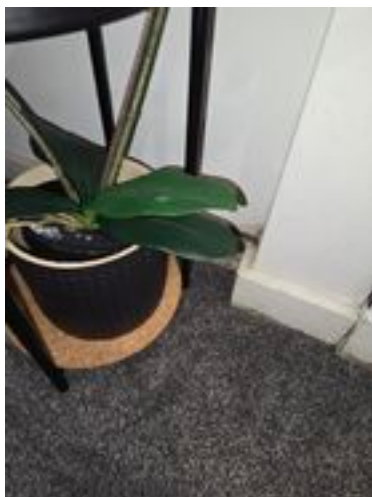
- Minor microbial activity present on the skirting boards behind the bed.
 - Visible microbial activity present behind the plant along the external wall, FRA is unable to determine if this is due to the event.

Microbial Activity

- FRA recommends the removal of the impacted materials;
 - Plaster wall lining from floor to ceiling high.
 - Plaster ceiling lining, approximately 2sqm.
 - Skirting boards behind the bed and along the external wall.

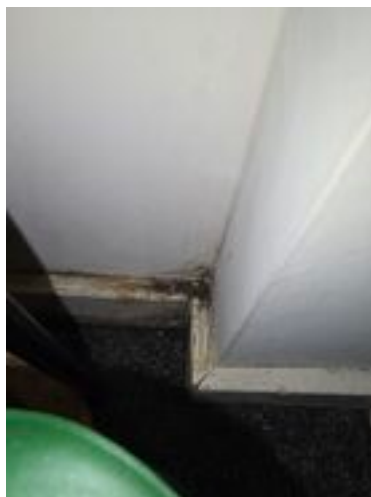
Microbial Activity

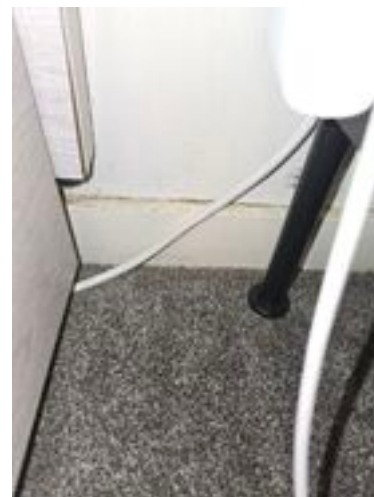
Minor Microbial Activity

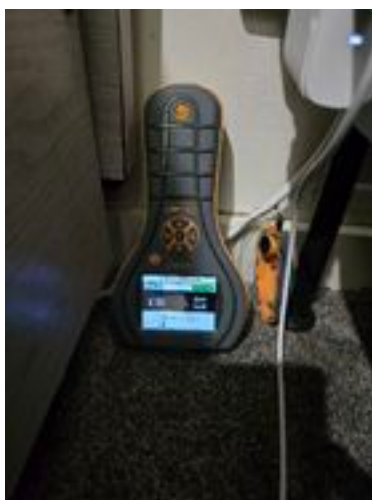
- Performed moisture readings which indicated all building materials are within a dry standard.

Moisture Reading, Carpet

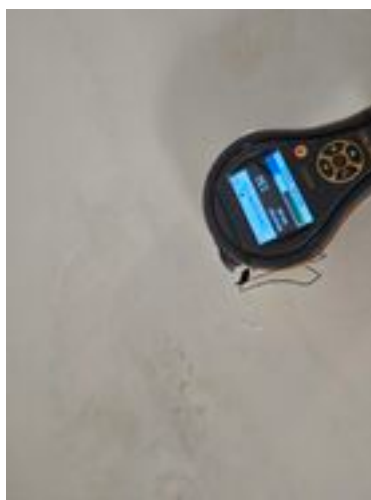
Moisture Reading, Ceiling

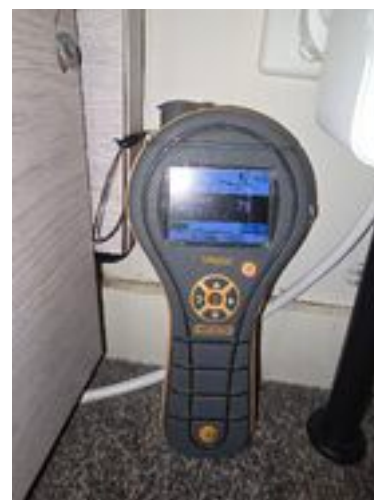
Moisture Reading, Wall

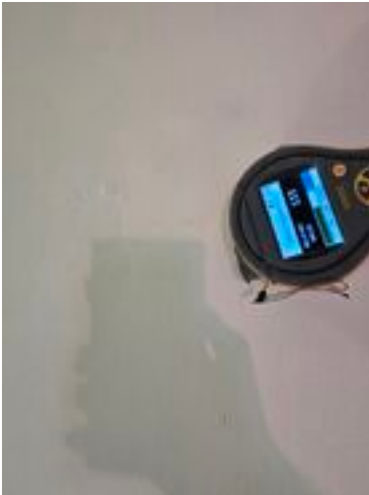
Moisture Reading, Wall

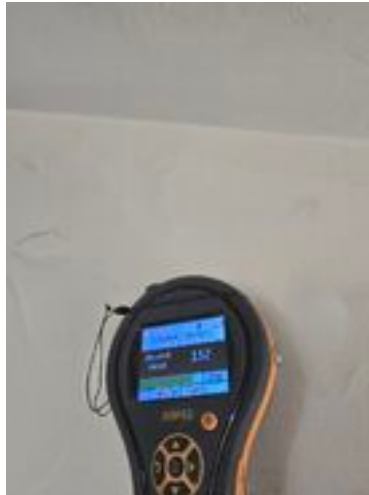
Moisture Reading, Wall

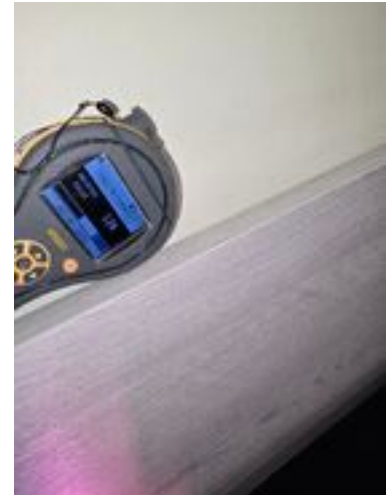
Moisture Reading, Wall

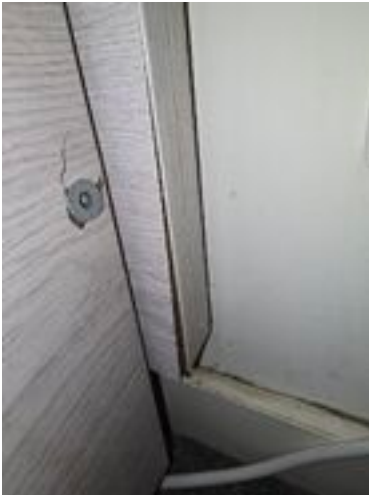
- Visible bubbling and warping of the plaster wall behind the bed.
 - Visible swelling of the bed frame, FRA is unable to determine if this is related to the event.

Water Damaged Bed-Frame

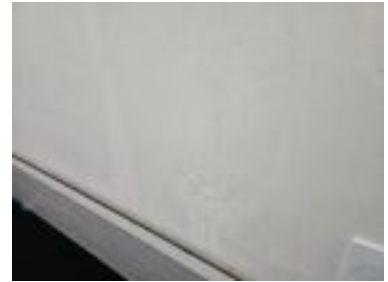
Water Damage

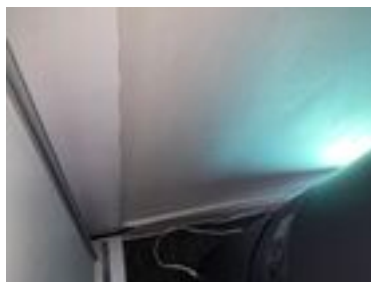
Water Damage

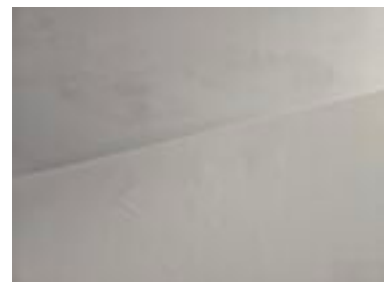
Water Damage

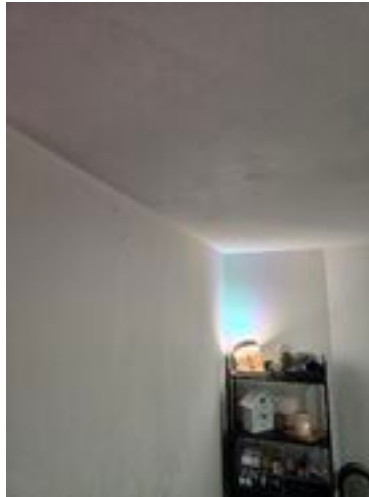
Water Damage

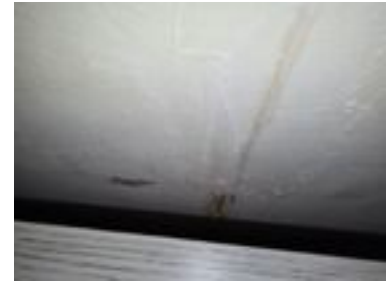
Water Stains
