PHOTO REPORT

FIXD Trade Group

Site Contact: Chawakorn Kamnuansil & Podjana Tienmon
Site Address: 243 Franklin Street
Melbourne VIC 3000
Job No: 418092
Order No.:
Project Mngr: Steven Bonfa
Date: 20/05/2025

REPORT

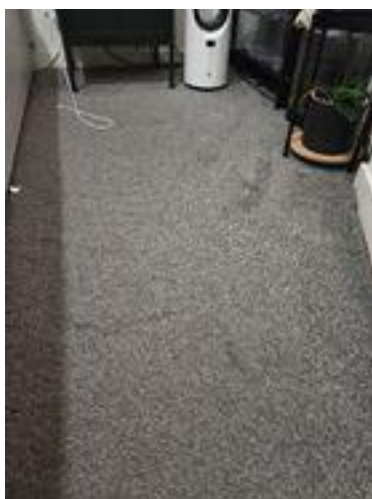
- Visible water stains present on the plaster ceiling and wall lining.
 - Carpet is frayed and wrinkled, it is unlikely that this has been caused by the event.

Carpet Damage

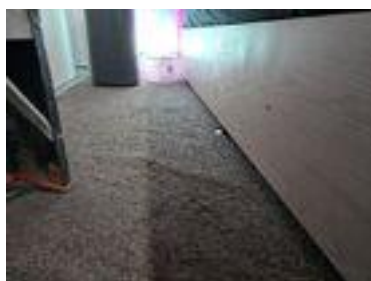
Carpet Damage

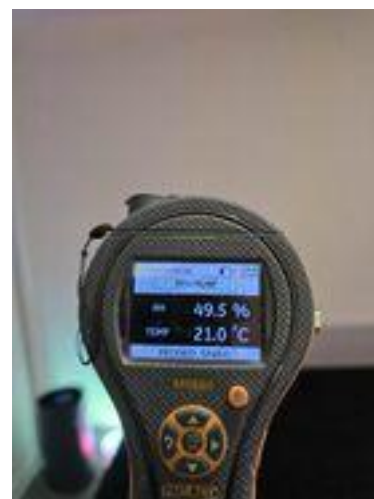
Location	Humidity (Percentage)	Temperature
Internal	49.5%	21.0°C

Internal RH Temp

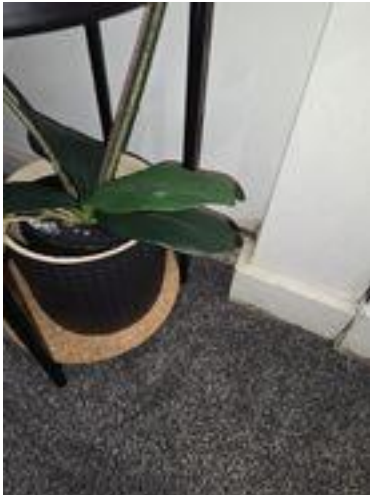
- Minor microbial activity present on the skirting boards behind the bed.
 - Visible microbial activity present behind the plant along the external wall, FRA is unable to determine if this is due to the event.

Microbial Activity

- FRA recommends the removal of the impacted materials;
 - Plaster wall lining from floor to ceiling high.
 - Plaster ceiling lining, approximately 2sqm.
 - Skirting boards behind the bed and along the external wall.

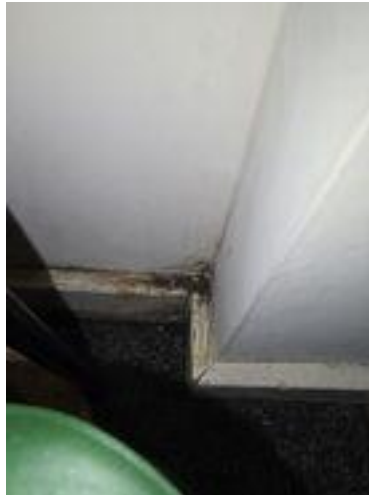
Microbial Activity

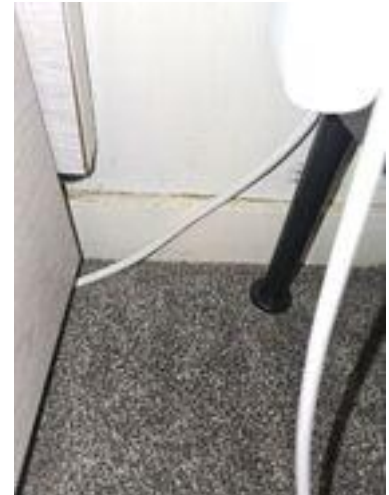
Minor Microbial Activity

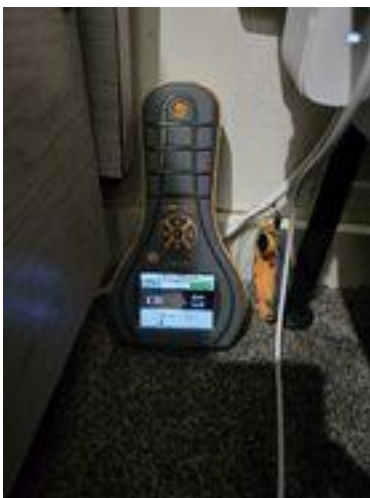
- Performed moisture readings which indicated all building materials are within a dry standard.

Moisture Reading, Carpet

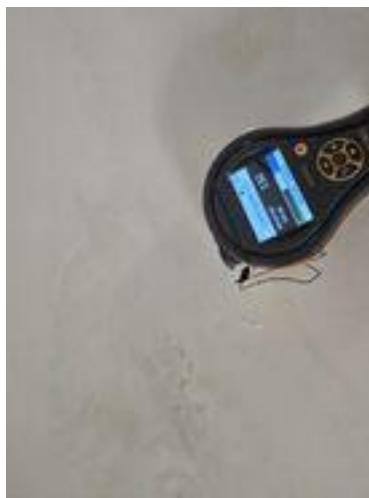
Moisture Reading, Ceiling

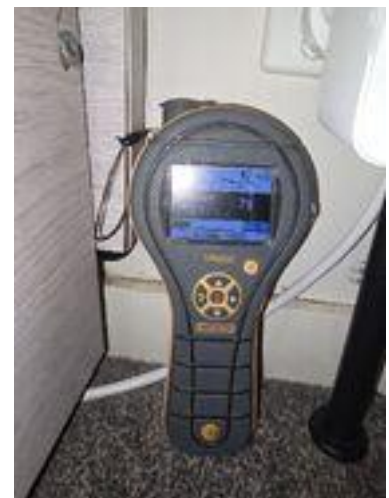
Moisture Reading, Wall

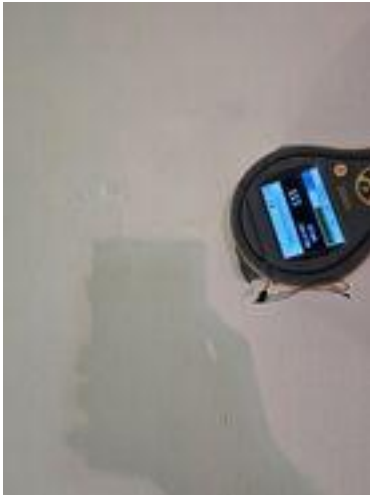
Moisture Reading, Wall

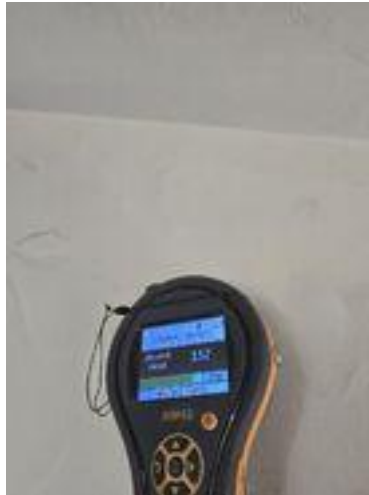
Moisture Reading, Wall

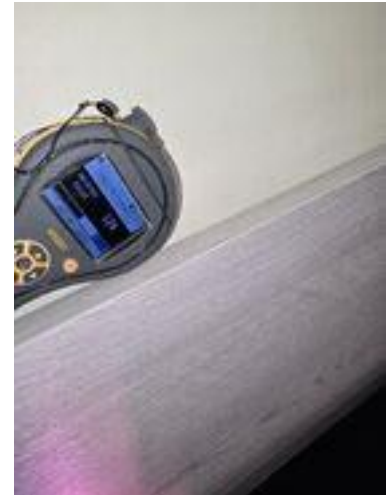
Moisture Reading, Wall

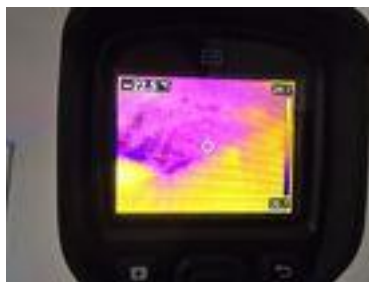
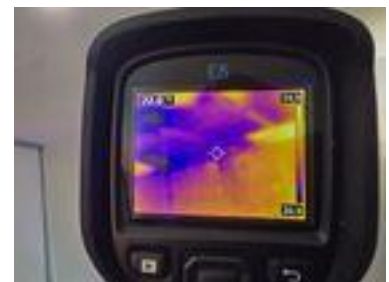
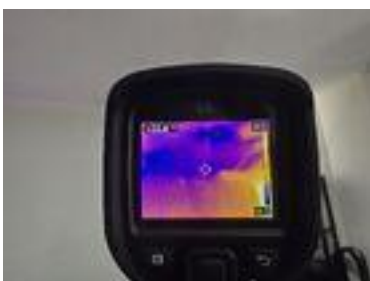
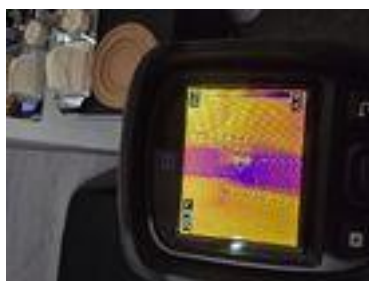
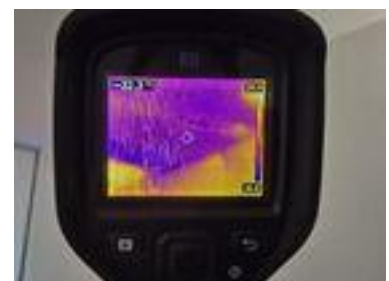
Thermal Imaging

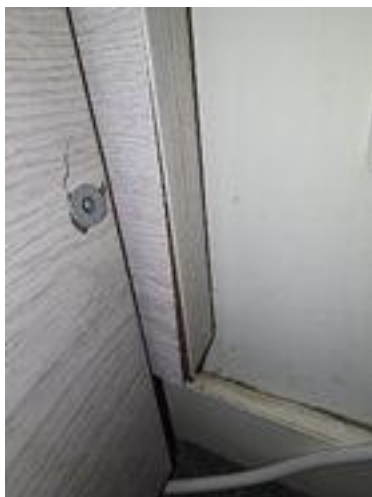
- Visible bubbling and warping of the plaster wall behind the bed.
 - Visible swelling of the bed frame, FRA is unable to determine if this is related to the event.

Water Damaged Bed-Frame

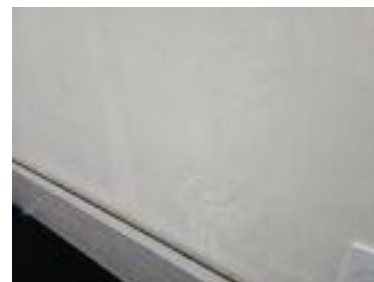
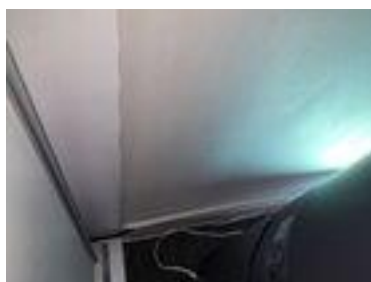
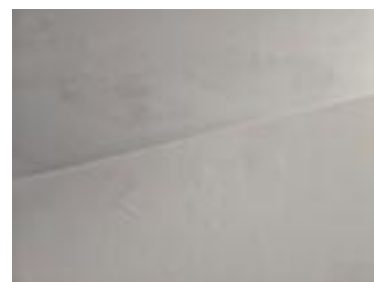
Water Damage

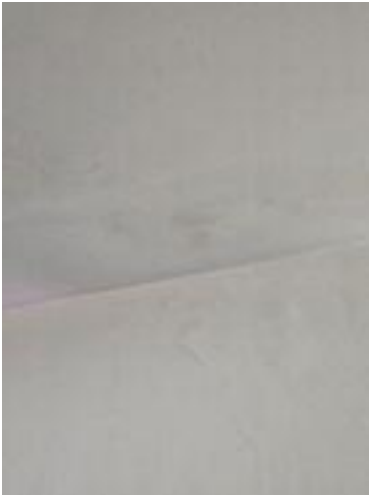
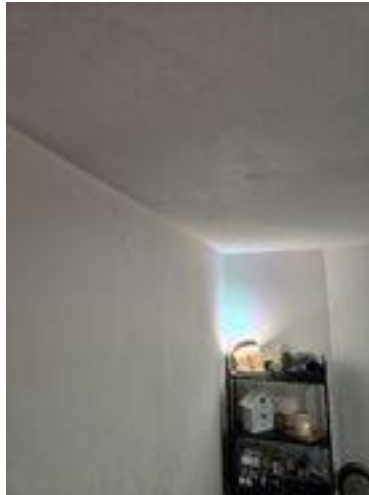
Water Damage

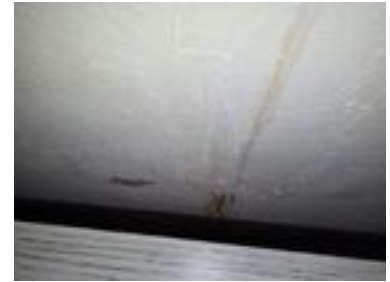
Water Stains
