**BUILDING SURVEY AND VALUATION REPORT**

**Carried out on  
18<sup>th</sup> March 2013**

**Surveyor: Mr D Jason G Williams Bsc (Hons) MRICS**

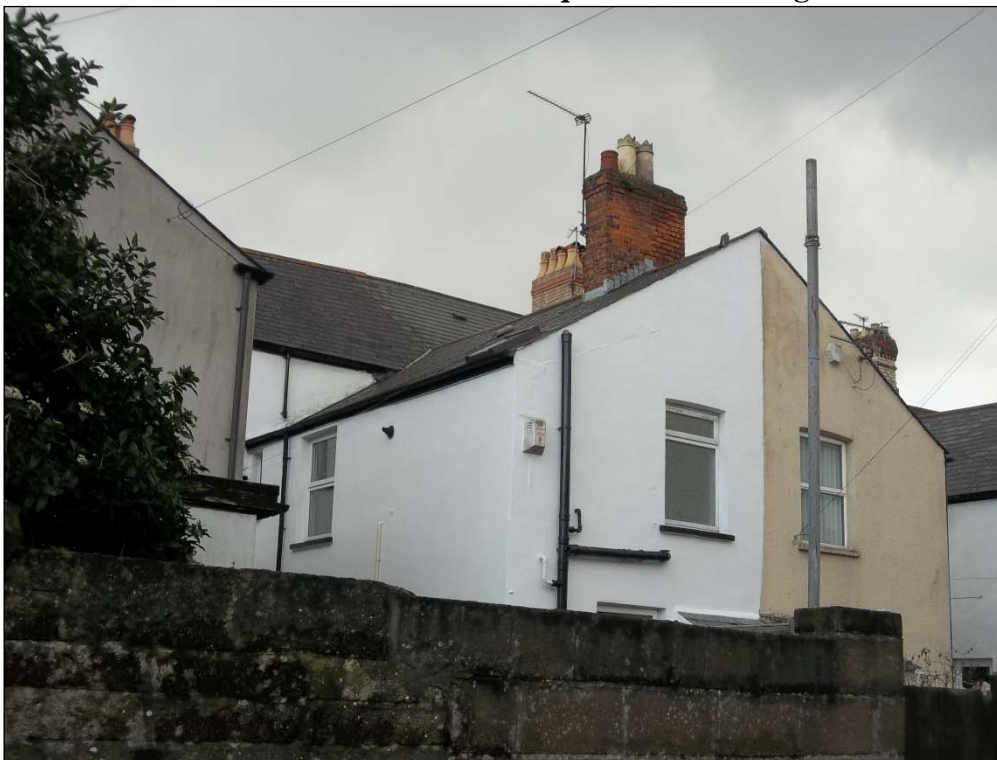
**Photograph 2 – Rear Elevation. This photograph also shows the poor condition of the rear shared stack which requires overhauling.**

There is also a rear shared brick built chimney stack. This requires overhauling, including the raking out and re-pointing of defective mortar joints and vegetation growth, checking and upgrading the lead work and flashings as necessary. All works to be carried out by a competent building contractor.

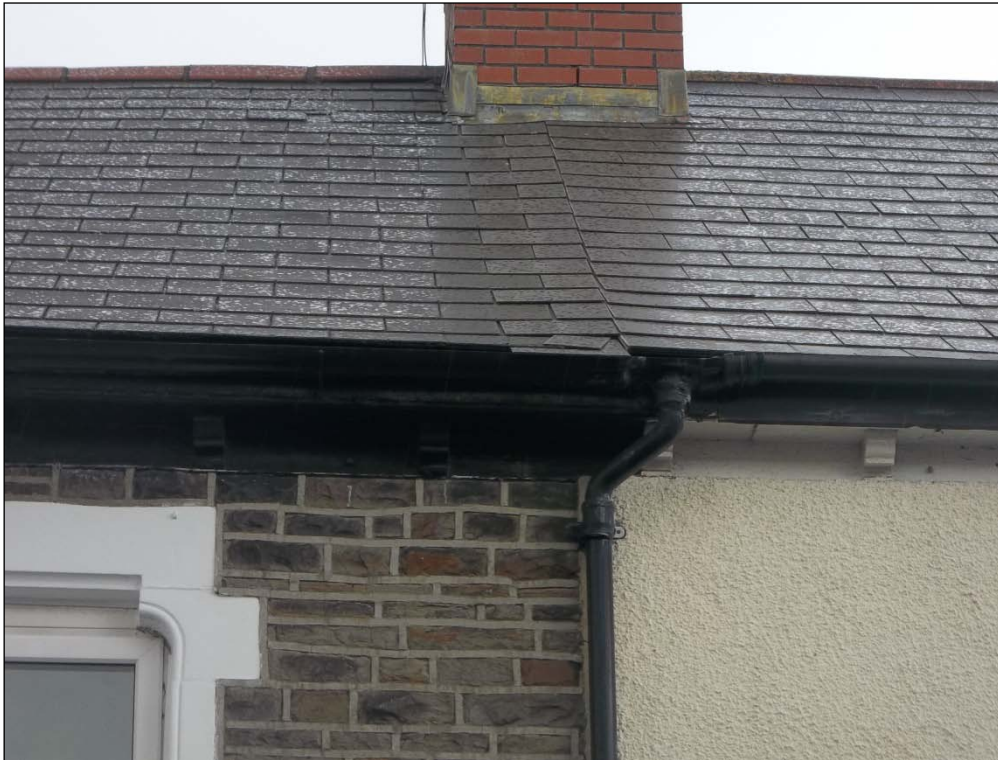
**Photograph 3 – Note some slipped artificial slates on the front elevation.**

A couple of damaged artificial slates were noted, which will require renewal. These man made slates can vary in quality enormously and do begin to fade and look unsightly with age. They will be subject to periodic repairs.

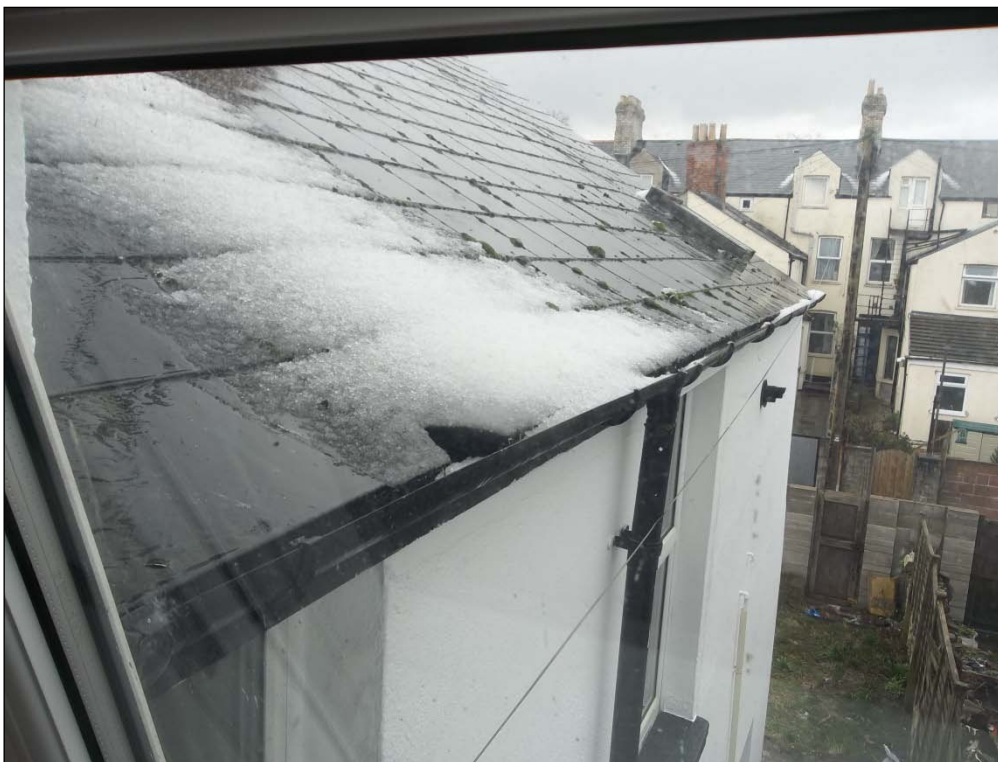
**Photograph 4 – During the inspection there was a hailstone shower as illustrated in the photograph. Note the broken slate at eaves level.**

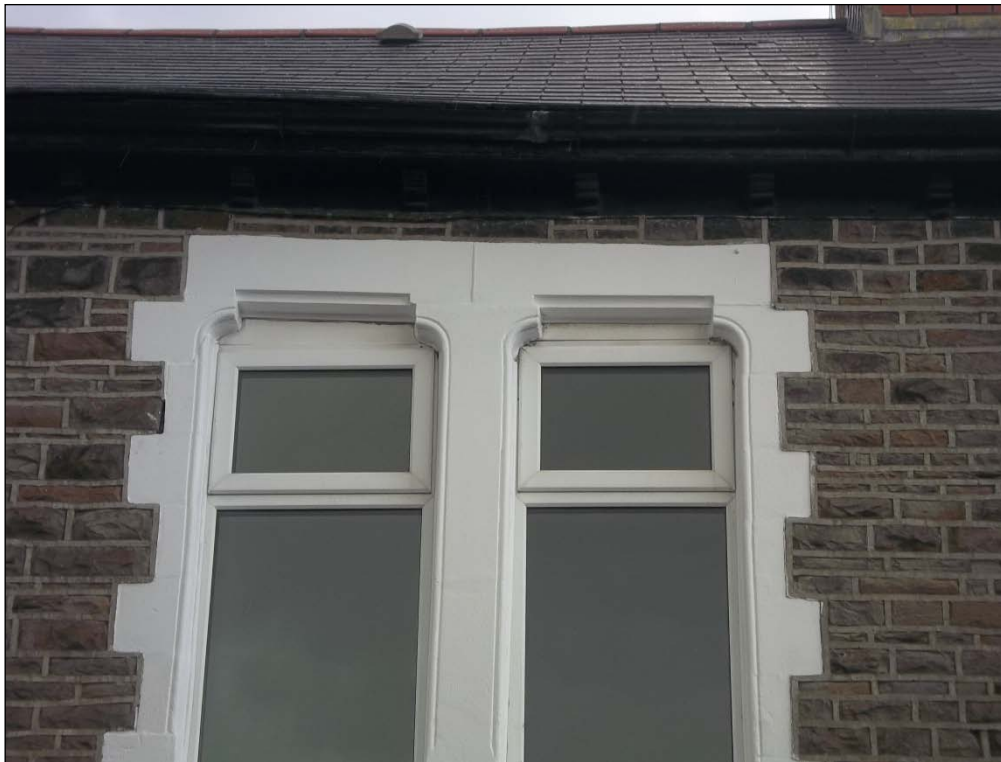
There is a ridge running down the middle of the front elevation roof slope and this appears to tie in with unevenness to the front double bedroom floor and distortion around the front bay and two windows above. The reason for this movement is assumed to be an inadequately sized/distorted Bressumer beam directly beneath the double windows on the first floor. This beam is supporting part of the front elevation wall and roof, and is likely to have warped and distorted with age. Interestingly, all the other properties in the street of the same design as this property appear to be suffering from this. Nevertheless, the possibility of future renewal or strengthening in accordance with local authority consents and structural engineers calculations cannot be entirely ruled out.

**Photograph 5 – Note distortion to roof and window heads, probably as a result of the movement of the Bressumer beam.**

5. Replace defective and perished internal plasterwork.
6. Movement was noted to the front elevation wall, probably due to an over stressed or inadequate sized Bressumer beam. You should budget for possible renewal or upgrading, in accordance with local authority consents and Chartered Structural Engineer supervision. This could prove costly.

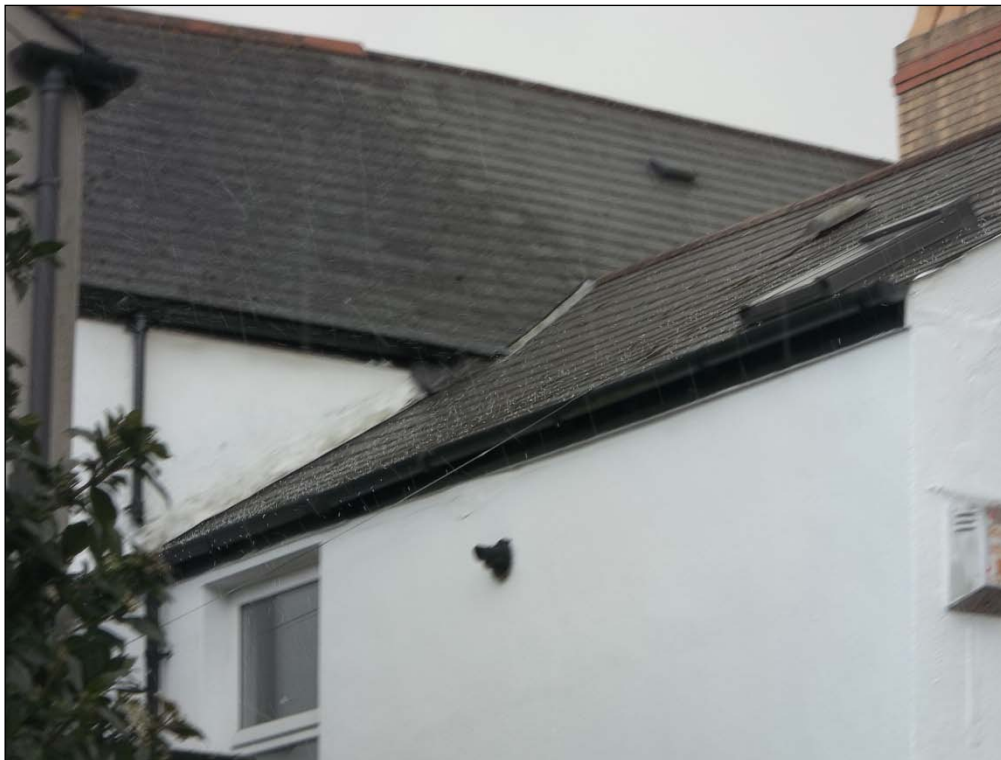
Undulation and distortion was noted to the rear addition roof and intermediary supports are likely to be required for the rear addition purlin.

**Photograph 6 – Undulation to rear roof slopes. Intermediary support will be required.**

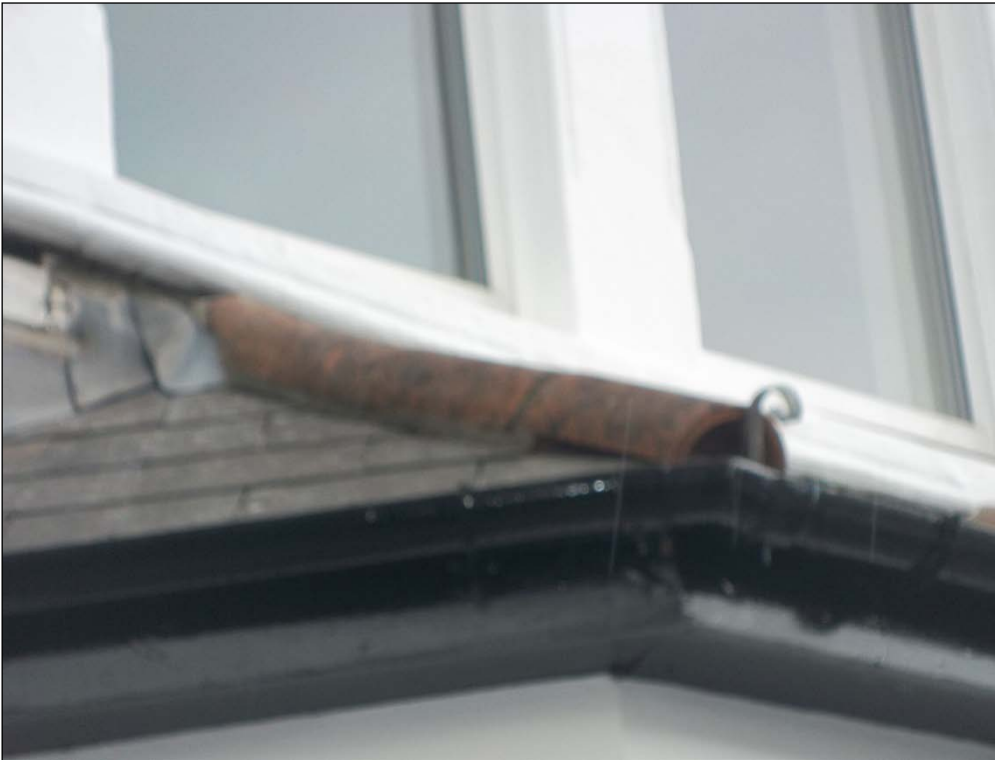
**Photograph 7 – Hip tiles to the front bay require re-bedding.**

The ridge/hip tiles on the front bay require some re-pointing.

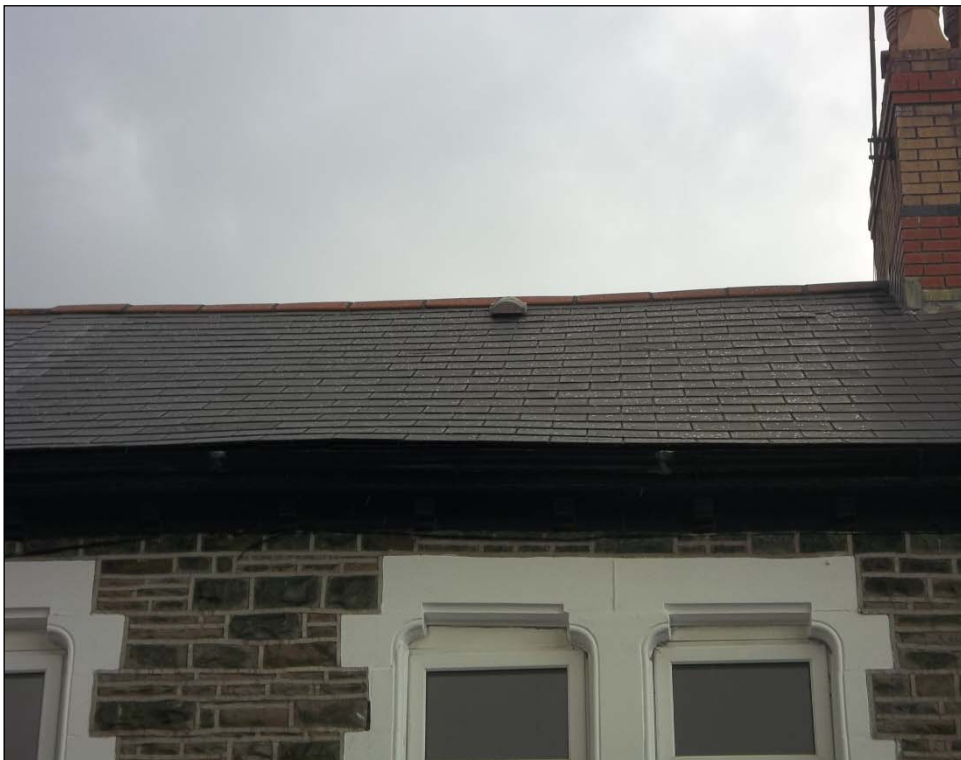
Some slight undulation was noted to the front roof slopes, although this is not considered unusual or excessive in a property of this age and type.

**Photograph 8 – Note undulation to front roof slope.**

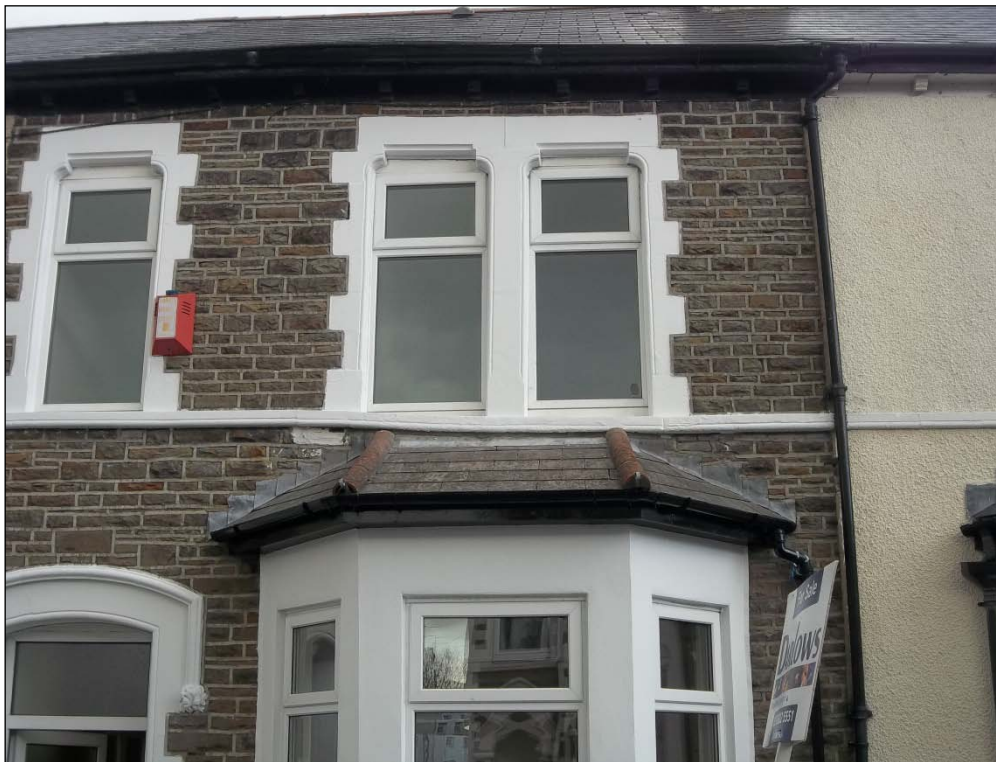
Cracks and deflections to outer walls were observed. The worst of which being across the top of the Bressumer beam on the front elevation and the possibility of remedial repairs to this area cannot be entirely ruled out.

**Photograph 9 – Note undulation to front elevation wall immediately above the bay. The reasons for this are discussed in the report.**

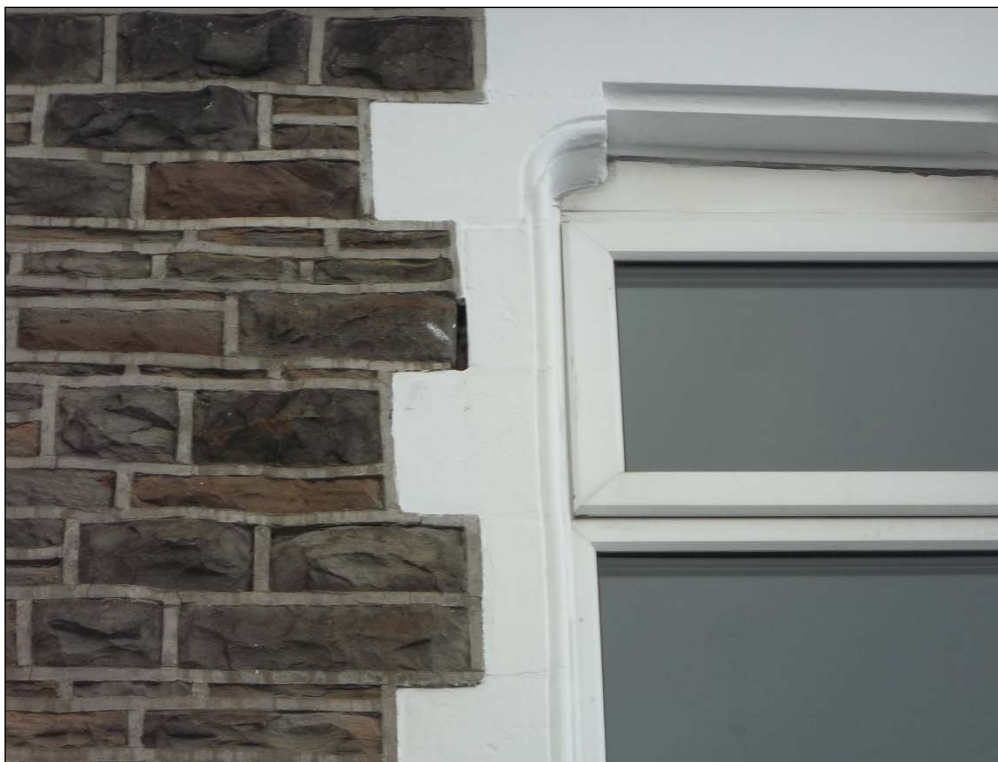
However, the face stone walls have been pointed with a sand and cement render, as opposed to a lime mortar and this can cause spalling and damage to the adjacent stonework.

**Photograph 10 – Distortion to the window head on the first floor front elevation. Also note sand and cement pointing, not lime pointing, and areas of missing pointing.**

On the front elevation, some open mortar joints were noted which would benefit re-pointing.

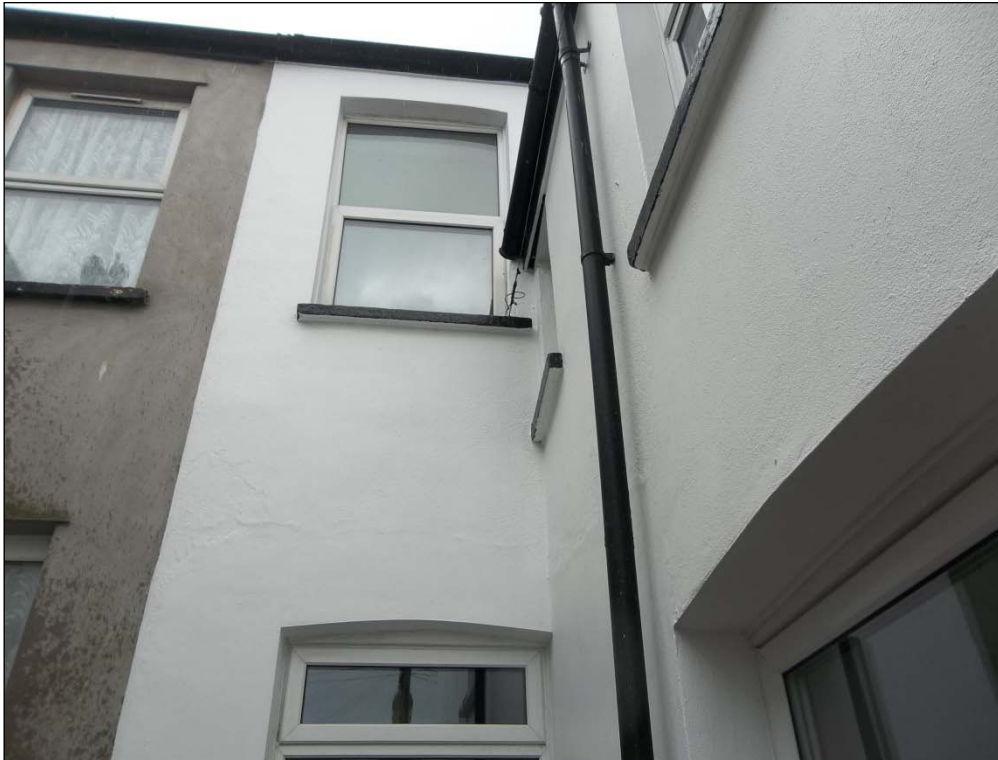
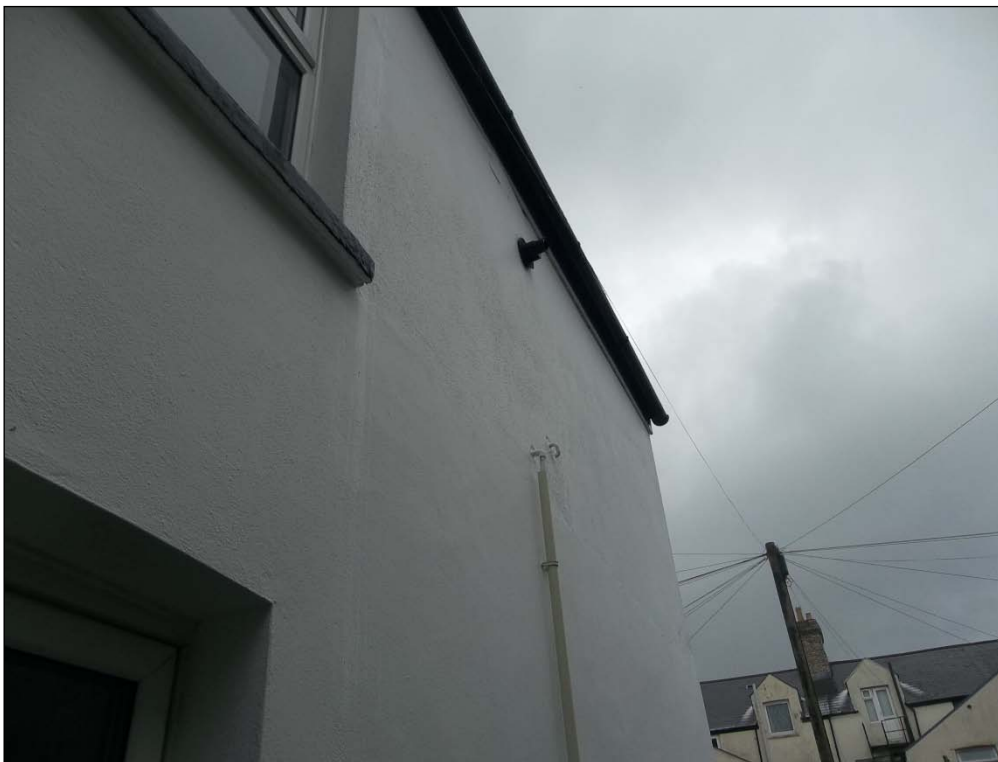
**Photographs 11 & 12 – The lower part of the rear addition appears to be re-rendered. The upper part is an older rendering which may require some attention in due course.**

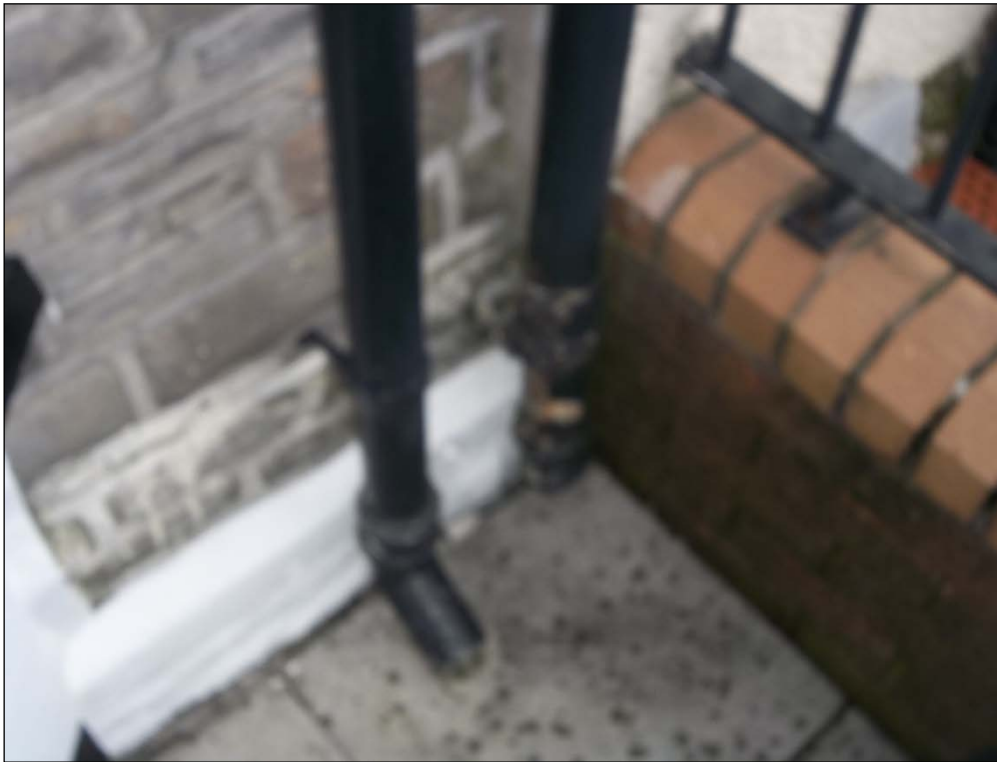
**Photograph 13 – Downpipe leading directly into the ground. The existence of soakaways however cannot be confirmed.**

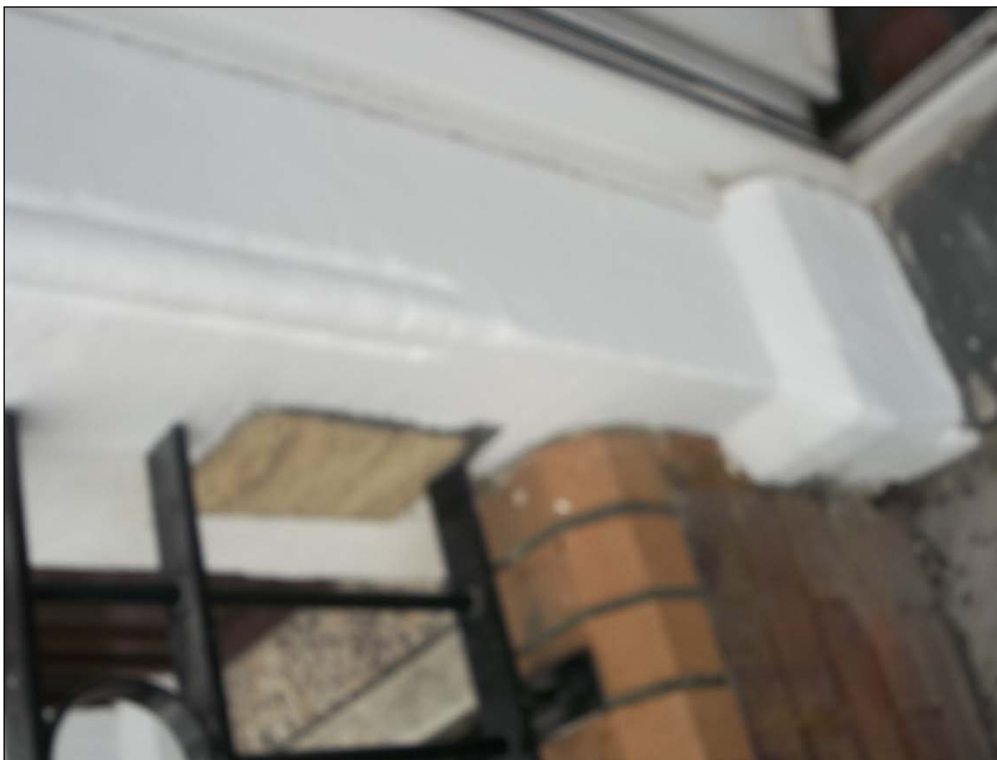
**Photograph 14 – Example of boundary wall built up against house with no vertical damp proof course or gap between the boundary walls and the main dwelling. This can encourage penetrating damp.**

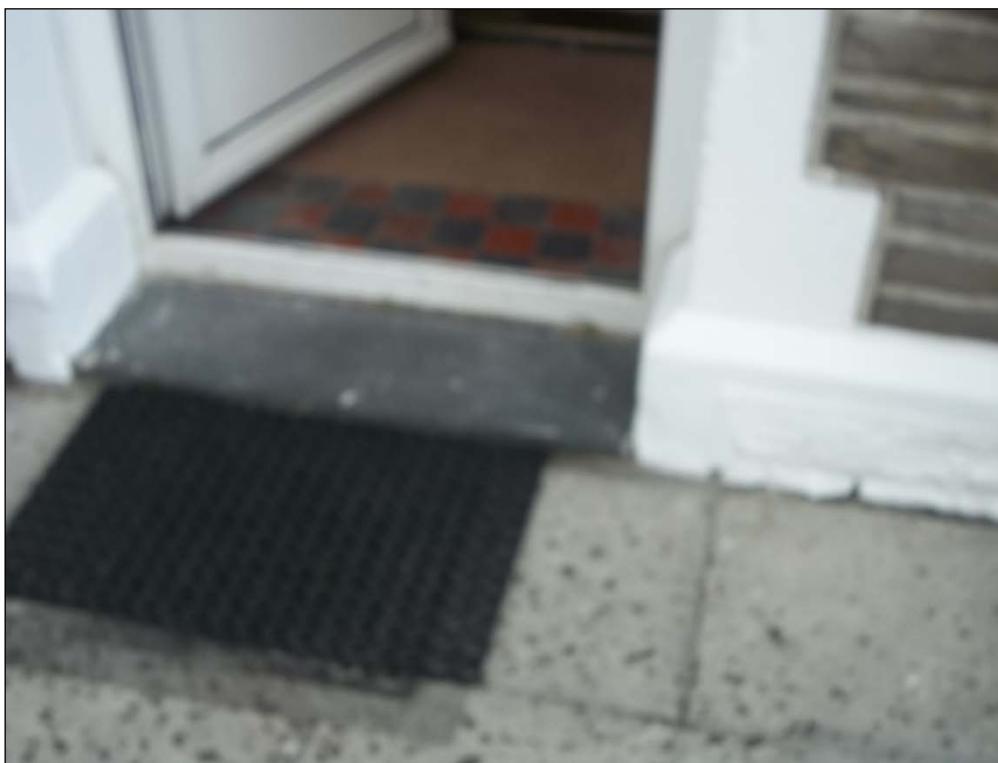
**Photograph 15 – External path levels are too high.**

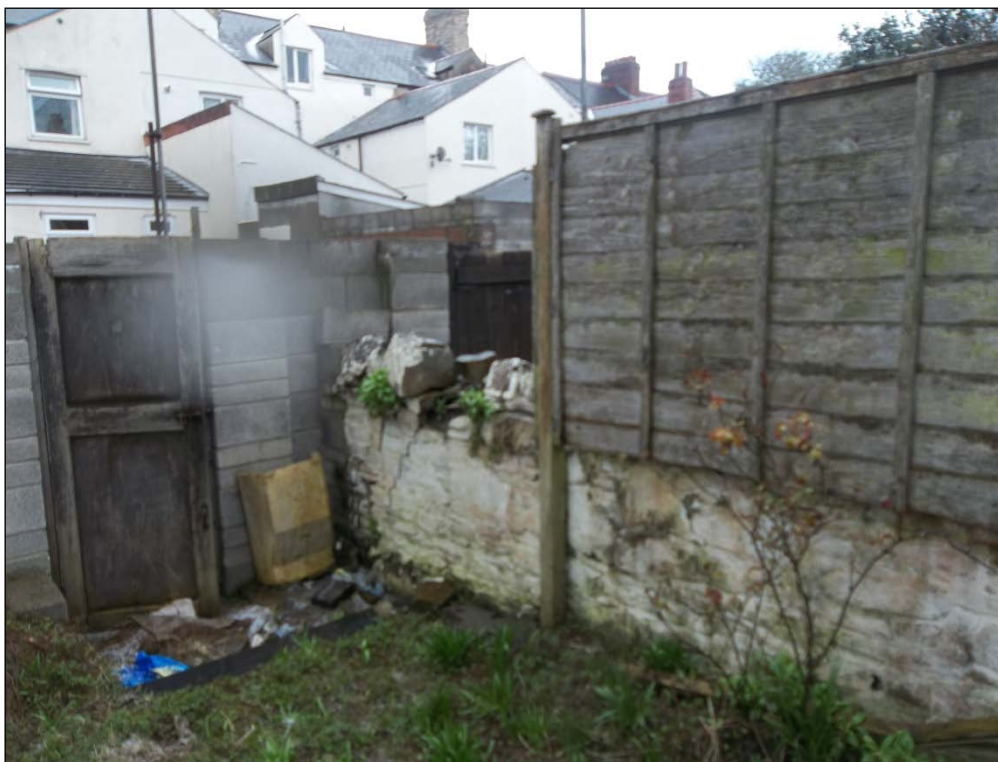
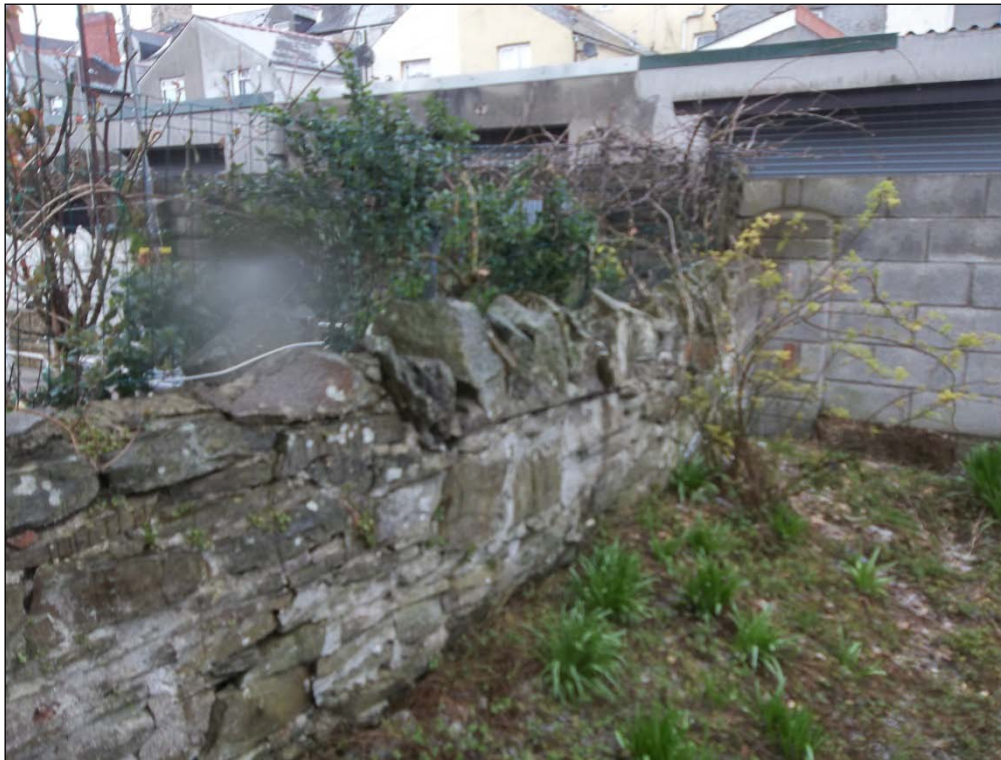
**Photographs 16 & 17 – Distortion and damage to boundary walls and fences which require upgrading.**

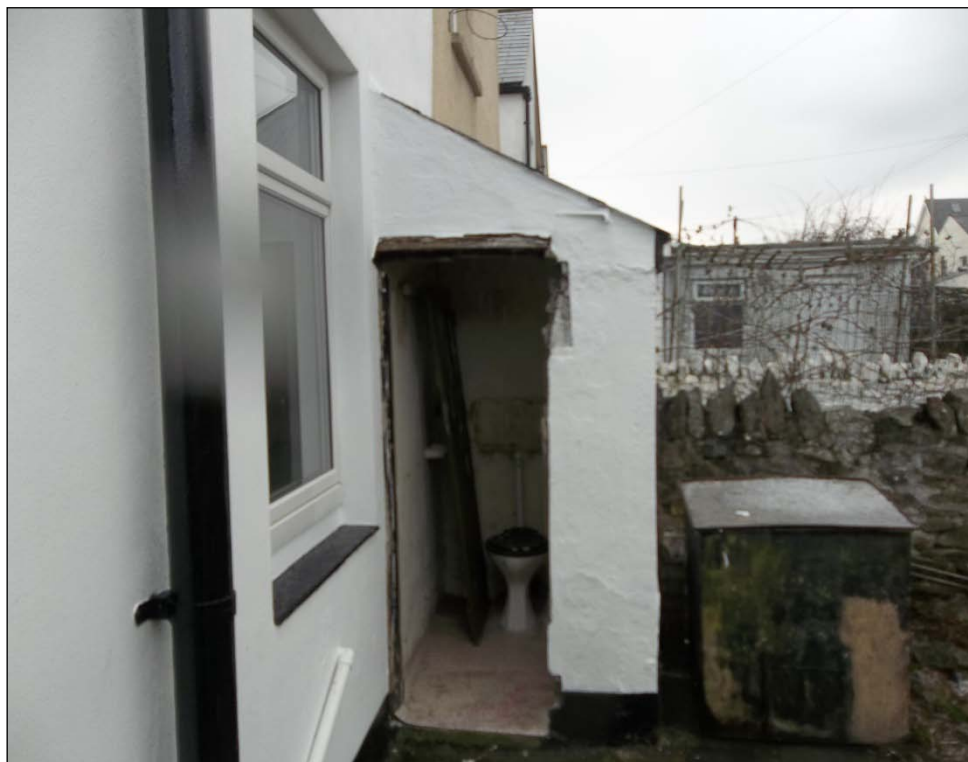
There is one outside WC. This requires overhauling of the slate roof and the single brick walls are causing damp penetration to occur. There is rot to the lintels which requires renewal and the door itself requires re-fixing. The WC is old and is likely to require renewal.

**Photograph 18 – Poor condition of lean-to outside WC.**

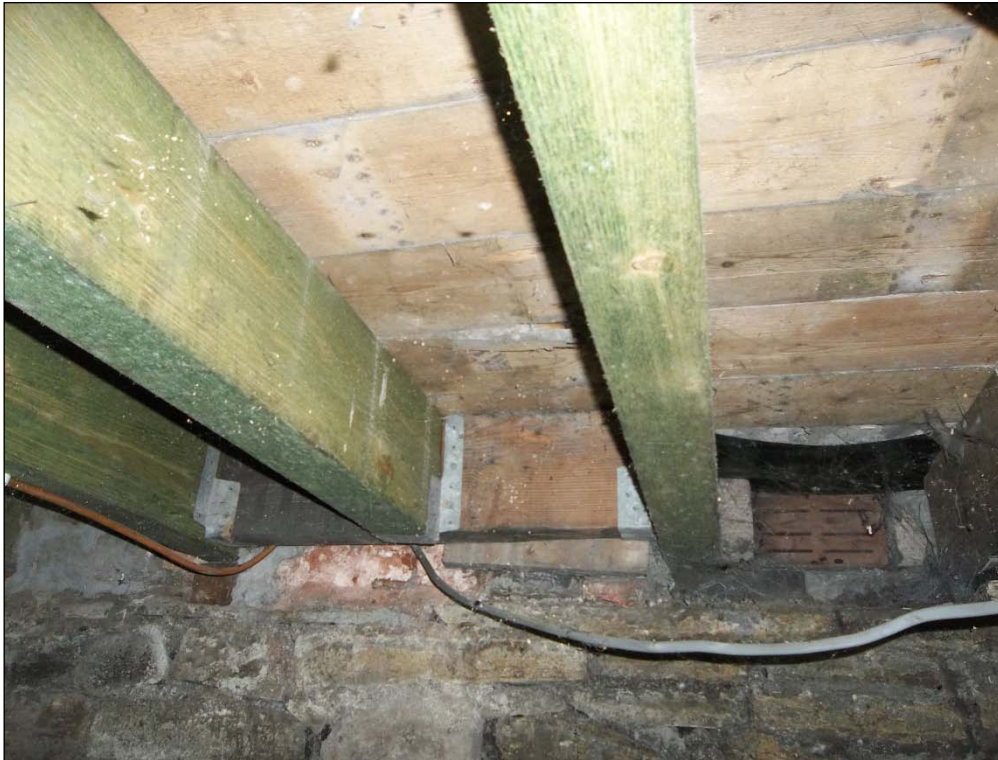
To the ground floors, some past repair was noted from within the basement area by the using of herringbone strutting and new joists ends (i.e., joist hangers etc. installed). This indicates there has been a problem in the past. See Section 6.

**Photograph 19 – Past repair to joists in cellar. Note galvanised joist hangers. Conveyancers to carry out further investigations.**

Past repair was noted to the timber ground floors from within the basement. Conveyancers to carry out further investigations and refer back to the surveyor.

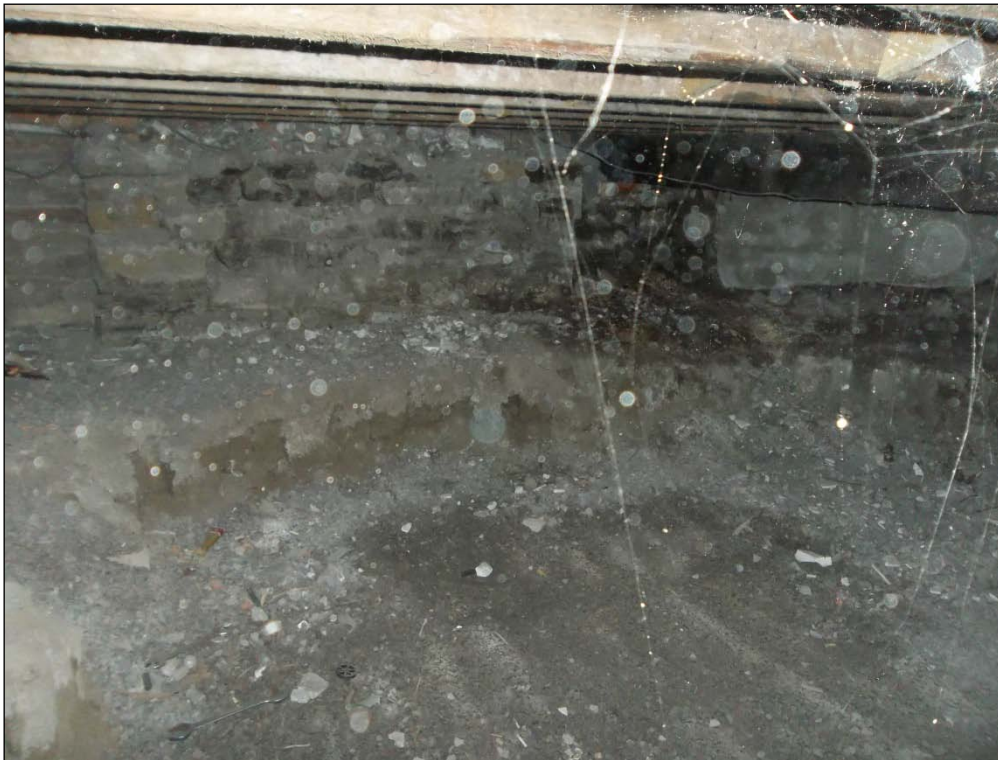
**Photograph 20 – The front basement room which cannot be properly accessed has been partially dug out.**

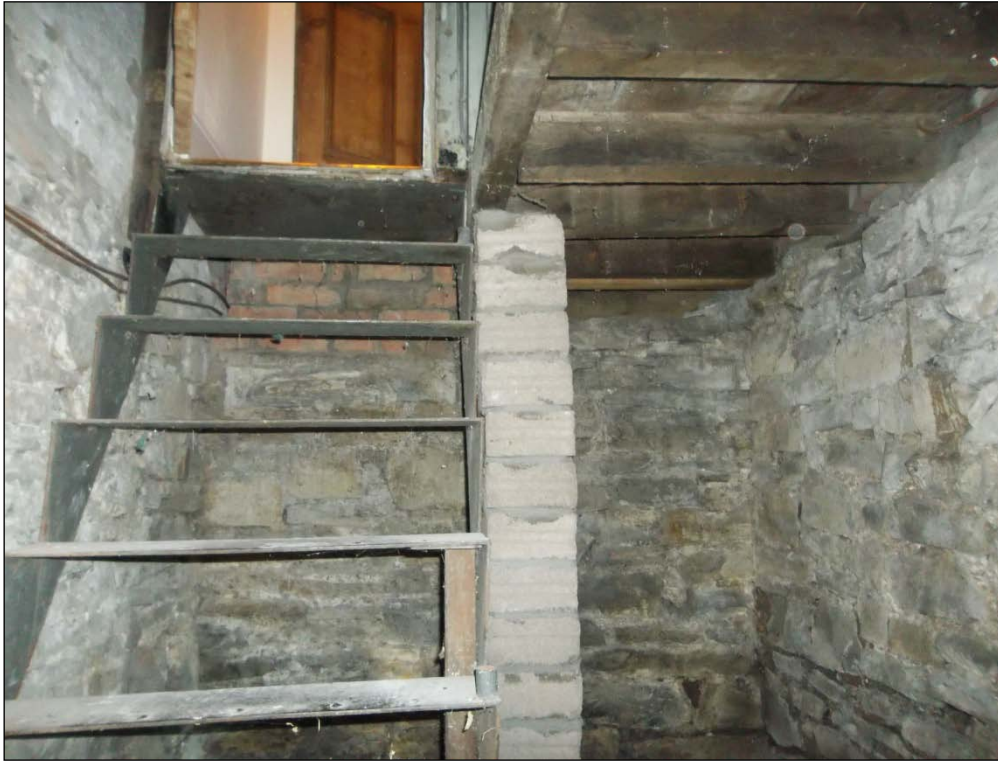
**Photograph 21 – Steep steps with limited headroom leading down to basement.**

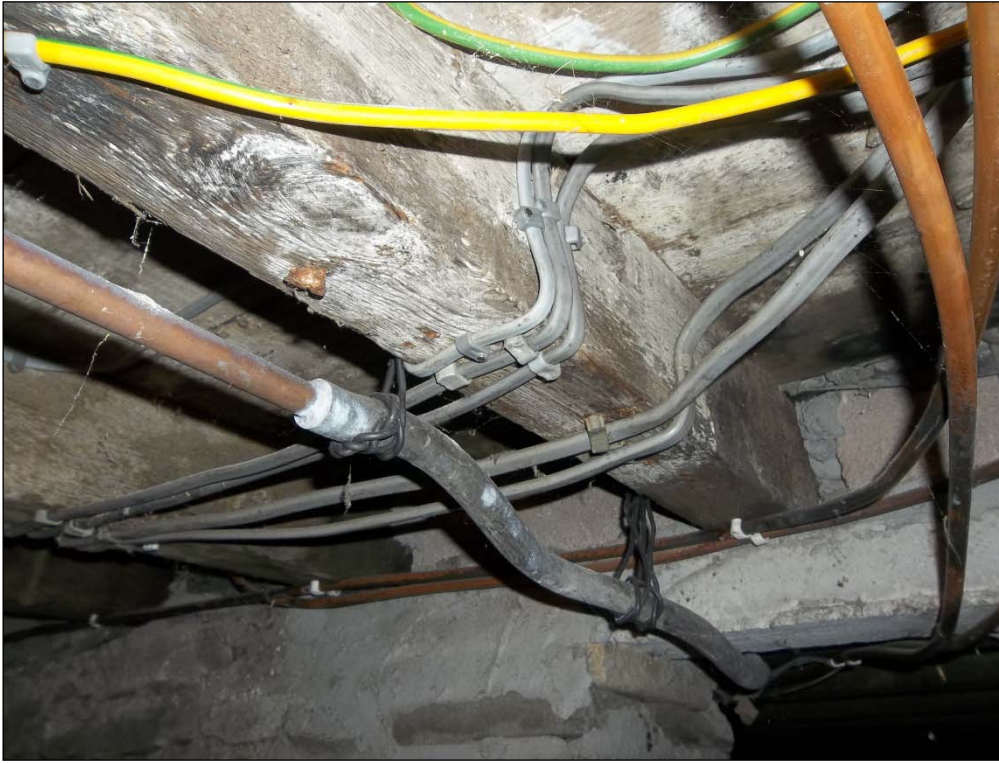
**Photograph 23 – Lead rising main which would benefit replacement in Alkethene.**

2. Confirm the condition of the drainage.
3. A competent plumber to replace old lead pipework in modern building materials.
4. Seal firebreak walls to roof void and re-bed purlins.

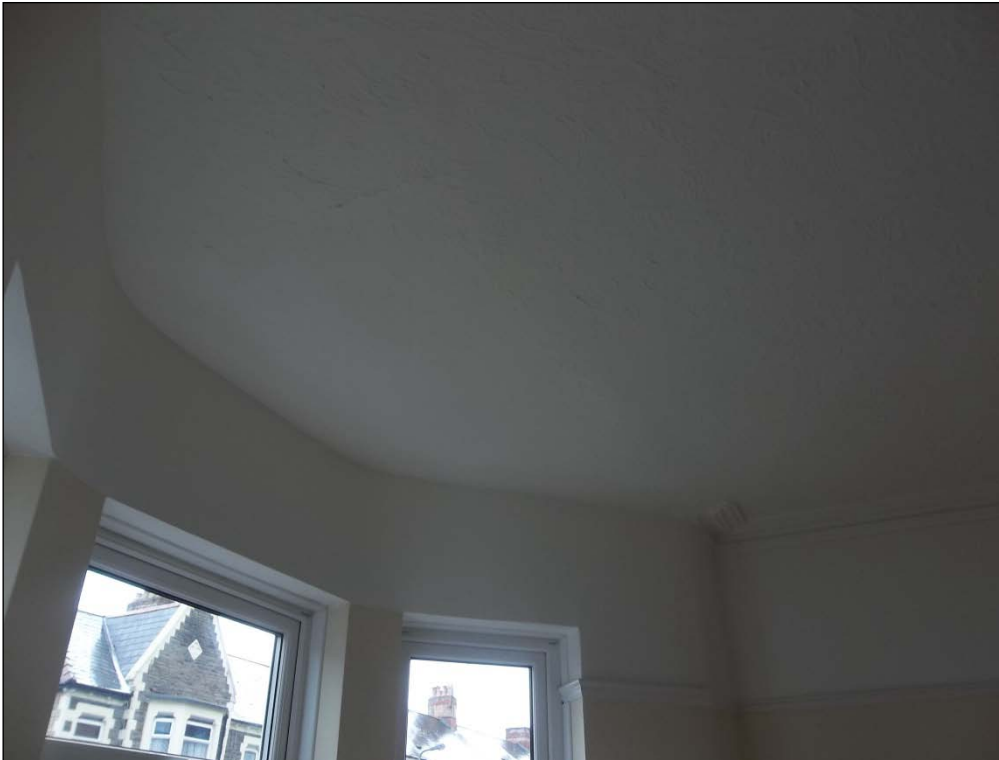
Interestingly, the covings to the front living room do not extend into the bay itself, possibly indicating past repairs. See Section 6 – Matters to be referred to your Conveyancer.

**Photograph 25 – This is the front bay. The covings go all around the room but not into the bay. There may have been past repairs and conveyancers to further investigate.**

Any past repairs regarding the beam on the front elevation as referred to under Item 3.6 – External Walls and Elevations.

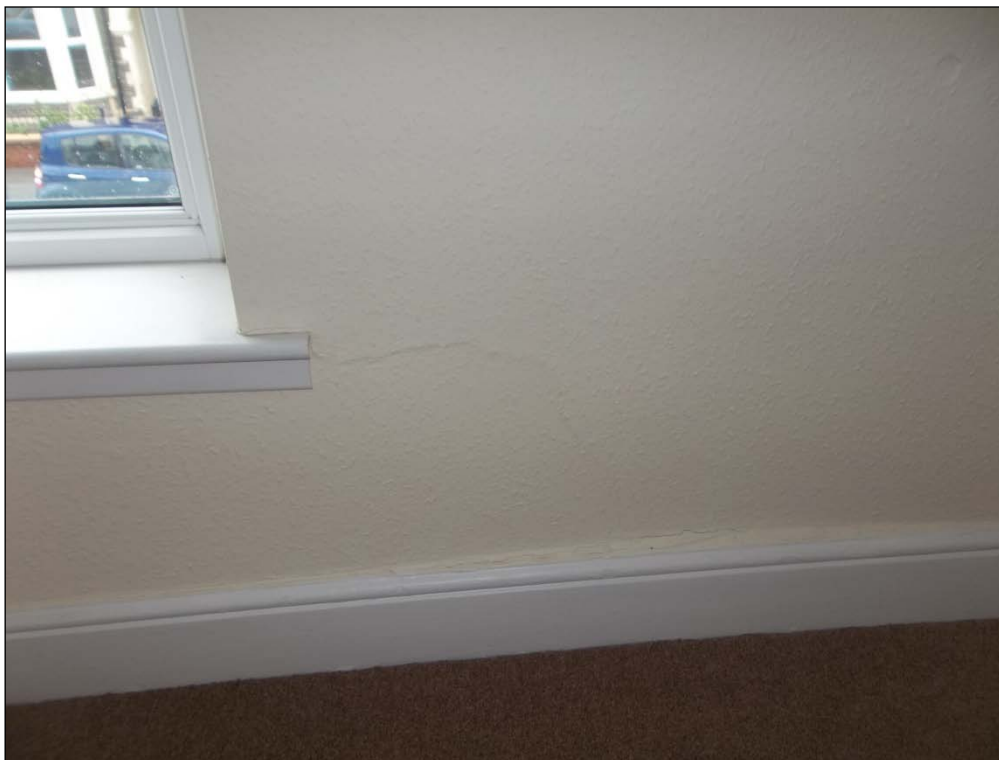
**Photograph 26 – Some cracking to first floor front bedroom around the line of the Bressumer beam.**

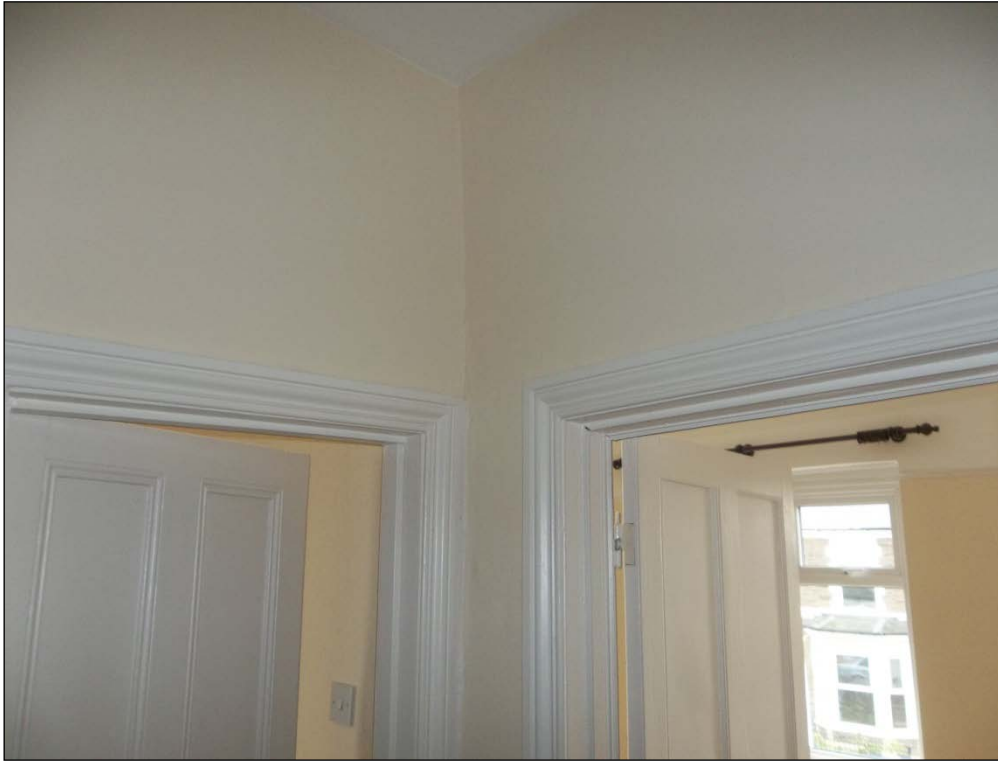
**Photograph 27 – Example of old movement to door frames.**

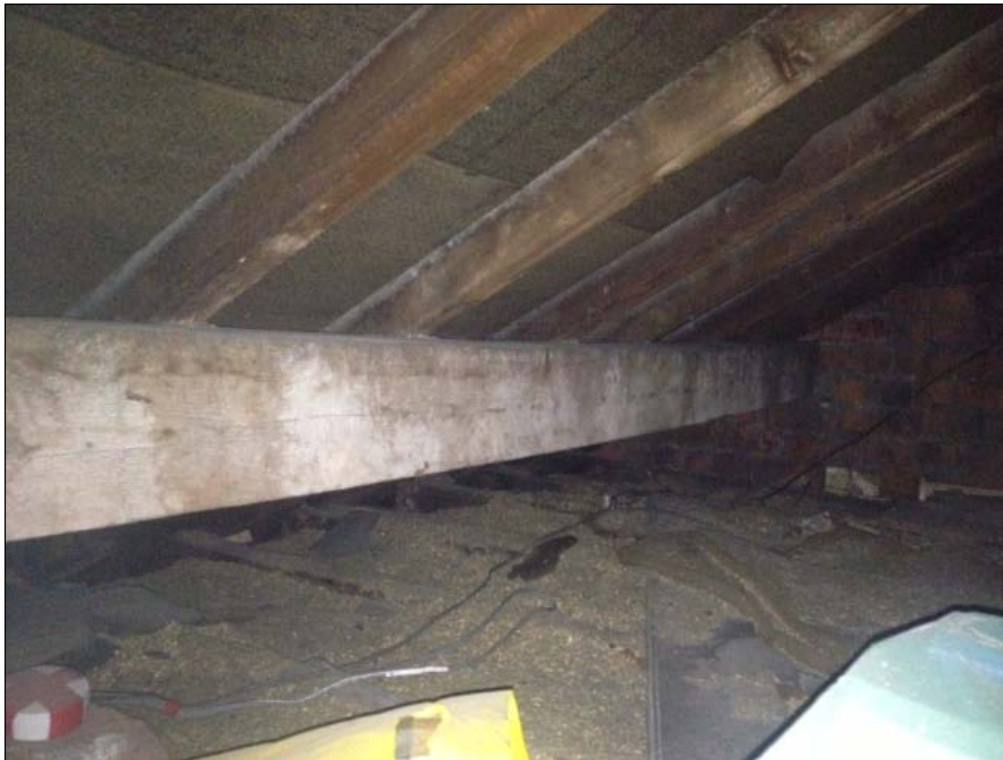
**Photograph 28 – Example of purlin on rear addition requiring re-bedding.**

The purlins would benefit some re-bedding and, as already mentioned, would also require intermediary support.

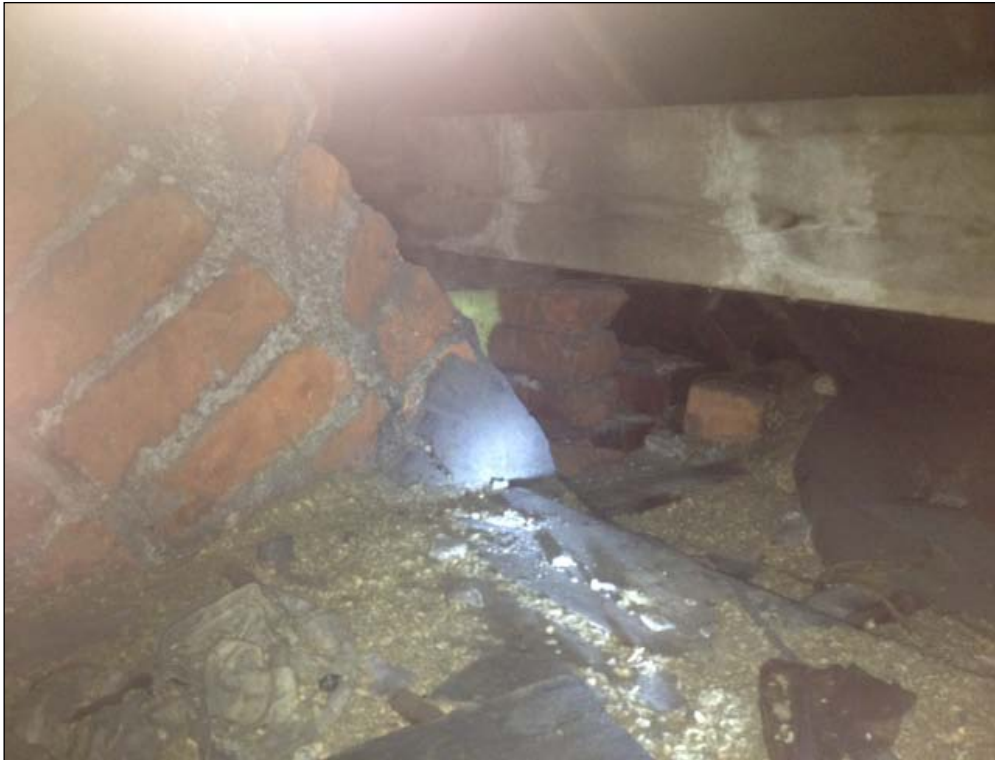
**Photograph 29 – Rear elevation purlin would benefit intermediary support and hence the reason for the bowing.**
