Introduction

A large condensate leak occurred in December 2004 on a platform operated by Total E&P in the North Sea. No ignition occurred but if it had the consequences could have been very serious. Control of major risks – including hydrocarbon releases – is a main theme for E&P.

TOTAL  	<h1 style="text-align: center; color: red;">SAFETY FEEDBACK NOTICE</h1>		
	<h1 style="text-align: center; color: red;">CONDENSATE LEAK</h1>		
	DGEP / HSE	Ref: 5 - 2005	Issued: 24/3/05

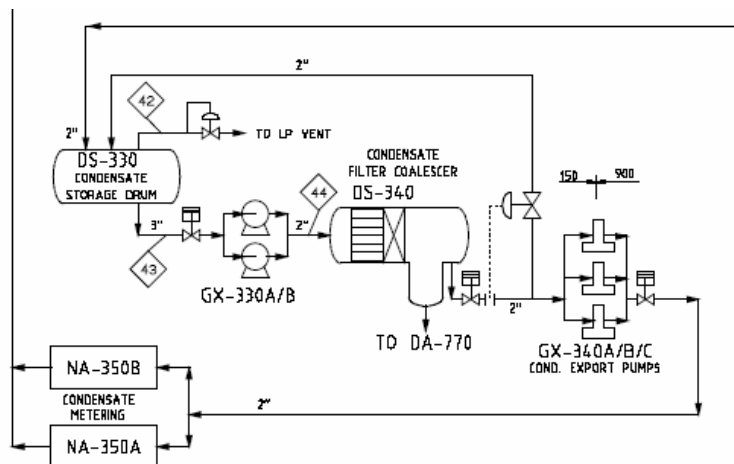
Two condensate booster pumps GX330 A/B supply condensate from a flash drum to a coalescer.

The pumps (positive displacement type) are situated on the cellar deck of a process platform. The deck is plated with drains connecting to a Skimovex unit. The deck is largely enclosed by firewalls and weather cladding.

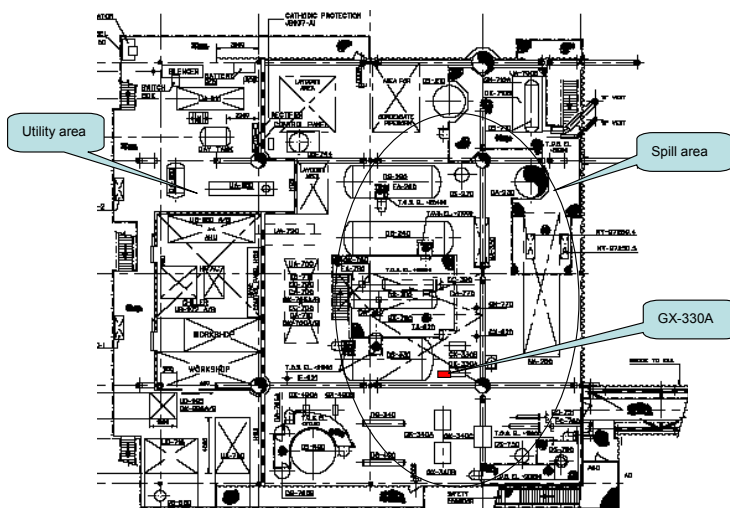
At 0705 a.m. the Skimovex high level alarm activated in the Control Room. Investigation showed a large leak of condensate in spray form from pump GX330A. The pump was stopped from the Control Room. The leak began to stop. Vapourised condensate then activated the fixed gas detection system. Personnel were mustered. Cellar deck ventilation was maximized and clean-up operations started. The emergency was handled in a satisfactory manner.

Leaking condensate covered approximately 65% of the deck area of 644m². The condensate release quantity has been estimated as being between 350 and 500 kg.

- The aft bearing of the output shaft of the gear box was found damaged (to be investigated further). The damaged bearing caused play on the output shaft, to which the pump drive shaft is connected. Out of centre rotation of the pump drive shaft caused the single mechanical seal to be destroyed allowing a leak to occur.

- Upgrade or change the pumps. Improvements being studied are: upgrade the gearbox; provide a double seal arrangement with accumulator and leak detection (verify API guidance); install a pulsation damper as originally proposed in 2004.

- Review leak detection based on gas detection above the booster pumps and liquid level detection in the pump drip pan.
- Perform a survey to establish an integrity matrix for condensate and other sensitive systems, including pump type, seals, fluid, controls, flanges, vibration monitoring, means of detection etc. Then make a gap analysis to establish monitoring protocols/improvements.
