Introduction

GP	<h1 style="text-align: center; color: red;">SAFETY FEEDBACK NOTICE</h1>		
	<h1 style="text-align: center; color: red;">ACCIDENT ON MUD BLENDER</h1>		
	DGEP / HSE	Ref: 18 - 2005	Issued: 27/09/05

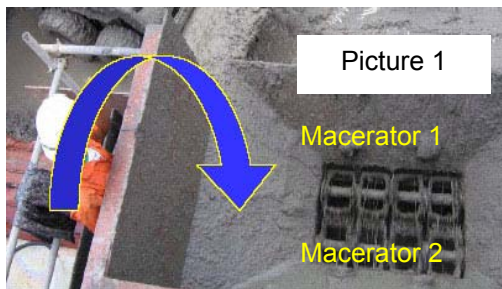
1. The pipe fitter cleaned the mud blender by entering the mud blender through the top of the equipment (temporary platform provided). *Picture 1.*
2. The mud pump operator cleaned the mud pump, assisted by the mud blender operator with his flashlight (the lighting on those locations was minimal, barely enough for work)

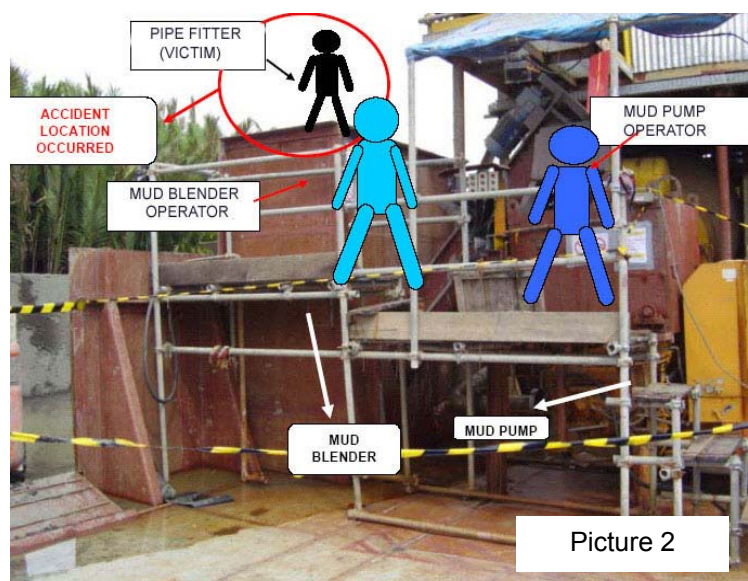
At approximately 22.45, the mud pump operator went out of mud pump while the mud blender operator went to the mud blender to provide more lighting for the pipe fitter. *Picture 2.*

Without clear instructions, the mud pump operator switched on macerator 1 of the mud blender. The pipe fitter who was standing on the mud blender between the 2 macerators was hit by macerator 1 on his face and upper body, while fortunately macerator 2 was not started.
