Client Name	Holiday Inn Express Dublin City Centre	Job No	206
Client Site	Findlater House Ltd 28-32 O'Connell Street Dublin 1 D01 T2X2		
Client Contact	Darren Murray		
Date	04/04/2024	PPM Visit	1 of 2

Maintenance Report

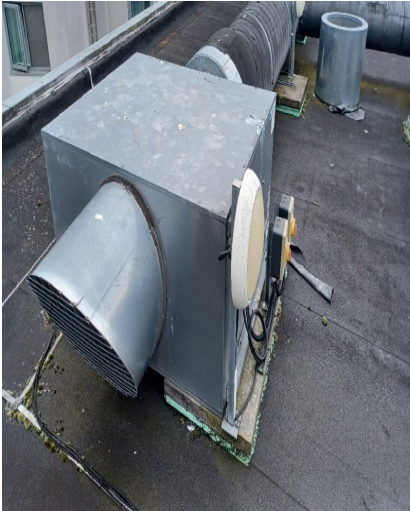
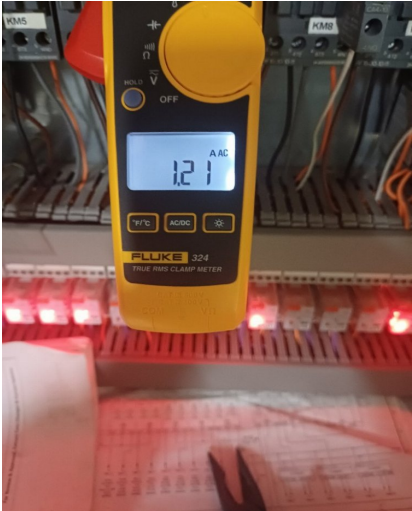
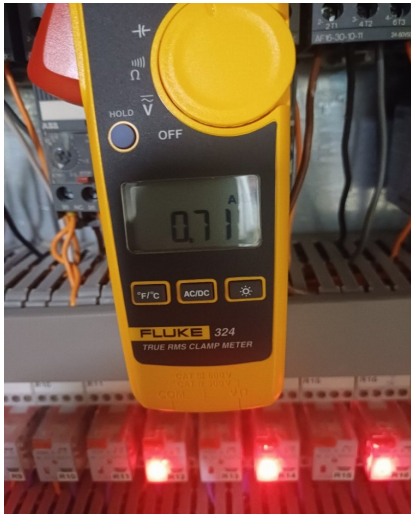
Asset No	03	Asset Location	Roof
Make	ELTA	Model	TD-560-EC
Year	N/A

24. Bearing ok	Yes	Bearing ok	Yes	
25. Drive Belts Changed	N/A	Drive Belts Changed	No	
26. Drive belt list and size	N/A	Drive belt list and size	N/A	
Engineer Comments				
Ppm for the Extract fan located on the roof of the building.				
Extract fan no.1 supplied from contactor Km8.				
Extract fan no.2 supplied from contactor Km9.				
No overloads present on contactors.				
Time schedule from via bms is 8am to 7.30pm each day

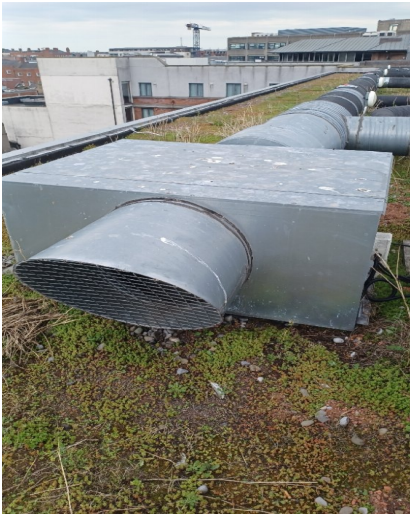
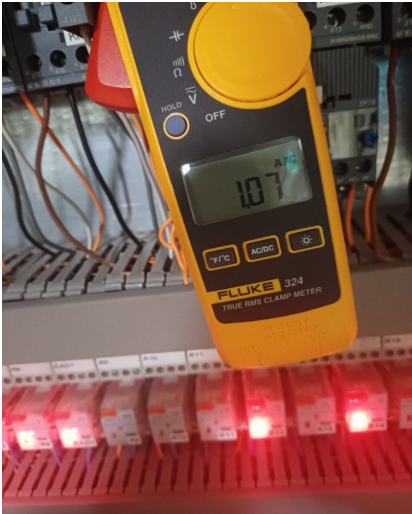
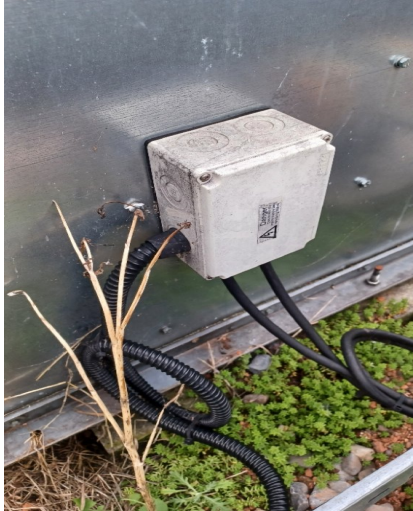
Asset No	04	Asset Location	Roof
Make	ELTA	Model	SDA400/4-1E
Year	N/A

24. Bearing ok		Yes	Bearing ok		
25. Drive Belts Changed		N/A	Drive Belts Changed		
26. Drive belt list and size		N/A	Drive belt list and size		N/A
Engineer Comments					
Checked operation of the Extract fan supplied from contactor Km10.					
Overloads present on contactor is set to 2.5a.					
Time schedule from via bms is 6.00am to 12am each day

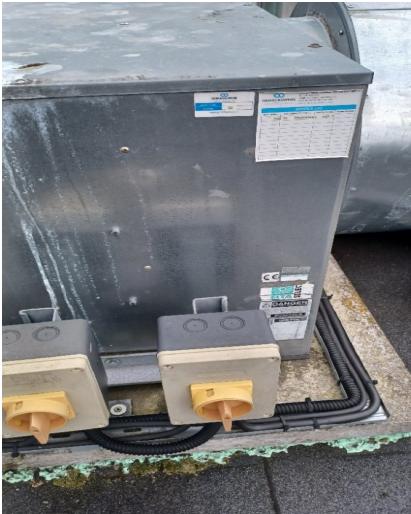
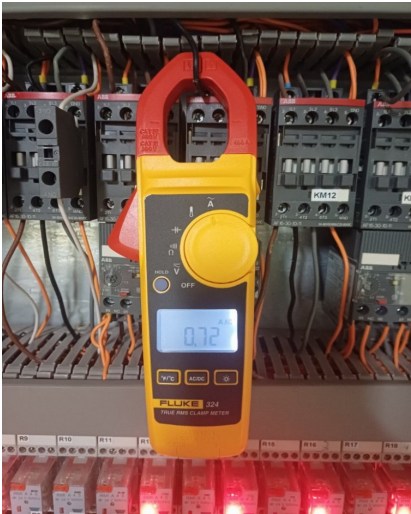
Asset No	05	Asset Location	Roof
Make	ELTA	Model	SM200-1ECL
Year	N/A

1. Area Serving	Ground floor toilets	3. Grills Cleaned	No
2. Panel Reference	EF-02	4. Dampers Checked	N/A
Extract Fan 1		Extract Fan 2	
Operating Details		Operating Details	
17. Design motor running current	1.95A flc	Design motor running current	N/A
18. Overload set	2.0A	Overload set	N/A
19. Actual motor running current	0.72A	Actual motor running current	N/A
	N/A		N/A
	N/A		N/A
20. Variable speed	Yes	Variable speed	
21. Running	@80% %	Running	N/A %
22. Fan Condition	Ok	Fan Condition	
23. Bearings greased	No	Bearings greased	N/A
24. Bearing ok	Yes	Bearing ok	
25. Drive Belts Changed	N/A	Drive Belts Changed	
26. Drive belt list and size	N/A	Drive belt list and size	N/A
Engineer Comments	Checked operation of the Extract fan supplied from contactor Km11. Overload present on contactor set to 2.0a Time schedule from via bms is 6am to 10pm each day

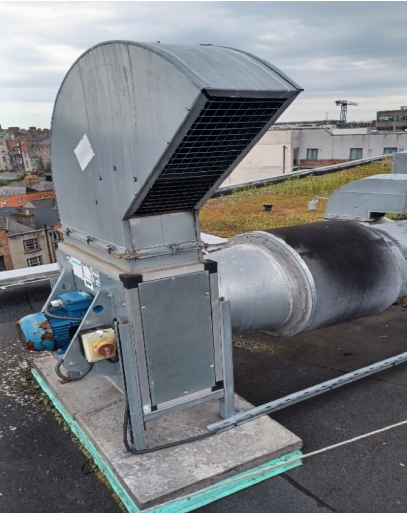
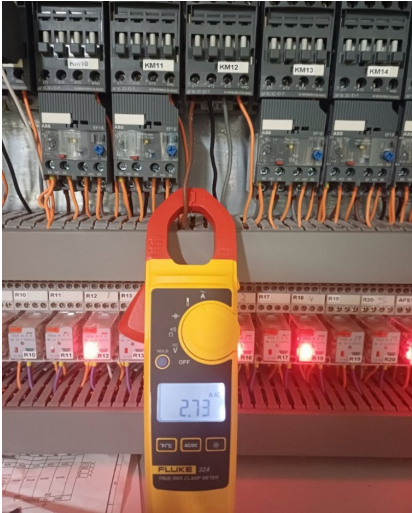
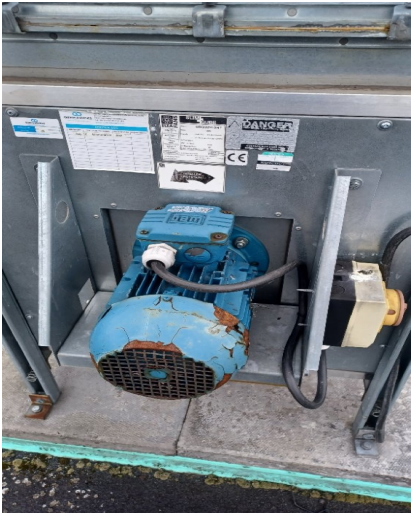
Asset No	06	Asset Location	Kitchen
Make	ELTA	Model	SSQ42/4-3HT
Year	N/A

24. Bearing ok	Yes	Bearing ok	
25. Drive Belts Changed	N/A	Drive Belts Changed	
26. Drive belt list and size	N/A	Drive belt list and size	N/A
Engineer Comments			
Maintenance carried out the Extract fan that is located on roof of the building.			
Extract fan supplied from contactor Km12.			
No overload present on contactor.			
Time schedule from via bms is 6am to 11pm each day

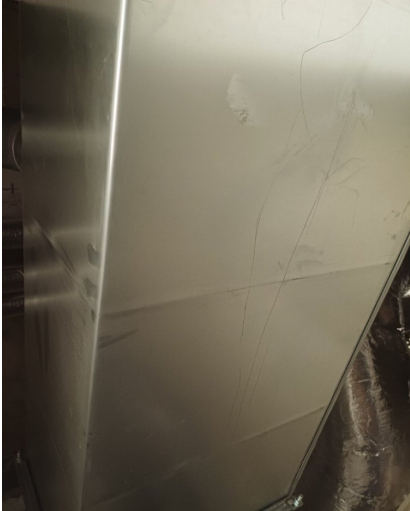
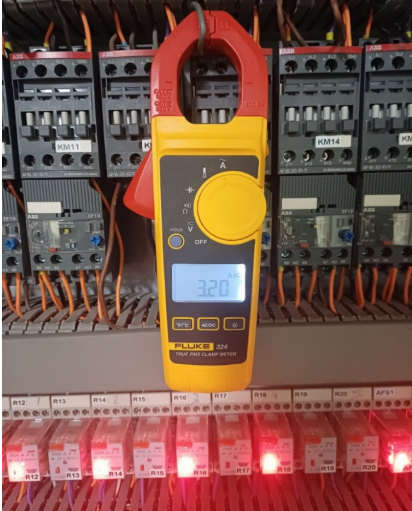
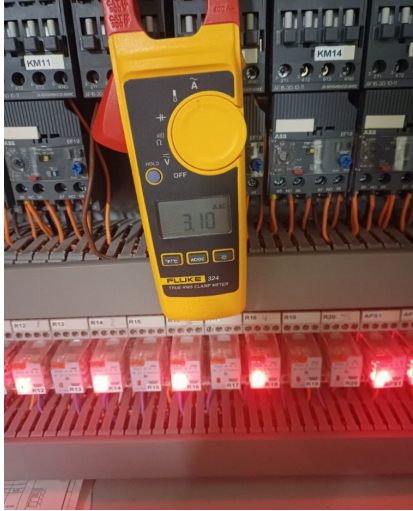
Asset No	07	Asset Location	Basement
Make	SEM	Model	250-1EC
Year	N/A

24. Bearing ok	Yes	Bearing ok	No
25. Drive Belts Changed	N/A	Drive Belts Changed	No
26. Drive belt list and size	N/A	Drive belt list and size	
Engineer Comments	Maintenance on the operation of the Extract fan supplied from contactor Km13. Overload present on contactor set to its max of 2.7a. Amp reading at time of visit to site was 3.3a Time schedule from via bms is 6am to 11pm each day A previous recommendation from past Maintenance visit is to change the O/L to a higher rating ampage. This has been previously quoted Q5840.

Repair Required	Yes		
Engineers Name	Iain Egan	Engineers Signature	T. Doffy

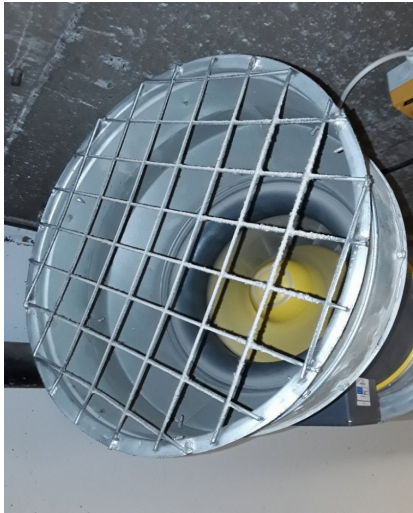
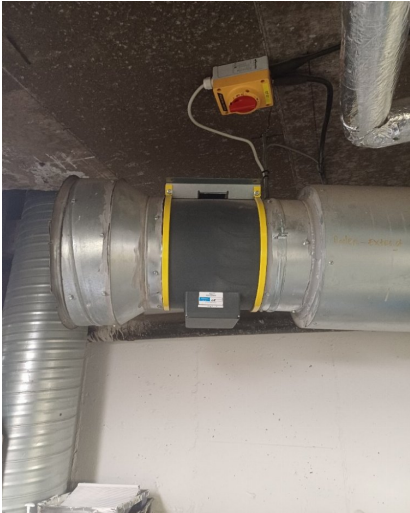
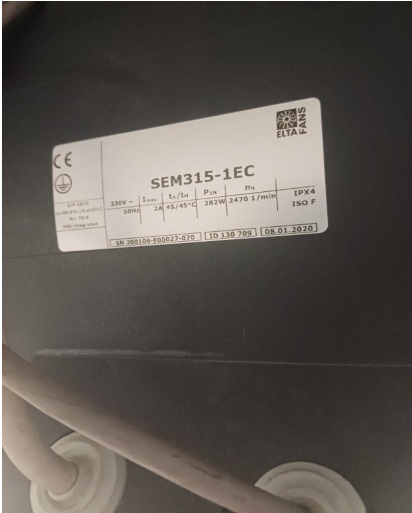
Asset No	08	Asset Location	Plantroom
Make	ELTA	Model	SEM315-1EC
Year	2015

24. Bearing ok	Yes	Bearing ok	
25. Drive Belts Changed	N/A	Drive Belts Changed	
26. Drive belt list and size	N/A	Drive belt list and size	
Engineer Comments	Ppm carried out on the operation of the Extract fan is located within the plant room. EF07 Extract fan supplied from contactor Km14 Time schedule from via bms is 12am to 12pm each day. Fan is controlled by speed controller which is located beside mcc panel, operating as required.

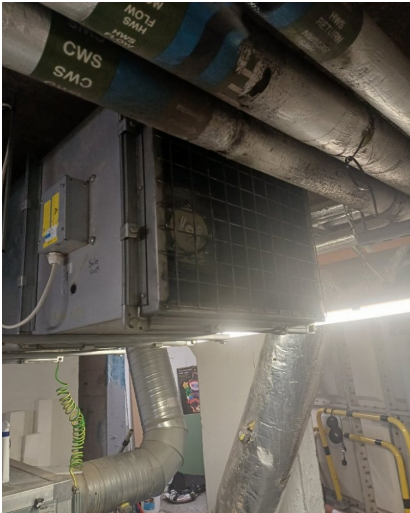
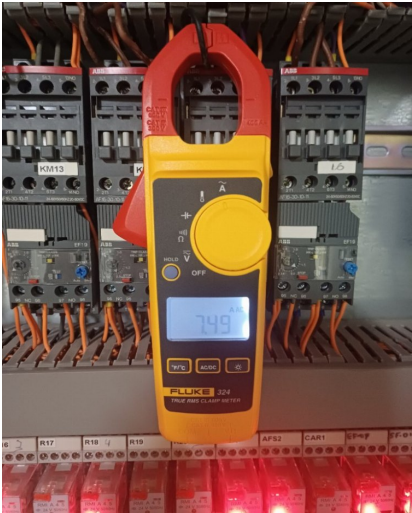
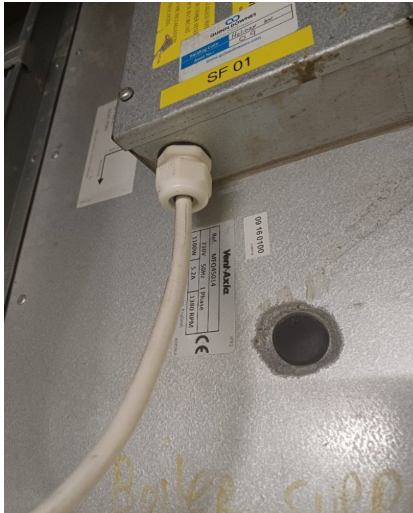
Asset No	09	Asset Location	Plantroom
Make	Vent-Axia	Model	MFQ45014
Year	N/A

24. Bearing ok	Yes	Bearing ok		
25. Drive Belts Changed	N/A	Drive Belts Changed		
26. Drive belt list and size	N/A	Drive belt list and size	N/A	
Engineer Comments				
Ppm carried out on the operation of the Supply fan for boiler - supplied from contactor Km15 in mcc panel. Motor running ok, but pulling higher amps than spec, motor could potentially fail at any time, recommend replacing fan. Overload on contactor set to its max of 6.3a. Amp reading at time of visit to site was 7.49a Time schedule from via bms is 6am to 11pm each day A previous recommendation from past Maintenance visit is to change the O/L to a higher rating ampage.

Repair Required	Yes		
Engineers Name	Iain Egan	Engineers Signature	T. Doffy
