AHU

Client Name	Holiday Inn Express Dublin City Centre	Job No	206
Client Site	Austinbrook Ltd 28-32 O'Connell Street Dublin 1 D01 T2X2		
Client Contact	Darren Murray		
Date	21/08/2023	PPM Visit	2 of 2

Asset No	02 AHU 2	Asset Location	Plant Room
Make	Salda	Model	Smart Air 2KR SW50R
Year	2016

Maintenance Report

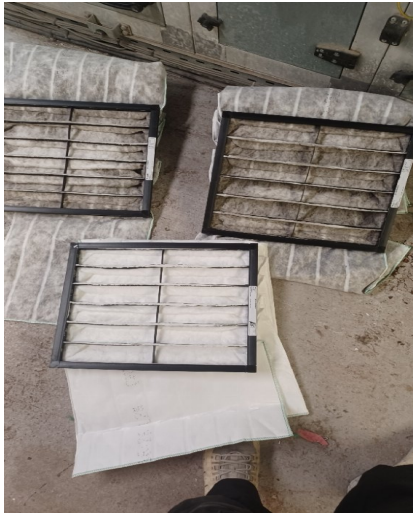
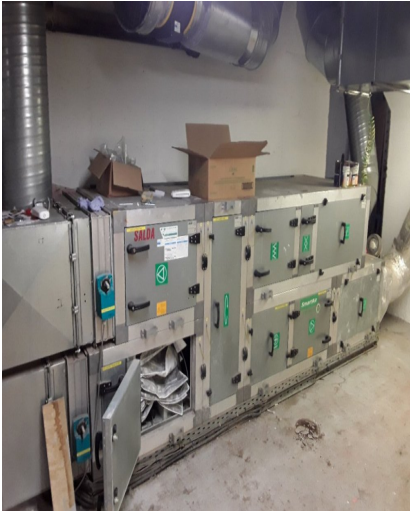
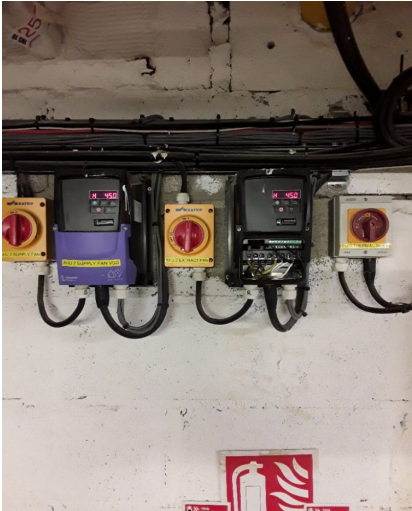
26. Bearing OK	Ok	26. Bearing OK	Yes
27. Drive Belts Changed	Direct drive	27. Drive Belts Changed	Direct drive
28. Drive Belt list and size	N/A	28. Drive Belt list and size	N/A
Engineer Comments	Checked operation of the ahu, checked filter condition - poor, needed to be replaced. Replaced filters with spares onsite, Checked fans and tightened electrical connections Checked thermal wheel and heater battery Cleaned chambers, operating correctly

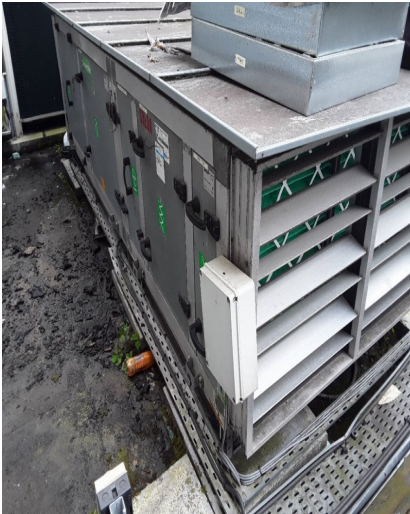
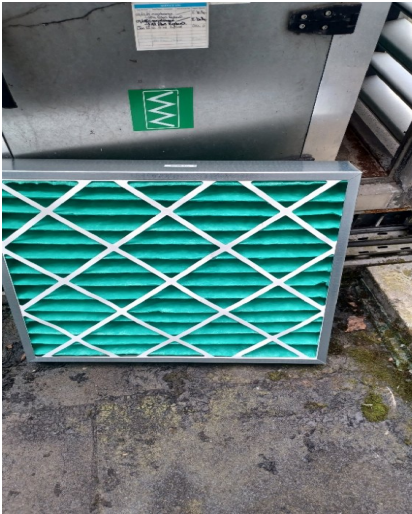
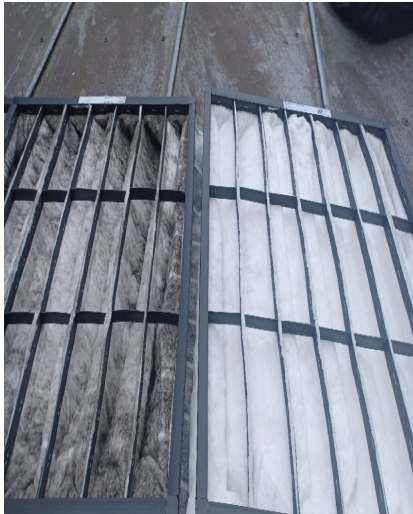
26. Bearing OK	Yes	26. Bearing OK	N/A
27. Drive Belts Changed	Direct drive	27. Drive Belts Changed	N/A
28. Drive Belt list and size	N/A	28. Drive Belt list and size	N/A
Engineer Comments	Checked operation of the ahu, checked filter condition - poor, needed to be replaced. Replaced filters with spares onsite, Checked fans and tightened electrical connections Cleaned chambers, operating correctly
