Extract Fan

Client Name	Holiday Inn Express Dublin City Centre	Job No	206
Client Site	Austinbrook Ltd 28-32 O'Connell Street Dublin 1 D01 T2X2		
Client Contact	Darren Murray		
Date	21/08/2023	PPM Visit	2 of 2

Maintenance Report

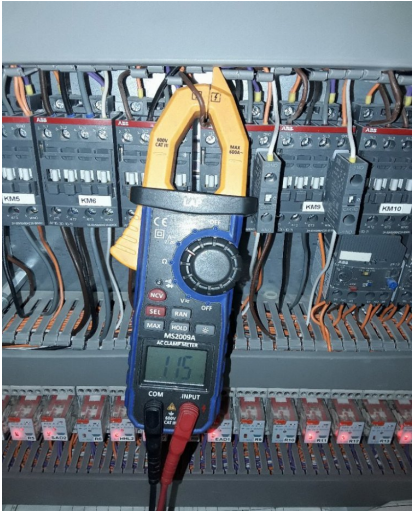
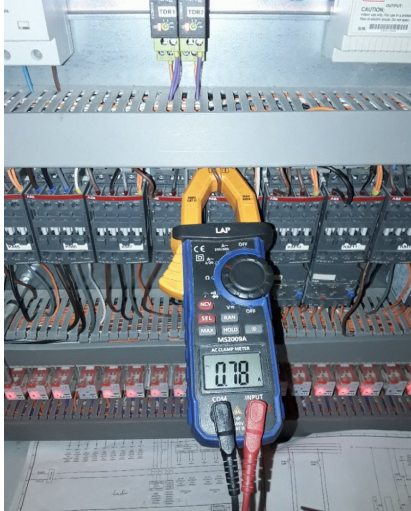
Asset No	03	Asset Location	Roof
Make	ELTA	Model	TD-560-EC
Year	N/A

24. Bearing ok	Yes	Bearing ok	Yes
25. Drive Belts Changed	N/A	Drive Belts Changed	No
26. Drive belt list and size	N/A	Drive belt list and size	N/A
Engineer Comments	Checked operation of the Extract fan located on roof of building. Extract fan no.1 supplied from contactor Km8. Extract fan no.2 supplied from contactor Km9. No overloads present on contactors. Time schedule from via bms is 8am to 7.30pm each day

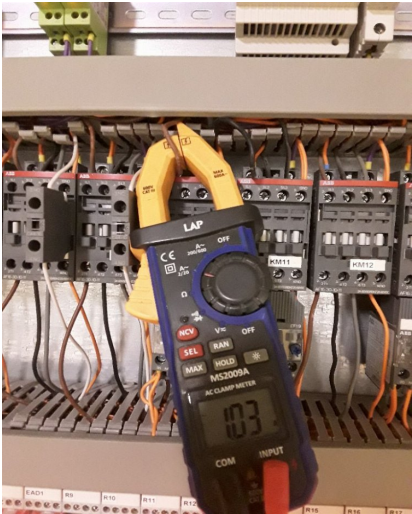
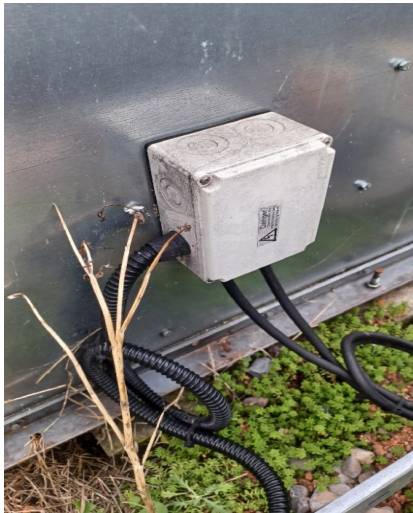
Asset No	04	Asset Location	Roof
Make	ELTA	Model	SDA400/4-1E
Year	N/A

1. Area Serving	Ground floor	3. Grills Cleaned	No
2. Panel Reference	EF-01	4. Dampers Checked	N/A
Extract Fan 1		Extract Fan 2	
Operating Details		Operating Details	
17. Design motor running current	2.5A flc	Design motor running current	N/A
18. Overload set	2.5A	Overload set	N/A
19. Actual motor running current	1.03A	Actual motor running current	N/A
	N/A		N/A
	N/A		N/A
20. Variable speed	Yes	Variable speed	
21. Running	@80% %	Running	N/A %
22. Fan Condition	Ok	Fan Condition	
23. Bearings greased	No	Bearings greased	N/A
24. Bearing ok	Yes	Bearing ok	
25. Drive Belts Changed	N/A	Drive Belts Changed	
26. Drive belt list and size	N/A	Drive belt list and size	N/A
Engineer Comments	Checked operation of the Extract fan supplied from contactor Km10. Overloads present on contactor is set to 2.5a. Time schedule from via bms is 6.00am to 12am each day

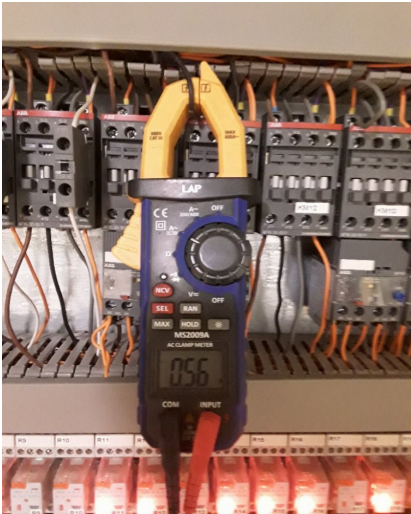
Asset No	05	Asset Location	Roof
Make	ELTA	Model	SM200-1ECL
Year	N/A

1. Area Serving	Ground floor toilets	3. Grills Cleaned	No
2. Panel Reference	EF-02	4. Dampers Checked	N/A
Extract Fan 1		Extract Fan 2	
Operating Details		Operating Details	
17. Design motor running current	1.95A flc	Design motor running current	N/A
18. Overload set	2.0A	Overload set	N/A
19. Actual motor running current	0.56A	Actual motor running current	N/A
	N/A		N/A
	N/A		N/A
20. Variable speed	Yes	Variable speed	
21. Running	@80% %	Running	N/A %
22. Fan Condition	Ok	Fan Condition	
23. Bearings greased	No	Bearings greased	N/A
24. Bearing ok	Yes	Bearing ok	
25. Drive Belts Changed	N/A	Drive Belts Changed	
26. Drive belt list and size	N/A	Drive belt list and size	N/A
Engineer Comments	Checked operation of the Extract fan supplied from contactor Km11. Overload present on contactor set to 2.0a Time schedule from via bms is 6am to 10pm each day

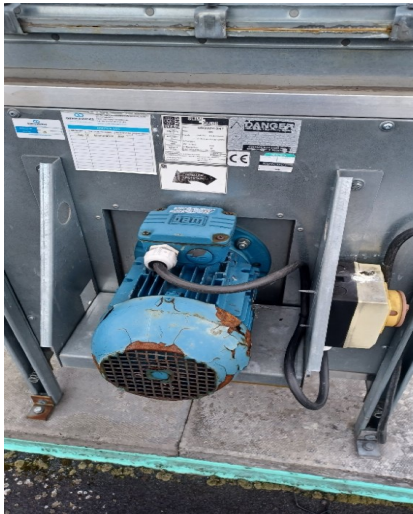
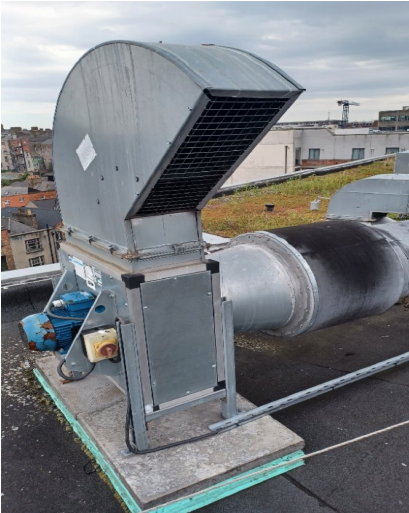
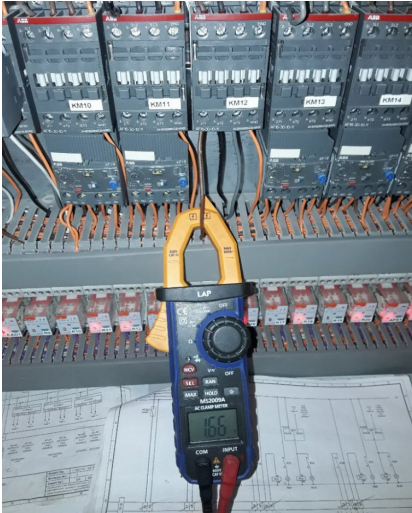
Asset No	06	Asset Location	Kitchen
Make	ELTA	Model	SSQ42/4-3HT
Year	N/A

1. Area Serving	Kitchen	3. Grills Cleaned	No
2. Panel Reference	EF-05	4. Dampers Checked	N/A
Extract Fan 1		Extract Fan 2	
Operating Details		Operating Details	
17. Design motor running current	4A flc	Design motor running current	N/A
18. Overload set	6A mcb	Overload set	N/A
19. Actual motor running current	1.66A	Actual motor running current	N/A
	1.75A		N/A
	1.79A		N/A
20. Variable speed	Yes	Variable speed	
21. Running	100% %	Running	N/A %
22. Fan Condition	Ok	Fan Condition	
23. Bearings greased	No	Bearings greased	N/A
24. Bearing ok	Yes	Bearing ok	
25. Drive Belts Changed	N/A	Drive Belts Changed	
26. Drive belt list and size	N/A	Drive belt list and size	N/A
Engineer Comments			
Checked operation of the Extract fan is located on roof of the building.			
Extract fan supplied from contactor Km12.			
No overload present on contactor.			
Time schedule from via bms is 6am to 11pm each day

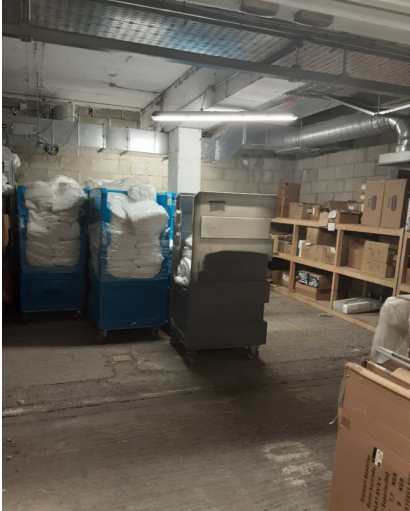
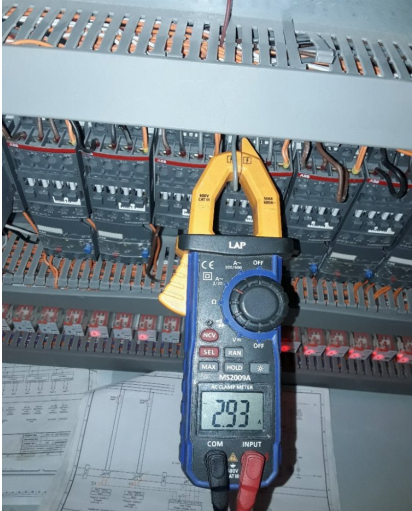
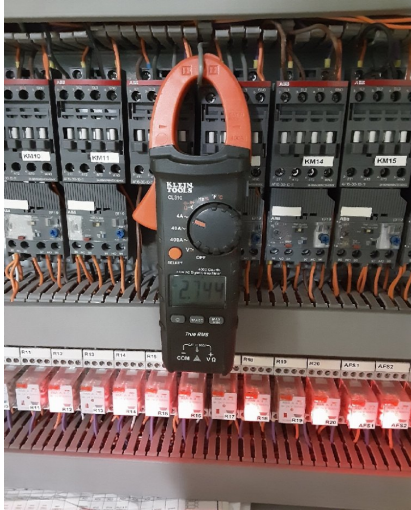
Asset No	07	Asset Location	Basement
Make	SEM	Model	250-1EC
Year	N/A

17. Design motor running current	4.5A	Design motor running current	N/A
18. Overload set	2.7A	Overload set	N/A
19. Actual motor running current	2.93A	Actual motor running current	N/A
	N/A		N/A
	N/A		N/A

24. Bearing ok	Yes	Bearing ok	No
25. Drive Belts Changed	N/A	Drive Belts Changed	No
26. Drive belt list and size	N/A	Drive belt list and size	
Engineer Comments	Checked operation of the Extract fan supplied from contactor Km13. Overload present on contactor set to its max of 2.7a. Amp reading at time of visit to site was 2.93a Time schedule from via bms is 6am to 11pm each day A previous recommendation from past Maintenance visit is to change the O/L to a higher rating ampauge. This has been previously quoted Q5840.

Repair Required	Yes		
Engineers Name	Des Cleere	Engineers Signature

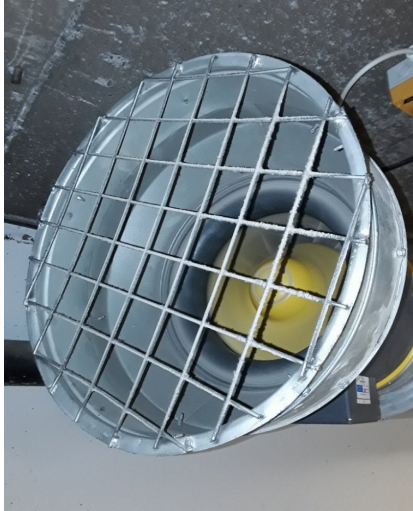
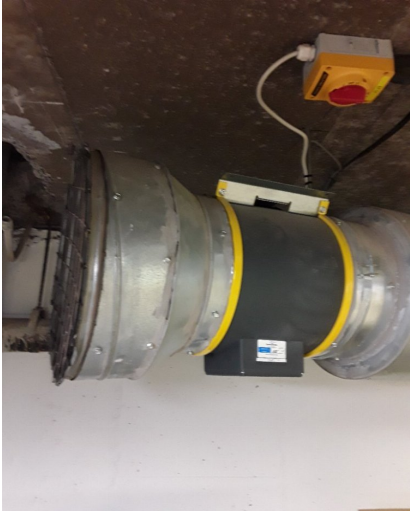
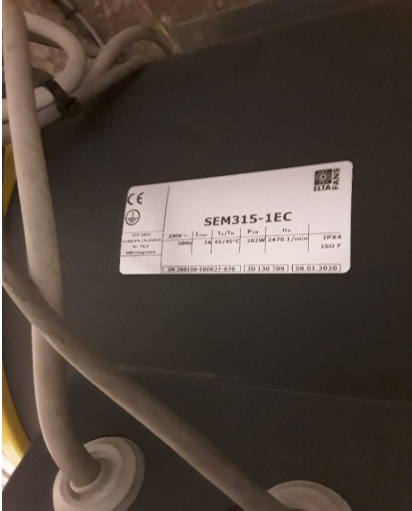
Asset No	08	Asset Location	Plantroom
Make	ELTA	Model	SEM315-1EC
Year	2015

24. Bearing ok	Yes	Bearing ok	
25. Drive Belts Changed	N/A	Drive Belts Changed	
26. Drive belt list and size	N/A	Drive belt list and size	
Engineer Comments	Checked operation of the Extract fan is located within the plant room. EF07 Extract fan supplied from contactor Km14 Time schedule from via bms is 12am to 12pm each day. Unit is controlled by speed controller which is located beside mcc panel, operating correctly

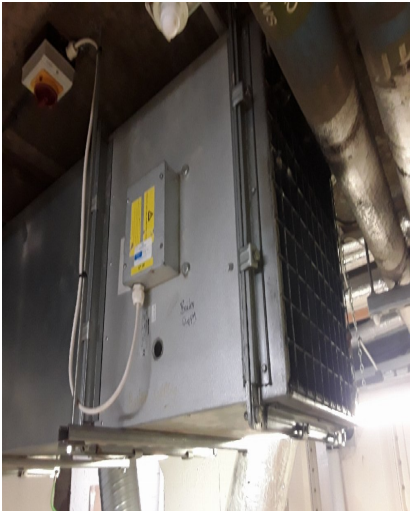
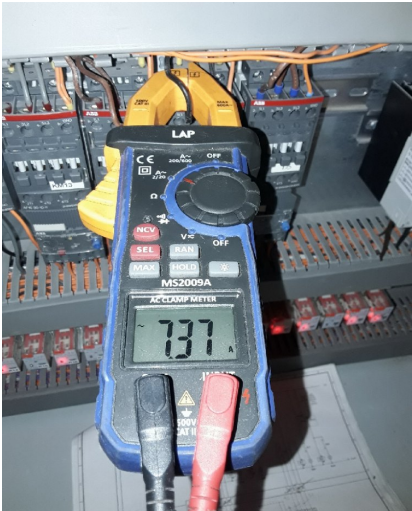
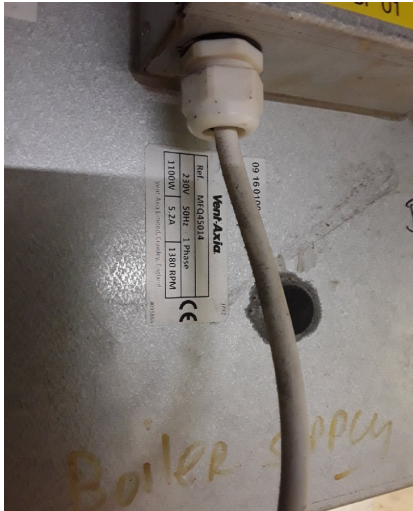
Asset No	09	Asset Location	Plantroom
Make	Vent-Axia	Model	MFQ45014
Year	N/A

17. Design motor running current	5.20A	Design motor running current	N/A
18. Overload set	6.30A	Overload set	N/A
19. Actual motor running current	7.37A	Actual motor running current	N/A
	N/A		N/A
	N/A		N/A

25. Drive Belts Changed	N/A	Drive Belts Changed	
26. Drive belt list and size	N/A	Drive belt list and size	N/A
Engineer Comments	Checked operation of the Supply fan SF01 - supplied from contactor Km15 in mcc panel. Motor running ok, but pulling higher amps than spec, motor could potentially fail at any time, recommend replacing fan. Overload on contactor set to its max of 6.3a. Amp reading at time of visit to site was 7.37a Time schedule from via bms is 6am to 11pm each day A previous recommendation from past Maintenance visit is to change the O/L to a higher rating ampage. This has been previously quoted Q5266.

Repair Required	Yes		
Engineers Name	Des Cleere	Engineers Signature
