Extract Fan

Client Name	Holiday Inn Express Dublin City Centre	Job No	206
Client Site	Austinbrook Ltd 28-32 O'Connell Street Dublin 1 D01 T2X2		
Client Contact	Darren Murray		
Date	23/03/2023	PPM Visit	1 of 2

Maintenance Report

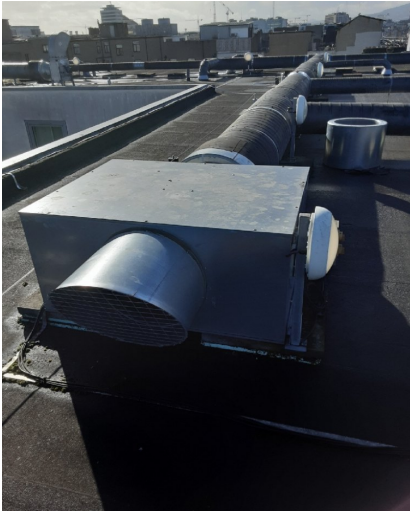
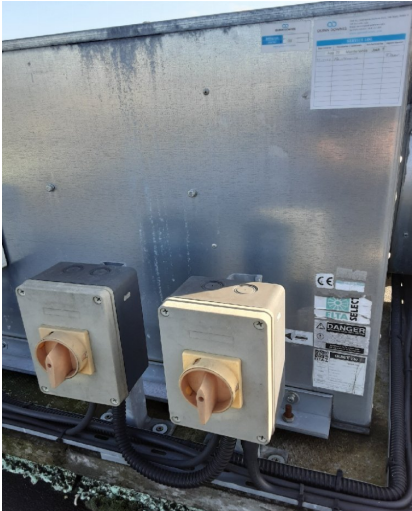
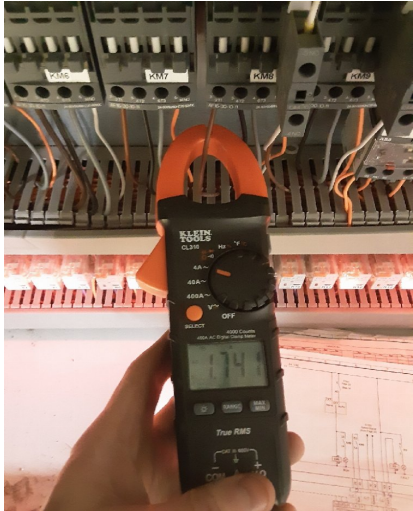
Asset No	03	Asset Location	Roof
Make	ELTA	Model	TD-560-EC
Year	N/A

24. Bearing ok	Yes	Bearing ok	Yes
25. Drive Belts Changed	N/A	Drive Belts Changed	No
26. Drive belt list and size	N/A	Drive belt list and size	N/A
Engineer Comments	Extract fans located on roof of building.  Extract fan no.1 supplied from contactor Km8.  Extract fan no.2 supplied from contactor Km9.  No overloads present on contactors.  Time schedule from via bms is 8am to 7.30pm each day

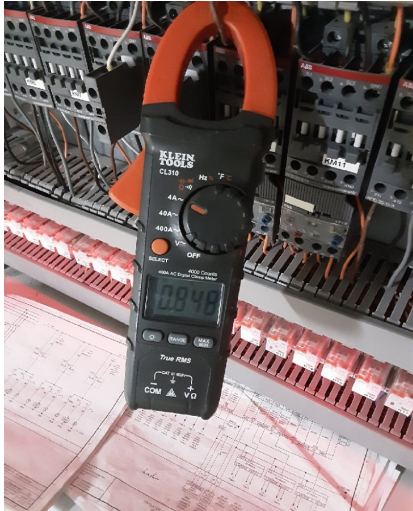
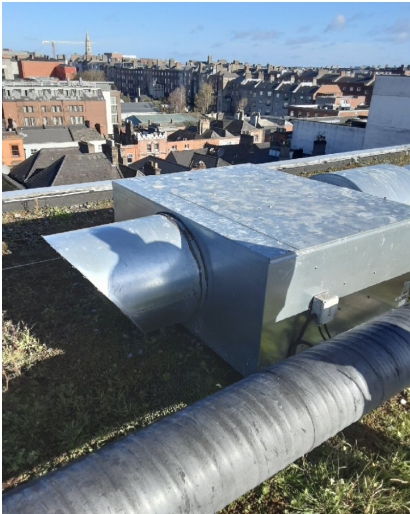
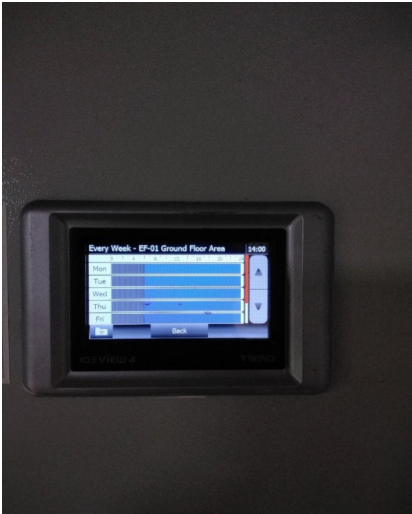
Asset No	04	Asset Location	Roof
Make	ELTA	Model	SDA400/4-1E
Year	N/A

1. Area Serving		Ground floor	3. Grills Cleaned	No
2. Panel Reference		EF-01	4. Dampers Checked	N/A
Extract Fan 1			Extract Fan 2	
Operating Details			Operating Details	
17. Design motor running current	2.5A flc	Design motor running current	N/A	
18. Overload set	2.5A	Overload set	N/A	
19. Actual motor running current	0.84A	Actual motor running current	N/A	
	N/A		N/A	
	N/A		N/A	
20. Variable speed	Yes	Variable speed		
21. Running	@80% %	Running	N/A %	
22. Fan Condition	Ok	Fan Condition		
23. Bearings greased	No	Bearings greased	N/A	
24. Bearing ok	Yes	Bearing ok		
25. Drive Belts Changed	N/A	Drive Belts Changed		
26. Drive belt list and size	N/A	Drive belt list and size	N/A	
Engineer Comments				
Extract fan supplied from contactor Km10.				
Overloads present on contactor is set to 2.5a.				
Time schedule from via bms is 6.00am to 12am each day

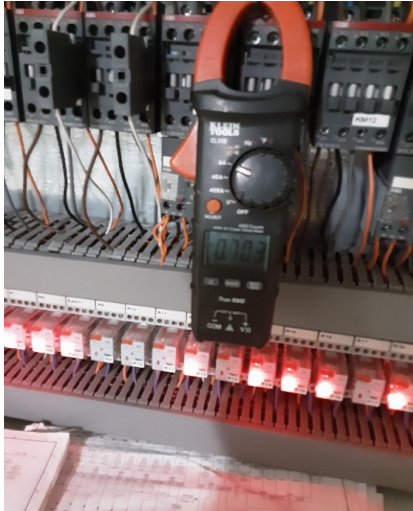
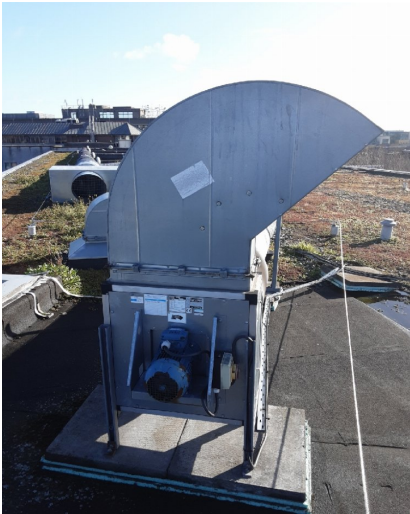
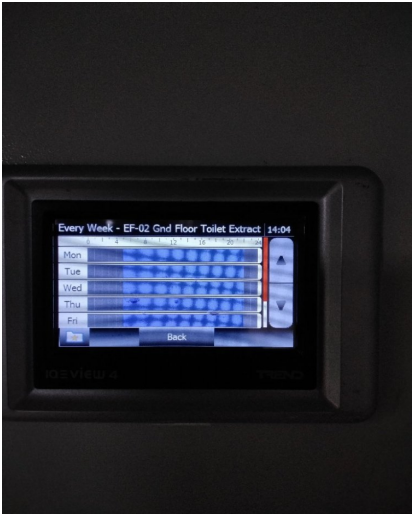
Asset No	05	Asset Location	Roof
Make	ELTA	Model	SM200-1ECL
Year	N/A

1. Area Serving		Ground floor toilets	3. Grills Cleaned	No
2. Panel Reference		EF-02	4. Dampers Checked	N/A
Extract Fan 1			Extract Fan 2	
Operating Details			Operating Details	
17. Design motor running current	1.95A f/c		Design motor running current	N/A
18. Overload set	2.0A		Overload set	N/A
19. Actual motor running current	0.70A		Actual motor running current	N/A
	N/A			N/A
	N/A			N/A
20. Variable speed	Yes		Variable speed	
21. Running	@80% %		Running	N/A %
22. Fan Condition	Ok		Fan Condition	
23. Bearings greased	No		Bearings greased	N/A
24. Bearing ok	Yes		Bearing ok	
25. Drive Belts Changed	N/A		Drive Belts Changed	
26. Drive belt list and size	N/A		Drive belt list and size	N/A
Engineer Comments				
Extract fan no supplied from contactor Km11.				
Overload present on contactor set to 2.0a				
Time schedule from via bms is 6am to 10pm each day

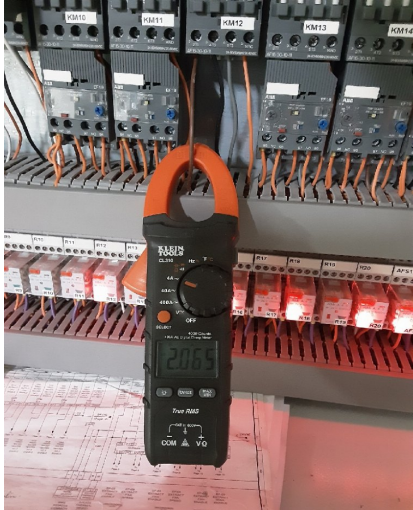
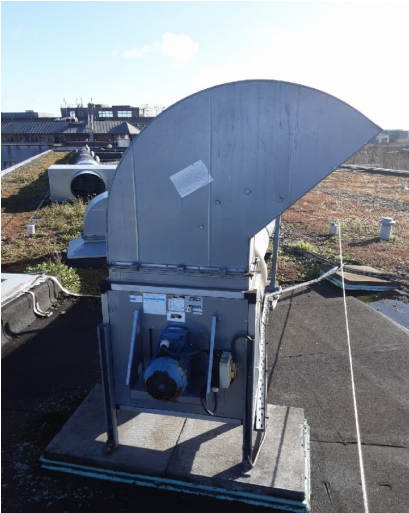
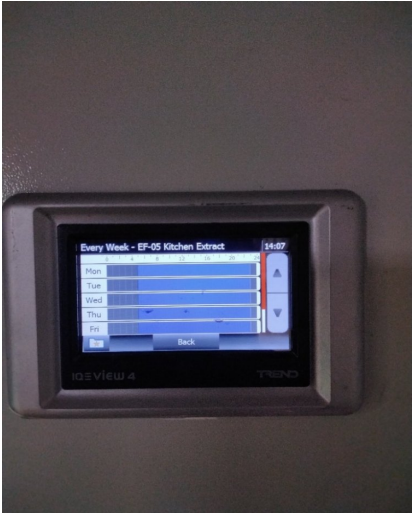
Asset No	06	Asset Location	Kitchen
Make	ELTA	Model	SSQ42/4-3HT
Year	N/A

1. Area Serving	Kitchen	3. Grills Cleaned	No
2. Panel Reference	EF-05	4. Dampers Checked	N/A
Extract Fan 1		Extract Fan 2	
Operating Details		Operating Details	
17. Design motor running current	4A flc	Design motor running current	N/A
18. Overload set	6A mcb	Overload set	N/A
19. Actual motor running current	2.06A	Actual motor running current	N/A
	2.00A		N/A
	2.12A		N/A
20. Variable speed	Yes	Variable speed	
21. Running	100% %	Running	N/A %
22. Fan Condition	Ok	Fan Condition	
23. Bearings greased	No	Bearings greased	N/A
24. Bearing ok	Yes	Bearing ok	
25. Drive Belts Changed	N/A	Drive Belts Changed	
26. Drive belt list and size	N/A	Drive belt list and size	N/A
Engineer Comments			
Extract fan is located on roof of the building.			
Extract fan supplied from contactor Km12.			
No overload present on contactor.			
Time schedule from via bms is 6am to 11pm each day

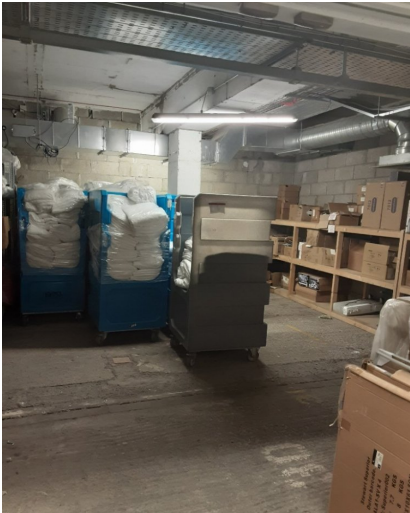
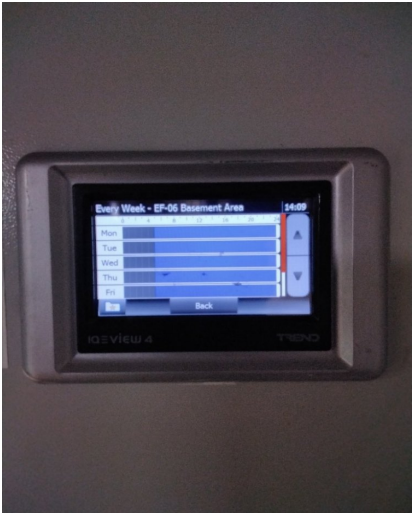
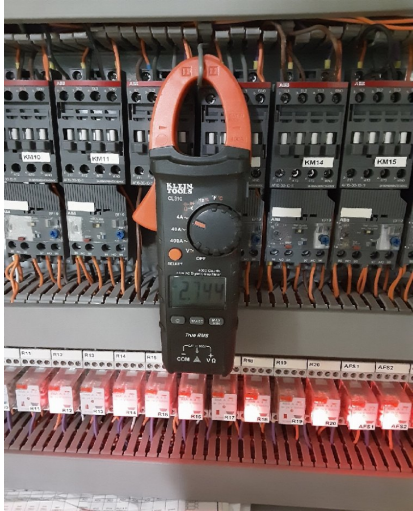
Asset No	07	Asset Location	Basement
Make	SEM	Model	250-1EC
Year	N/A

24. Bearing ok	Yes	Bearing ok	No
25. Drive Belts Changed	N/A	Drive Belts Changed	No
26. Drive belt list and size	N/A	Drive belt list and size	
Engineer Comments	Extract fan supplied from contactor Km13.  Overload present on contactor set to its max of 2.7a. Amp reading at time of visit to site was 2.74a  Time schedule from via bms is 6am to 11pm each day  A previous recommendation from past Maintenance visit is to change the O/L to a higher rating ampauge. This has been previously quoted Q5840.

Repair Required	Yes		
Engineers Name	Iain Egan	Engineers Signature

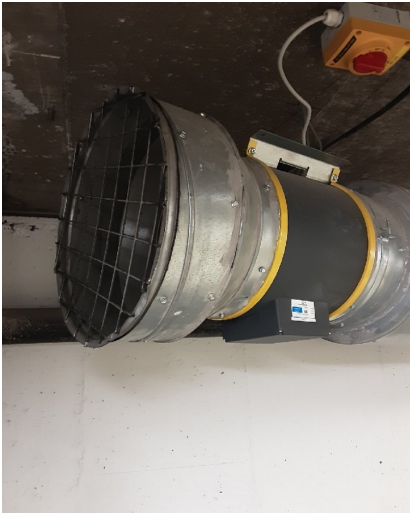
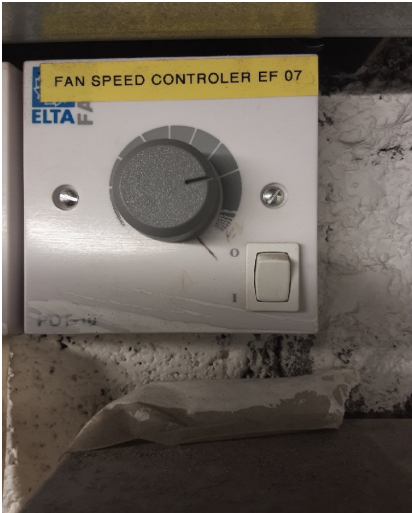
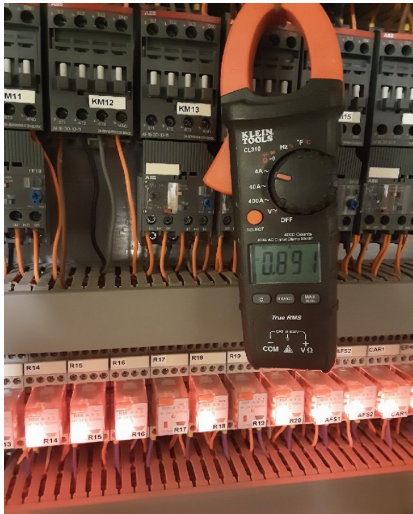
Asset No	08	Asset Location	Plantroom
Make	ELTA	Model	SEM315-1EC
Year	2015

24. Bearing ok	Yes	Bearing ok	
25. Drive Belts Changed	N/A	Drive Belts Changed	
26. Drive belt list and size	N/A	Drive belt list and size	
Engineer Comments	Extract fan is located within the plant room.  Extract fan supplied from contactor Km14.  Overload present on contactor set to 2.0a  Time schedule from via bms is 12am to 12pm each day.  Unit is controlled by speed controller which is labelled correctly and is located beside mcc panel.

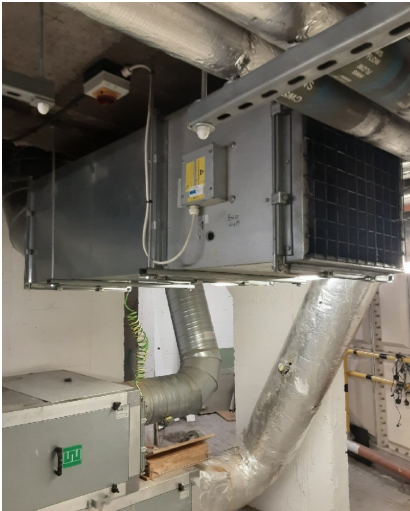
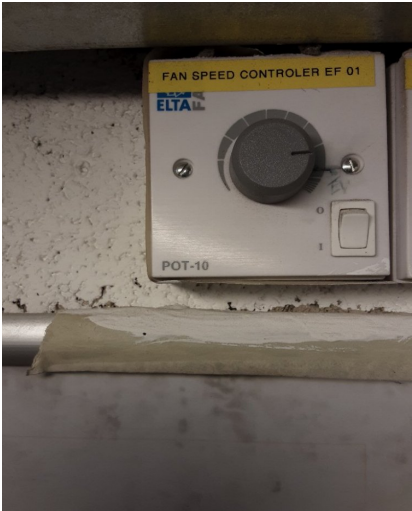
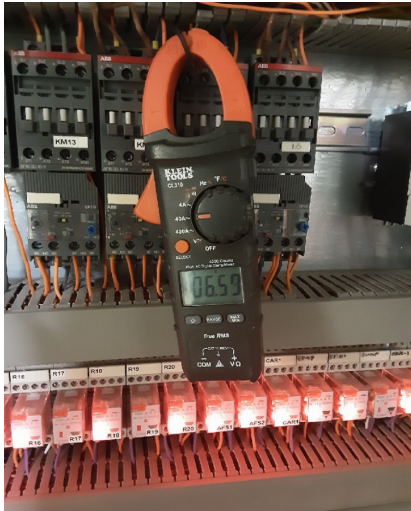
Asset No	09	Asset Location	Plantroom
Make	Vent-Axia	Model	MFQ45014
Year	N/A

25. Drive Belts Changed	N/A	Drive Belts Changed	
26. Drive belt list and size	N/A	Drive belt list and size	N/A
Engineer Comments	Supply fan supplied from contactor Km15.  Overload present on contactor set to its max of 6.3a. Amp reading at time of visit to site was 6.5a  Time schedule from via bms is 6am to 11pm each day  A previous recommendation from past Maintenance visit is to change the O/L to a higher rating ampage. This has been previously quoted Q5266.  This fan if not operational shuts down gas supply to gas fired water heaters via the gas detection panel as an alarm due to no fresh air entering the plant room.

Repair Required	Yes		
Engineers Name	Iain Egan	Engineers Signature
