ACCIDENT

Aircraft Type and Registration:	Avro RJ100, HB-IYU
No & Type of Engines:	4 Honeywell ALF507-1F turbofan engines
Year of Manufacture:	2000
Date & Time (UTC):	18 August 2007 at 0940 hrs
Location:	Runway 28, London City Airport
Type of Flight:	Commercial Air Transport (Passenger)
Persons on Board:	Crew - 5 Passengers - 88
Injuries:	Crew - None Passengers - None
Nature of Damage:	Significant structural damage to the lower rear fuselage
Commander's Licence:	Airline Transport Pilot's Licence
Commander's Age:	47 years
Commander's Flying Experience:	9,000+ hours (of which 1,340 were on type) Last 90 days - 118 hours Last 28 days - 25 hours
Information Source:	AAIB Field Investigation

Synopsis

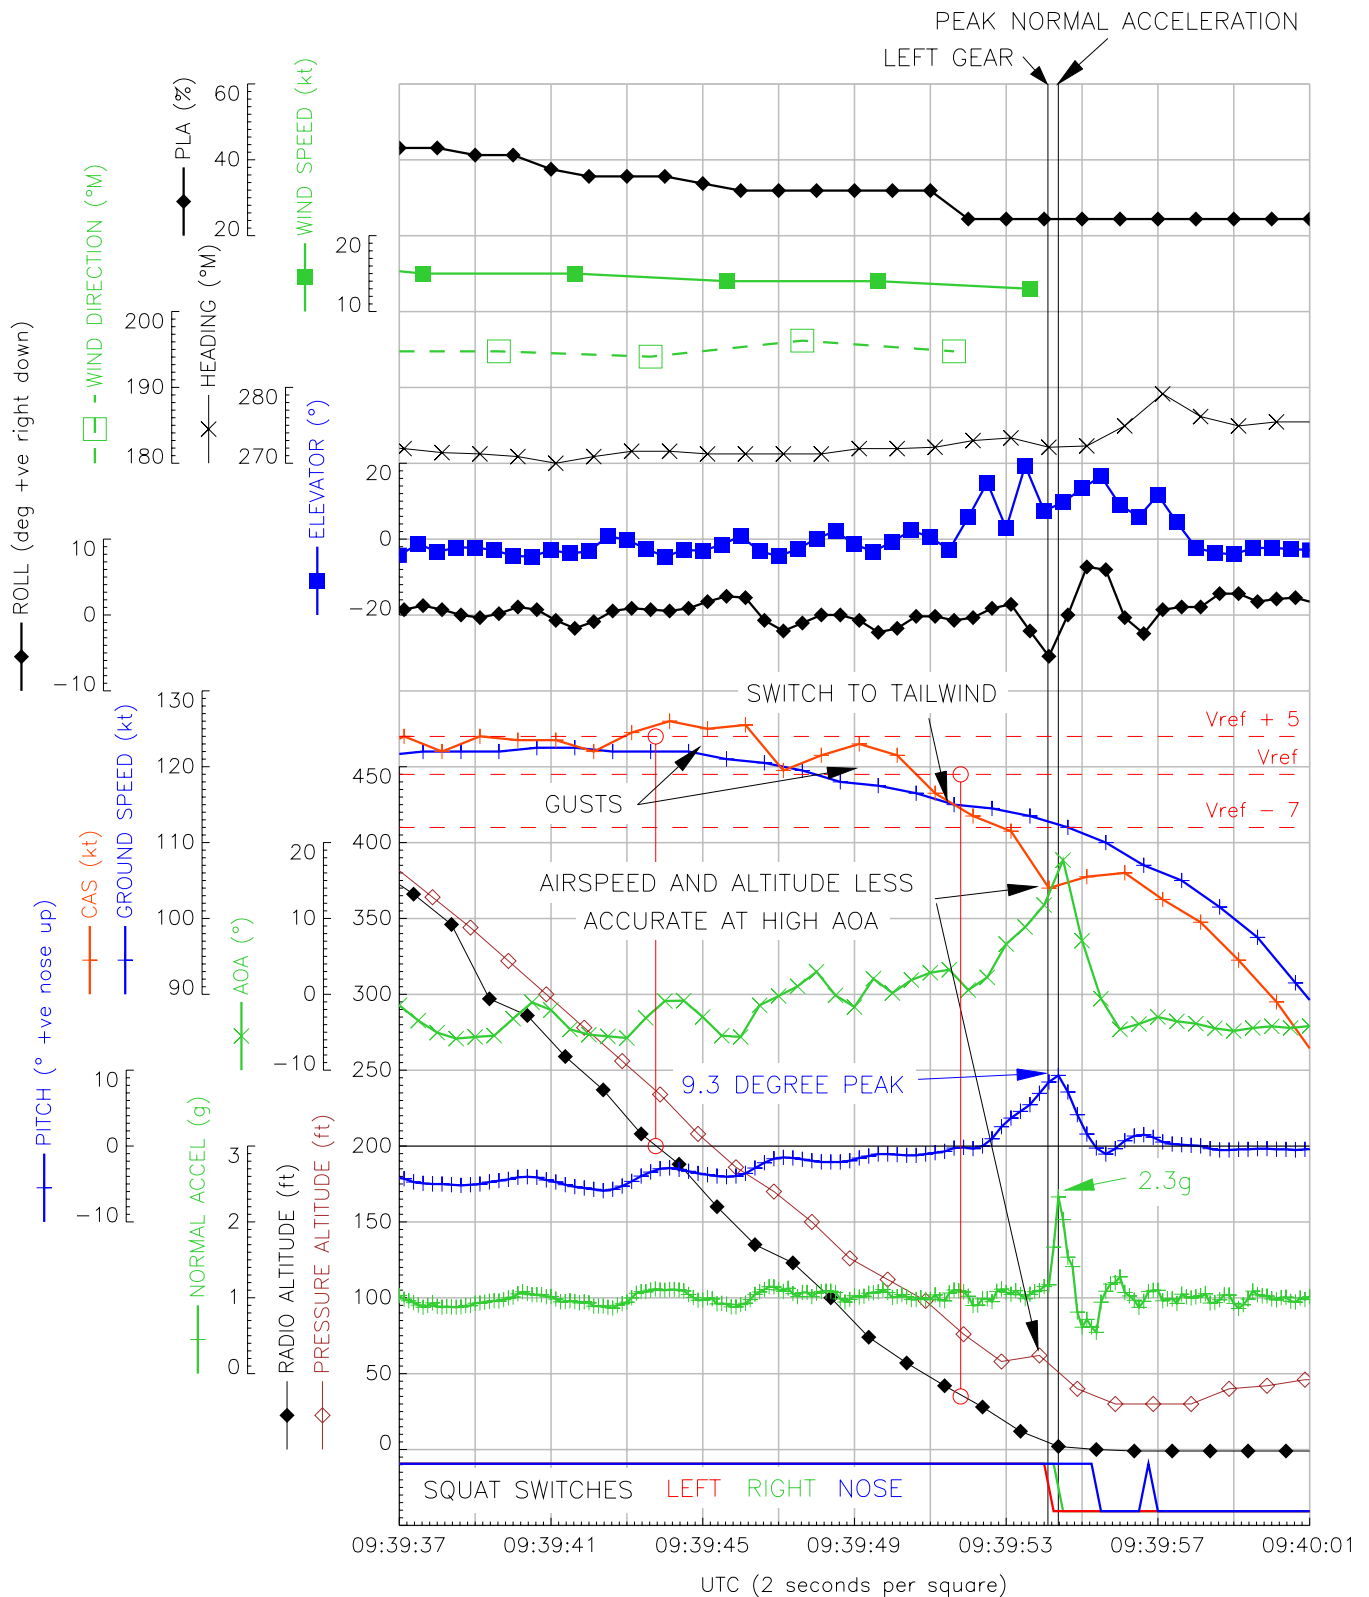
Figure 1
Salient FDR Parameter
(Accident to HB-IYU on 18 August 2007)

Figure 1 shows the salient parameters from the FDR, covering the approach from approximately 350 ft agl. This also shows the relevant target speeds for comparison.

With a radio height of between 50 ft and 30 ft agl, the power levers were retarded. A comparison of calibrated airspeed and groundspeed indicates that the aircraft had a variable and slight headwind component until approximately 50 ft agl, at which point it became a variable and slight tailwind. At this point the descent rate was approximately 900 ft/min and reducing smoothly. The FDR data showed no sudden drop in altitude, though the sample rate could be a limitation in capturing a short duration event.

Prior to 50 ft agl the aircraft had a nose-down pitch attitude that was slowly being brought level. As the power levers were moved back, large elevator inputs were recorded and during this period of increased elevator activity the aircraft developed an average nose-up pitch rate of 4.5°/sec. A left roll was also recorded; as this reached 5°, the left main gear weight-on-wheels sensor activated, and the roll direction reversed. At touchdown the pitch attitude reached 9.3° nose up and a 2.3g normal acceleration was recorded.

The co-pilot made a number of calls in the latter stages of the approach with reference to the target V_{REF} . These indicated that the aircraft was generally below the target speed and this is confirmed by the recorded data. Figure 1 shows that at 50 ft and 35 ft the aircraft was some 4 kt below target speed. At this point the thrust levers were retarded to idle and the recorded groundspeed reduced, without a corresponding decrease in the airspeed, indicating a loss of headwind or an increased tailwind component. The aircraft was already in a low energy state; then thrust was reduced and this reduction, and the loss of headwind component, both made the situation worse. A combination of these factors reduced the energy of the aircraft, which was felt as a 'sink' by the pilots, and the commander responded by pulling back to prevent a hard landing. It was this, probably instinctive, pull back on the column that caused the pitch attitude to increase to 9.3° at the point of touchdown.

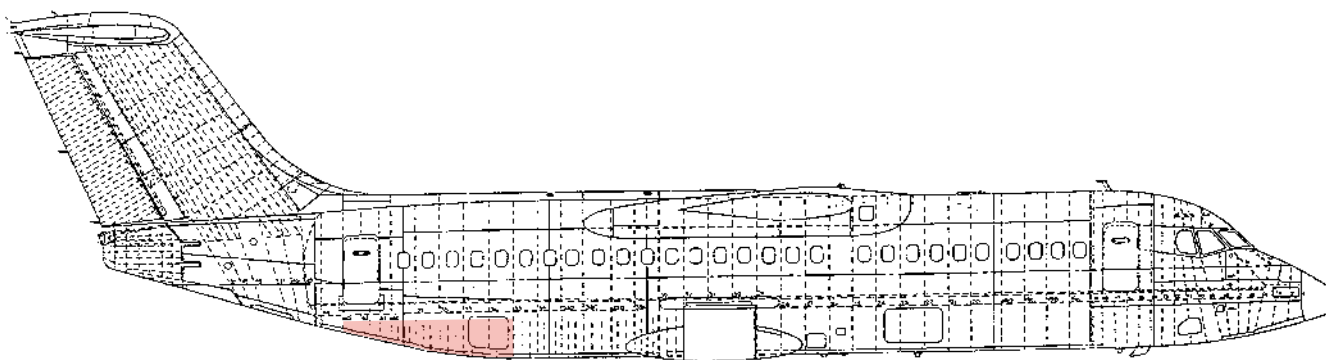
Figure 2

An inspection of the aircraft was carried out by the manufacturer¹ and the AAIB. The inspection revealed that significant structural damage had occurred to the lower fuselage in the area of the aft cargo hold between frames 35 to 43 and stringers 27 port to 27 starboard (Figure 2).

Area of damage to the lower fuselage

Nine frames had sustained various amounts of cracking and most of the frames in the damaged area had sustained some buckling or distortion. All the stringers

in the damaged area showed distortion of the skin attachment flange.

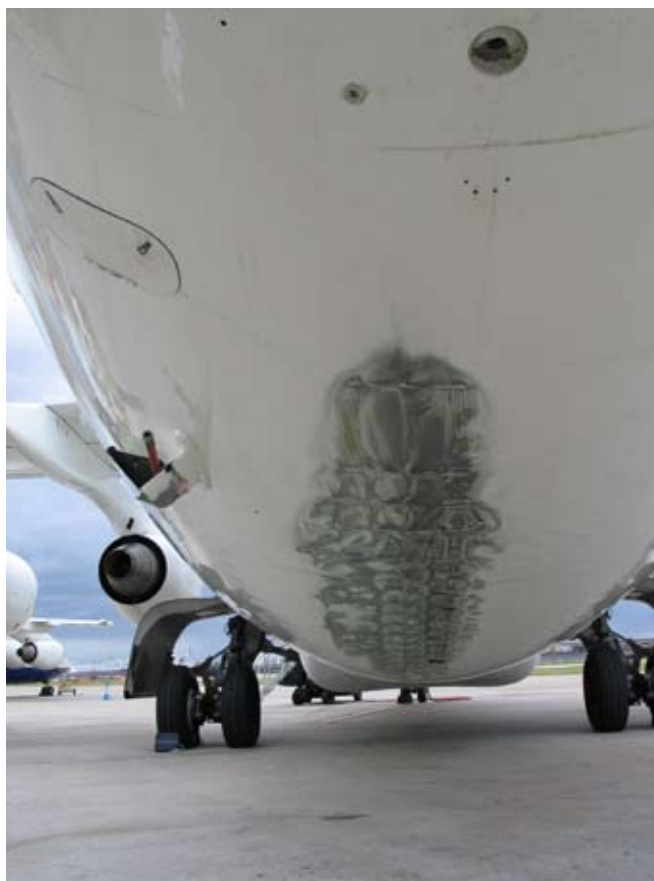
Figure 3

Scrape marks ran along the lower fuselage for approximately 3.9 m and were aligned approximately 4° to the left of the aircraft centreline (Figure 3).

The composite fairing around the rear galley drain pipe had been damaged and the pipe had been distorted upwards. The tailscape indicator had mostly worn away and the skin panels were extensively abraded and distorted. There was also a crack running fore-and-aft just outboard of stringer 34 port.

Damage to the rear of the aircraft

The damage to the lower rear fuselage and the marks on the runway indicated that the aircraft touched down 'left wing low' whilst yawed to the left by approximately 4°. Using the touchdown ground speed of 113 knots, the rear section of the aircraft would have been in contact with the runway for approximately 0.24 seconds.
