Inspection No: XXXXX  
 Questionnaire: Architectural  
 Recorder: Last Name, First Name  
 Last Edited By: Last Name, First Name

Subject: Building Name - Building #  
 Time In: YYYY-MM-DD HH:MM:SS  
 Time Out: YYYY-MM-DD HH:MM:SS  
 Last Edited: YYYY-MM-DD HH:MM:SS

Building 1 was Built in 1967. Building is in Good to Fair Condition. Community Center / Attain Lab at 1st Floor - (Abandoned Space)  
 Building Components Upgraded : Main Roof, Roof Drains, Bulkhead walls - Repointing, Chimney, Exterior Walls - Repointing in 2016.  
 \* The Infrared Thermography Roof Assessment Report for this building indicates possible wet insulation below the roofing. Refer to the Infrared Thermography Roof Assessment Report for this building for additional information.

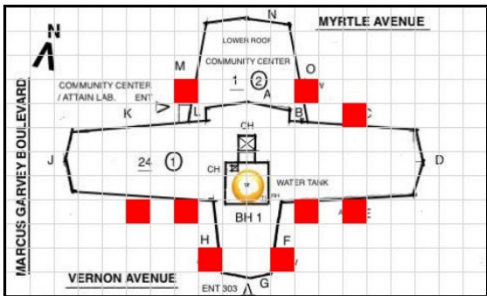
Deficiency Location/Instance

Areaway Drains	Inspected
Condition Rating	5- POOR
Deficiency?	Yes
Deficiency	Clogged

Deficiency Quantity	9
Quantity UOM	EACH
Potential Action	Repair
Urgency Of Action	1- Immediate
Purpose Of Action	4- Restore
Photo?	Yes
Photo Location	Facade E
