5 A Friendly Fire Accident

This chapter delves into the causation of the loss of a U.S. Army Black Hawk helicopter and all its occupants from friendly fire by a U.S. Air Force F-15 over northern Iraq in 1994. This example was chosen because the controversy and multiple viewpoints and books about the shootdown provide the information necessary to create most of the STAMP analysis. Accident reports often leave out important causal information (as did the official accident report in this case). Because of the nature of the accident, most of the focus is on operations. Appendix B presents an example of an accident where engineering development plays an important role. Social issues involving public health are the focus of the accident analysis in appendix C.

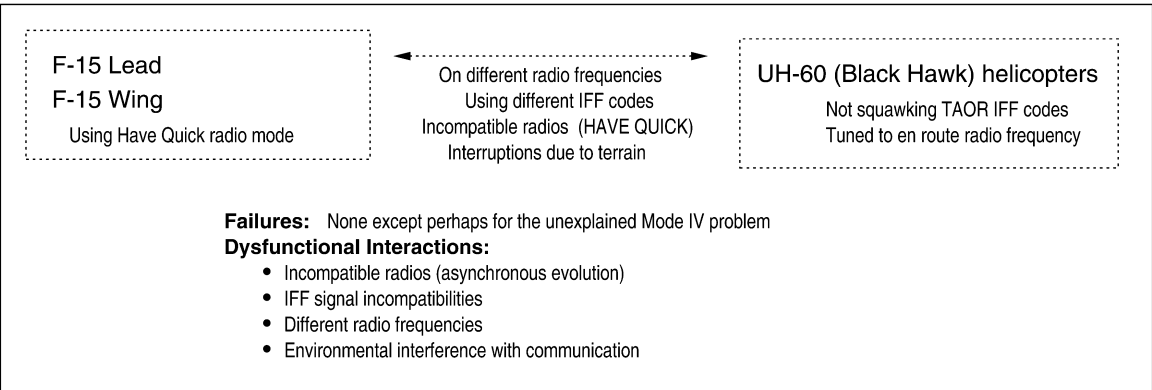
Figure 5.5
The physical level of the accident process.

The first step in the analysis is to understand the physical failures and dysfunctional interactions within the physical process that were related to the accident. Figure 5.5 shows this information.

All the physical components worked exactly as intended, except perhaps for the IFF system. The fact that the Mode IV IFF gave an intermittent response has never been completely explained. Even after extensive equipment teardowns and reenactments with the same F-15s and different Black Hawks, no one has been able to explain why the F-15 IFF interrogator did not receive a Mode IV response [200]. The Accident Investigation Board report states: “The reason for the unsuccessful

Mode IV interrogation attempts cannot be established, but was probably attributable to one or more of the following factors: incorrect selection of interrogation modes, faulty air-to-air interrogators, incorrectly loaded IFF transponder codes, garbling of electronic responses, and intermittent loss of line-of-sight radar contact.”⁷

There were several dysfunctional interactions and communication inadequacies among the correctly operating aircraft equipment. The most obvious unsafe interaction was the release of two missiles in the direction of two friendly aircraft, but there were also four obstacles to the type of fighter–helicopter communications that might have prevented that release.

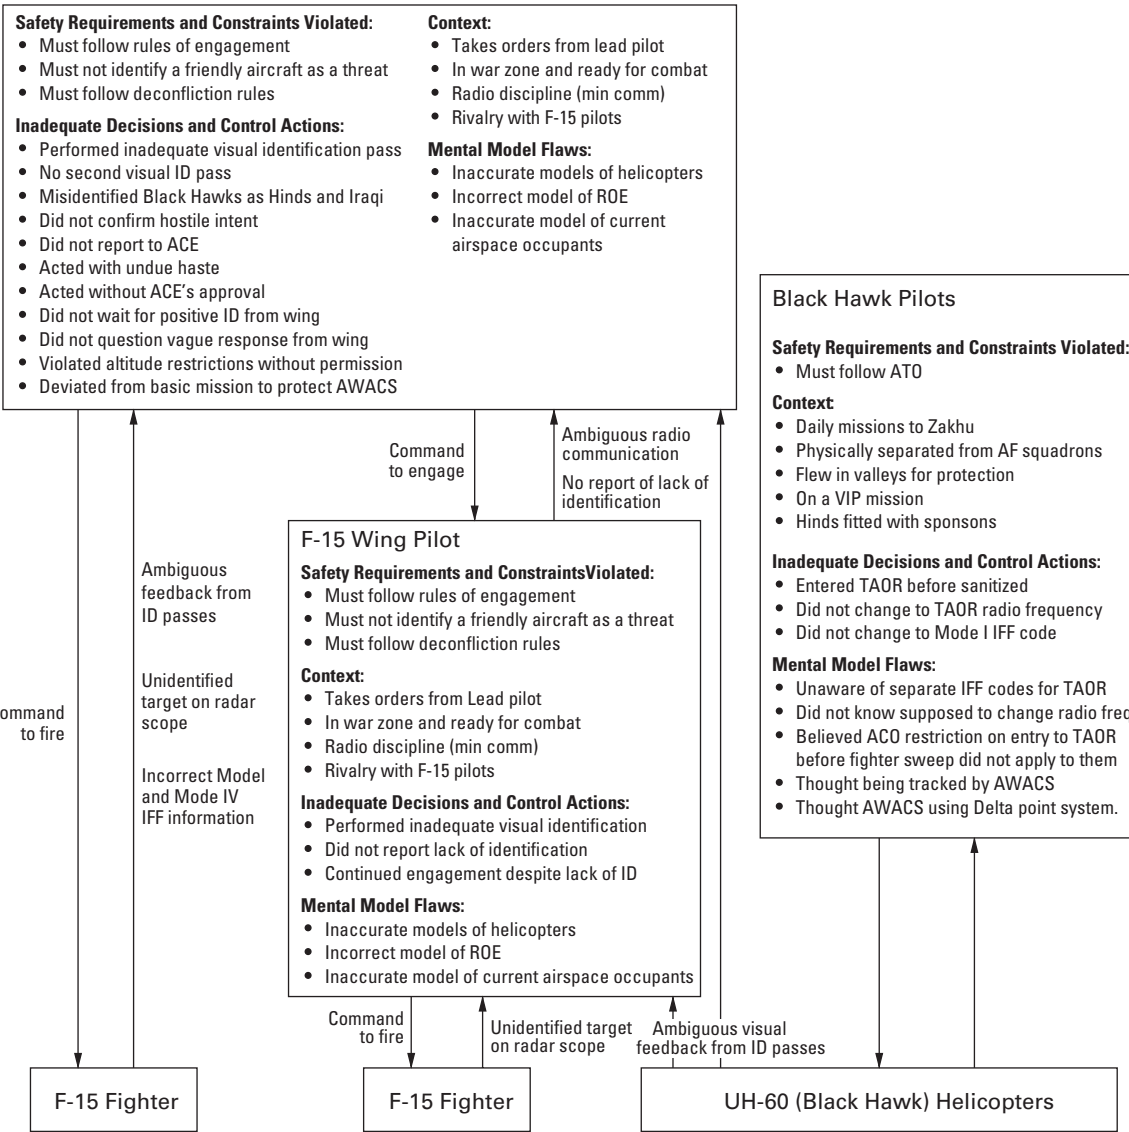
Figure 5.6
The analysis at the pilot level.

The pilots directly control the aircraft, including the activation of weapons (figure 5.6). The context in which their decisions and actions took place is first described, followed by the dysfunctional interactions at this level of the control structure. Then the inadequate control actions are outlined and the factors that led to them are described.

The following inadequate decisions and control actions can be identified for the lead F-15 pilot:

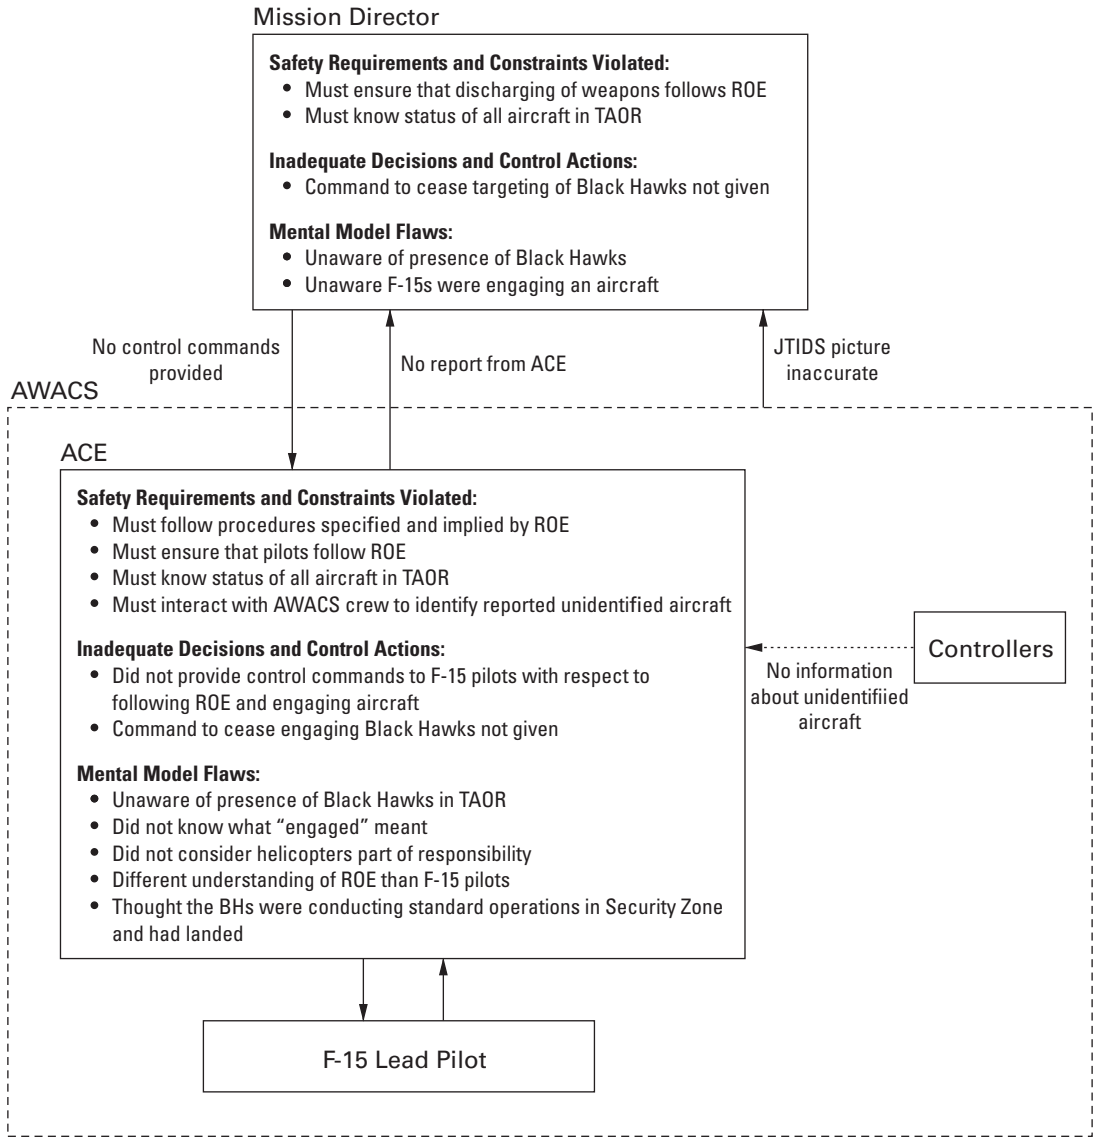
Figure 5.7
Analysis for the ACE and mission director.

Incorrect Control Algorithms: The control algorithms should theoretically have been effective, but they were never executed.

Inaccurate Mental Models: CFAC, and thus the Mission Director and ACE, exercised ultimate tactical control of the helicopters, but they shared the common view with the AWACS crew that helicopter activities were not an integral part of OPC air operations. In testimony after the accident, the ACE commented, "The way I understand it, only as a courtesy does the AWACS track Eagle Flight."

The Mission Director and ACE also did not have the information necessary to exercise their responsibility. The ACE had an inaccurate model of where the Black Hawks were located in the airspace. He testified that he presumed the Black Hawks were conducting standard operations in the Security Zone and had landed [159]. He also testified that, although he had a radarscope, he had no knowledge of AWACS radar symbology: "I have no idea what those little blips mean." The Mission Director, on the ground, was dependent on the information about the current airspace state sent down from the AWACS via JTIDS (the Joint Tactical Information Distribution System).

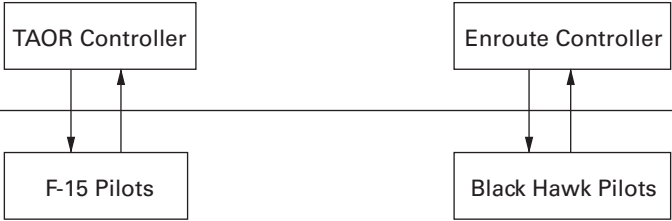
Figure 5.8
The analysis at the AWACS control level.

- Min Comm
- Poor morale, inadequate training, overworked
- Low activity at time of accident
- Terminal failure led to changed seating arrangement
- Airspace violations were rare

- Did not think helicopters were an integral part of OPC air operations
- Inaccurate models of airspace occupants and where they were
- Thought helicopters only going to Zakhu

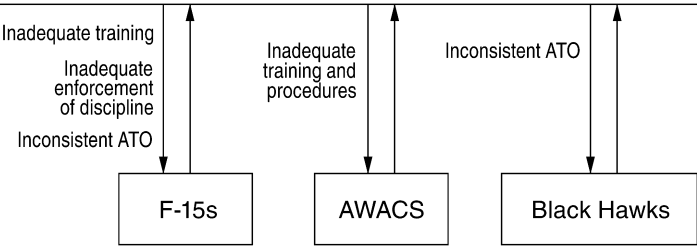
Figure 5.9
Analysis at the CFAC-MCC level.

- Inadequate training on ROE provided to new rotators
- Inadequate discipline
- Inadequate pilot training provided on visual identification
- Inadequate simulator and spin-up training for AWACS crews

- Rules and procedures did not provide adequate control over unsafe F-15 pilot behavior
- Army pilots given wrong information about IFF codes
- Inadequate procedures specified for shadow crew

- Nobody thought they were responsible for coordinating helicopter flights
