B The Loss of a Satellite

On April 30, 1999, at 12:30 EDT, a Titan IV B-32 booster equipped with a Centaur TC-14 upper stage was launched from Cape Canaveral, Florida. The mission was to place a Milstar-3 satellite into geosynchronous orbit. Milstar is a joint services satellite communications system that provides secure, jam-resistant, worldwide communications to meet wartime requirements. It was the most advanced military communications satellite system to that date. The first Milstar satellite was launched February 7, 1994, and the second was launched November 5, 1995. This mission was to be the third launch.

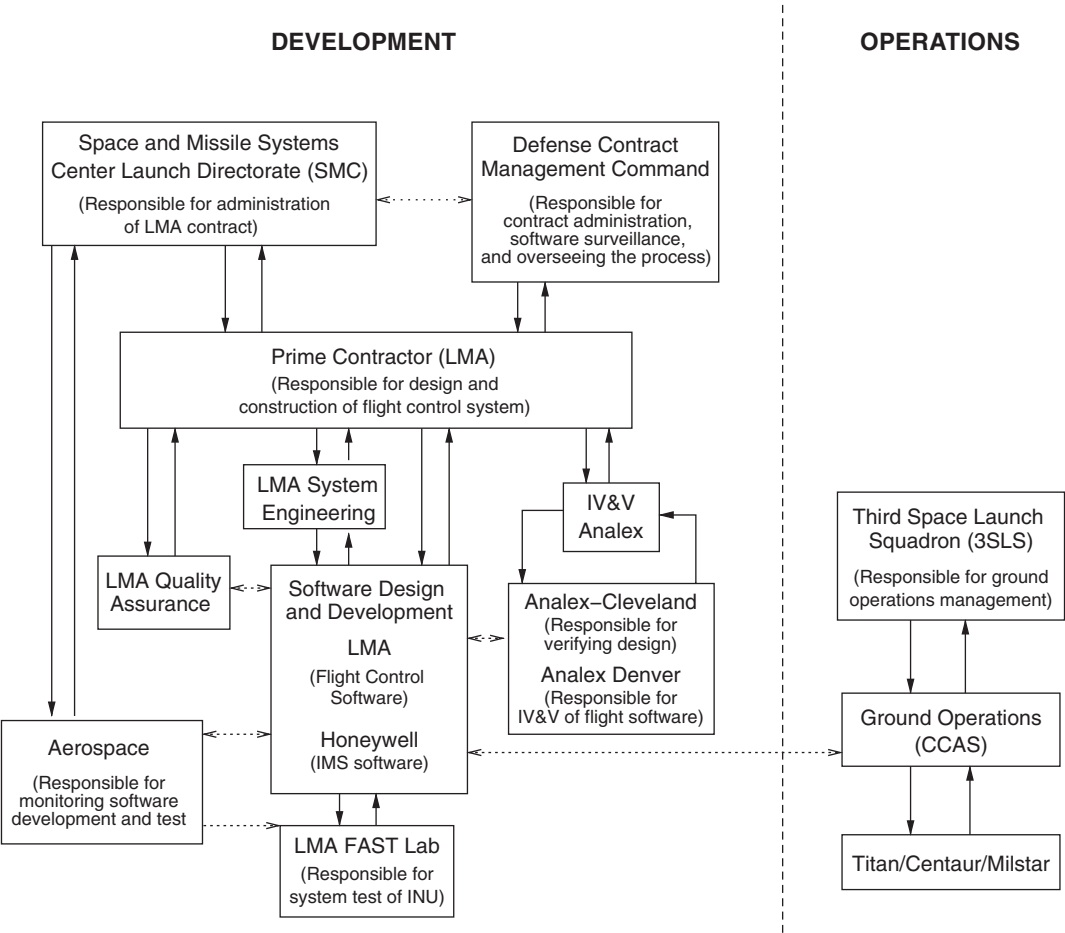
Figure B.1
Hierarchical control structure.

Figure B.1 shows the hierarchical control model of the accident, or at least those parts that can be gleaned from the official accident report.¹ Lockheed Martin Astronautics (LMA) was the prime contractor for the mission. The Air Force Space and Missile Systems Center Launch Directorate (SMC) was responsible for insight and administration of the LMA contract. Besides LMA and SMC, the Defense Contract Management Command (DCMC) played an oversight role, but the report is not clear about what exactly this role was beyond a general statement about responsibility for contract management, software surveillance, and overseeing the development process.

LMA designed and developed the flight control software, while Honeywell was responsible for the Inertial Measurement System (IMS) software. This separation of control, combined with poor coordination, accounts for some of the problems that occurred. Analex was the independent verification and validation (IV&V) contractor, while Aerospace Corporation provided independent monitoring and evaluation. Ground launch operations at Cape Canaveral Air Station (CCAS) were managed by the Third Space Launch Squadron (3SLS).

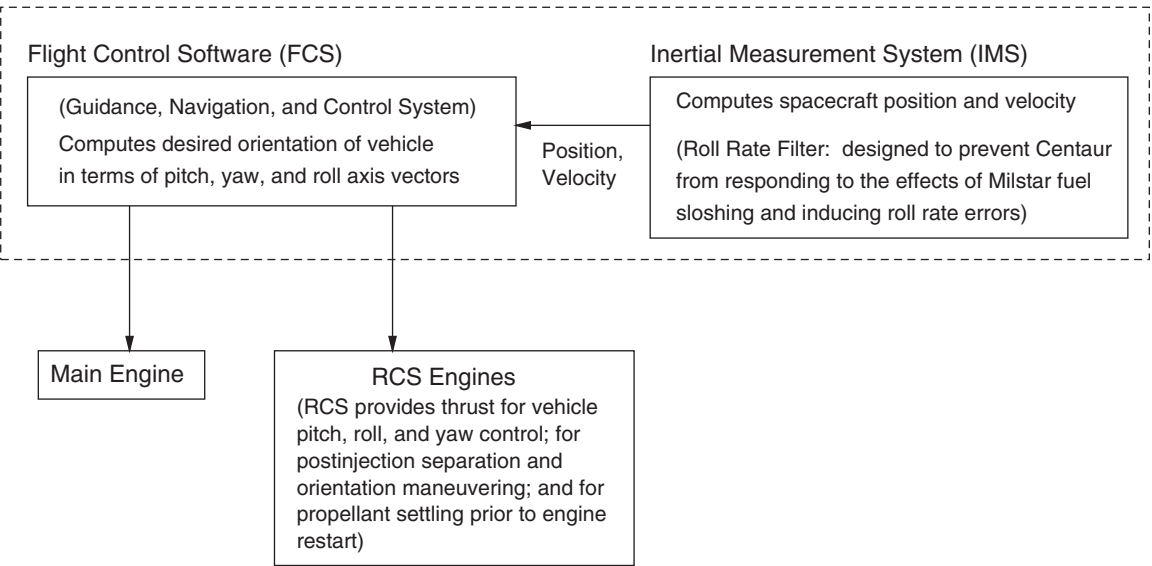
Figure B.2
Technical process control structure for INU.

Description of the Process Controller (the INU): The Inertial Navigation Unit (INU) has two parts (figure B.2): (1) the Guidance, Navigation, and Control System (the Flight Control Software or FCS) and (2) an Inertial Measurement System

(IMS). The FCS computes the desired orientation of the vehicle in terms of the pitch, yaw, and roll axis vectors and issues commands to the main engines and the reaction control system to control vehicle orientation and thrust. To accomplish this goal, the FCS uses position and velocity information provided by the IMS. The component of the IMS involved in the loss is a roll rate filter, which is designed to prevent the Centaur from responding to the effects of Milstar fuel sloshing and thus inducing roll rate errors.

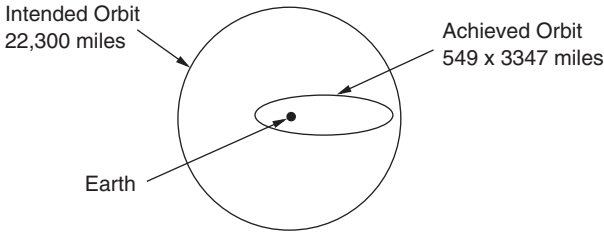
Figure B.3
Achieved orbit vs. intended orbit.

Third Burn: The goal of the third burn was to circularize the Centaur in its intended geosynchronous orbit. The FCS started the third burn at two hours, thirty-four minutes, and fifteen seconds after liftoff. It was started earlier and was shorter than had been planned. The vehicle tumbled throughout the third burn, but without the RCS there was no way to control it. Space vehicle separation was commanded at approximately two hours after the third burn began, resulting in the Milstar being placed in a useless low elliptical orbit, as opposed to the desired geosynchronous orbit (figure B.3).

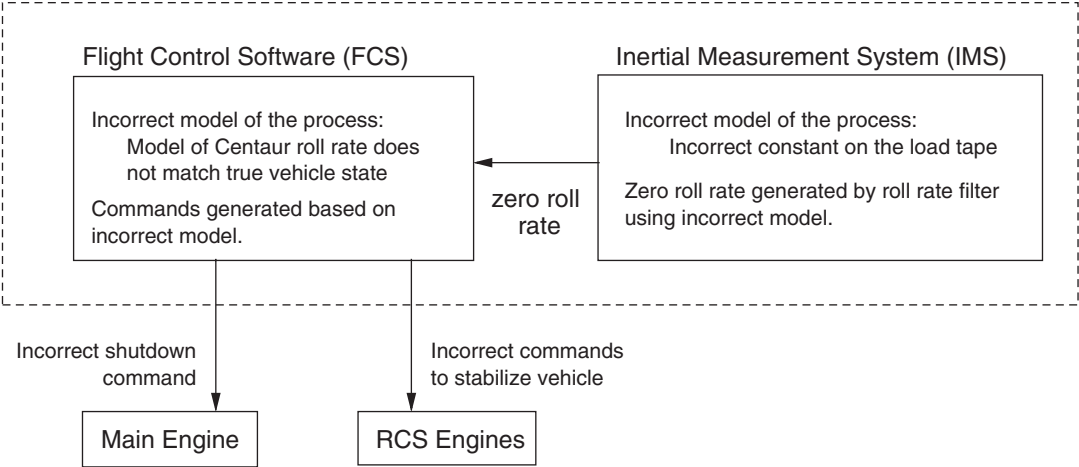
Figure B.4
Control flaws at the physical process and software controller levels.

Figure B.4 shows the automated controller flaws leading to the accident. The Inertial Measurement System (IMS) process model was incorrect; specifically, there was an incorrect roll rate filter constant in the IMS software file (figure B.4) that led to a dysfunctional interaction with the flight control software.²

The Flight Control Software also operated correctly, that is, according to its requirements. However, it received incorrect input from the IMS, leading to an incorrect internal FCS model of the state of the spacecraft—the roll rate was

thought to be zero or near zero when it was not. There was a mismatch between the FCS internal model of the process state and the real process state. This mismatch led to the RCS issuing incorrect control commands to the main engine (to shut down early) and to the RCS engines. Using STAMP terminology, the loss resulted from a dysfunctional interaction between the FCS and the IMS. Neither failed. They both operated correctly with respect to the instructions (including constants) and data provided.

Process Models: Both the FCS and the IMS had process models that did not match the real process state, leading to the hazardous outputs from the software. The FCS model of the vehicle orientation did not match the actual orientation due to incorrect input about the state of a controlled variable (the roll rate). The IMS provided the bad input because of an incorrect model of the process, namely, the I1(25)

constant used in the roll rate filter. That is, the feedback or monitoring channel of the FCS provided incorrect feedback about the roll rate.

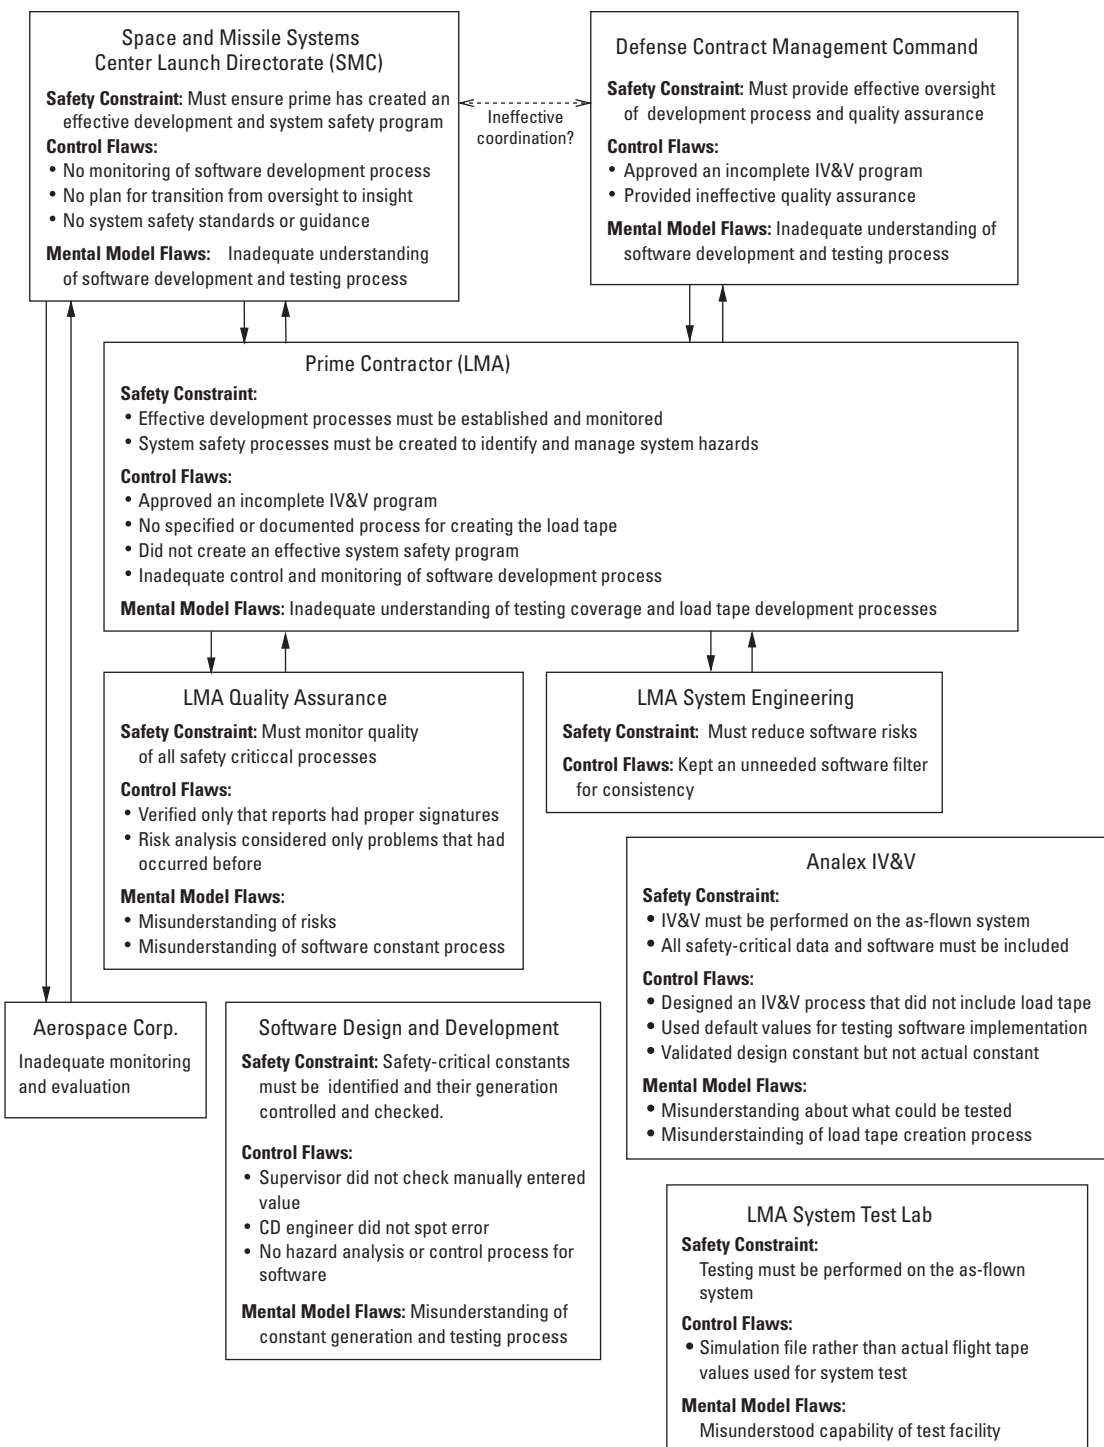
Figure B.5
STAMP model of development process.

Figures B.5 and B.6 summarize the STAMP-based accident analysis.

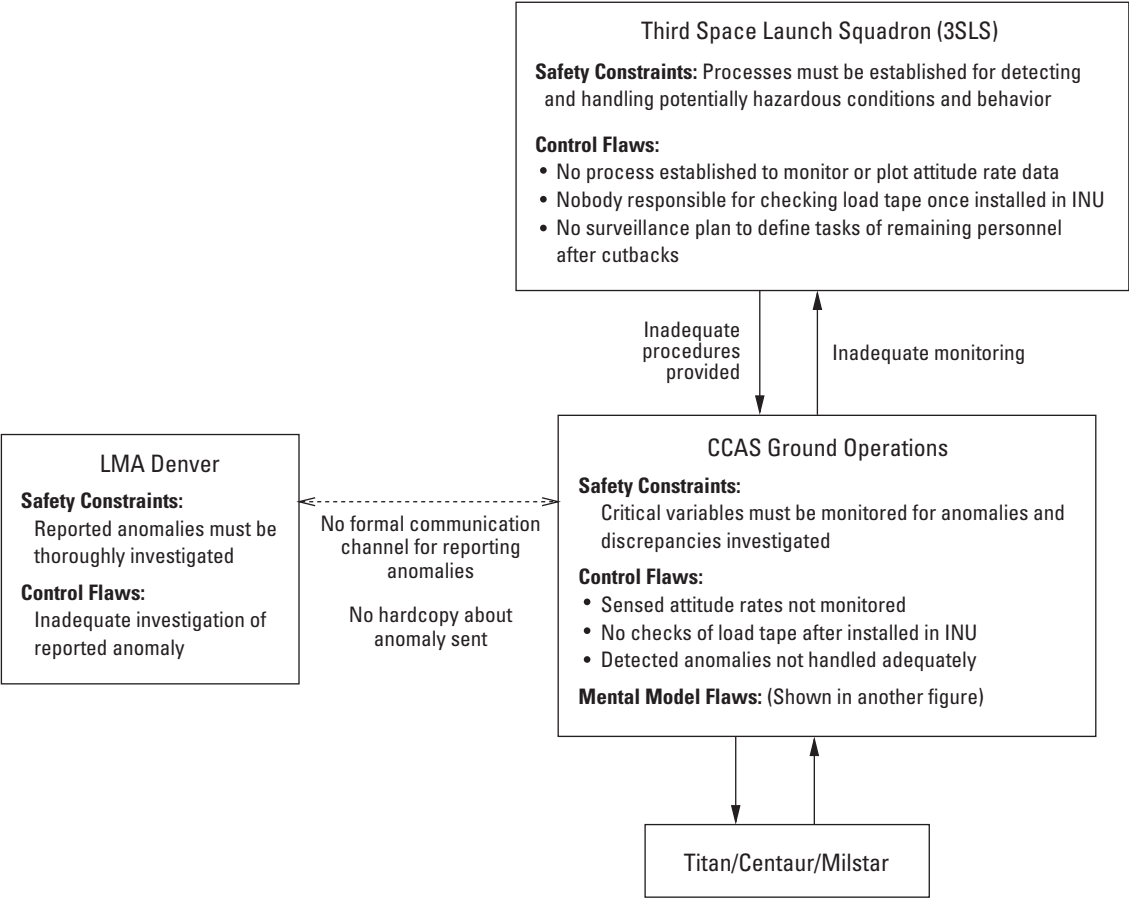
Figure B.6
STAMP model of launch operations process.

The function of launch site operations (figure B.6) is to monitor launchpad behavior and tests and to detect any critical anomalies prior to flight. Why was the roll-rate error not detected during launch operations?

Context: Management had greatly reduced the number of engineers working launch operations, and those remaining were provided with few guidelines as to how they should perform their job. The accident report says that their tasks were not defined by their management so they used their best engineering judgment to determine which tasks they should perform, which variables they should monitor, and how closely to analyze the data associated with each of their monitoring tasks.

1. One week before launch, LMA personnel at CCAS observed much lower roll rate filter values than they expected. When they could not explain the differences at their level, they raised their concerns to Denver LMA Guidance Product Integrity Engineers (PIEs), who were now at CCAS. The on-site PIEs could not explain the differences either, so they directed the CCAS personnel to call the control dynamics (CD) design engineers in Denver. On Friday, April 23, the LMA guidance engineer telephoned the LMA CD lead. The CD lead was not in his office so the guidance engineer left a voice mail stating she noticed a significant change in roll rate when the latest filter rate coefficients were entered. She requested a return call to her or to her supervisor. The guidance engineer also left an email for her supervisor at CCAS explaining the situation. Her supervisor was on vacation and was due back at the office on Monday morning, April 26, when the guidance engineer was scheduled to work the second shift. The CD lead and the CD engineer who originally specified the filter values listened to the voice mail from the guidance engineer. They called her supervisor at CCAS who had just returned from vacation. He was initially unable to find the email during their conversation. He said he would call back, so the CD engineer left the CD lead's office. The CD lead subsequently talked to the guidance engineer's supervisor after he found and read the email. The CD lead told the supervisor at CCAS that the filter values had changed in the flight tape originally loaded on April 14, 1999, and the roll rate output should also be expected to change. Both parties believed the difference in roll rates observed were attributable to expected changes with the delivery of the flight tape.

2. On the day of the launch, a 3SLS INU Product Integrity Engineer (PIE) at CCAS noticed the low roll rates and performed a rate check to see if the gyros were operating properly. Unfortunately, the programmed rate check used a default set of I1 constants to filter the measured rate and consequently reported that the gyros were sensing the earth rate correctly. If the sensed attitude rates had been monitored at that time or if they had been summed and plotted to ensure they were properly sensing the earth's gravitational rate, the roll rate problem could have been identified.

3. A 3SLS engineer also saw the roll rate data at the time of tower rollback, but was not able to identify the problem with the low roll rate. He had no documented requirement or procedures to review the data and no reference to compare to the roll rate actually being produced.
