High Voltage Diagnostics and Trouble Shooting in MicroBooNE

(The MicroBooNE Collaboration)

(Dated: March 28, 2017)

At the end of January, MicroBooNE ramped down it's drift HV system after a series of unusual and worrying behavior on HV monitoring plots. This document presents a summary of the tests performed, diagnostics developed, and a chronological ordering of events. We also include some "lessons learned" that may be useful to future LArTPCs.

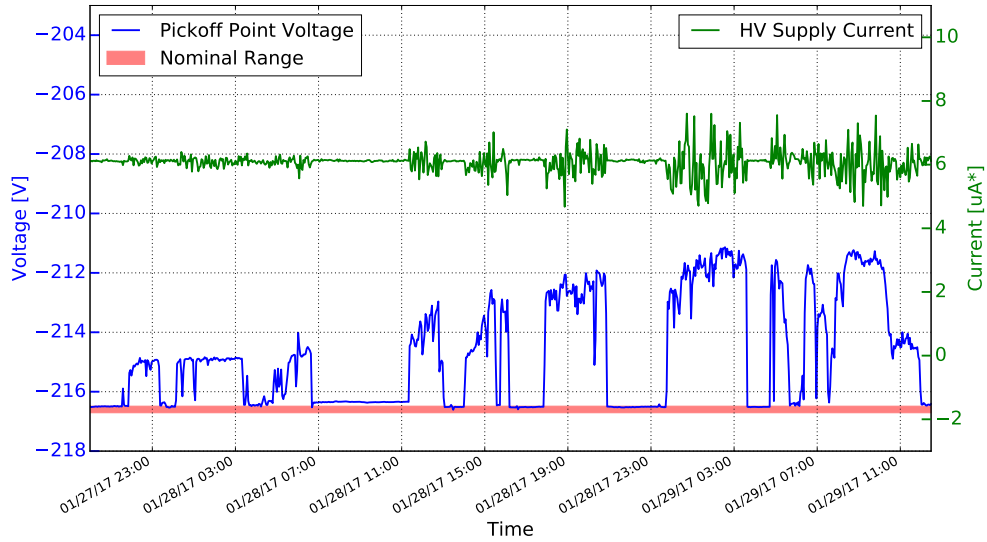
25 The first symptom to be detected during MicroBooNE’s high voltage incident
26 was large, sustained deviations on the pickoff point (see Section II E). Nominally,
27 this point sits at a value of approximately $\frac{5M\Omega}{17.1G\Omega} = 0.029\%$ of the applied voltage by
28 the power supply. As seen in Figure 1, the pickoff point values deviated significantly
29 from the nominal values. In this figure, the band of nominal values is selected as the
30 minimum and maximum of a two week stable period.

35 The current shown in the figure demonstrates clear increases in noisiness when the
36 pickoff point deviations occur, indicating that whatever the cause of the problems is,
37 it affects both the HV power supply and the pickoff point simultaneously.

Figure 1. Pickoff point deviations over the weekend of Jan 27th. Though the absolute calibration is not correct on the current from the HV power supply, there is clearly a correlation between the pickoff point deviations and noise on the HV power supply.

to calculate an RMS of the calculated current from the back of the power supply, and can make only qualitative comparisons to historical data. We have since implemented archiving of not just the values output by the power supply, but also the noise on those value measurements.

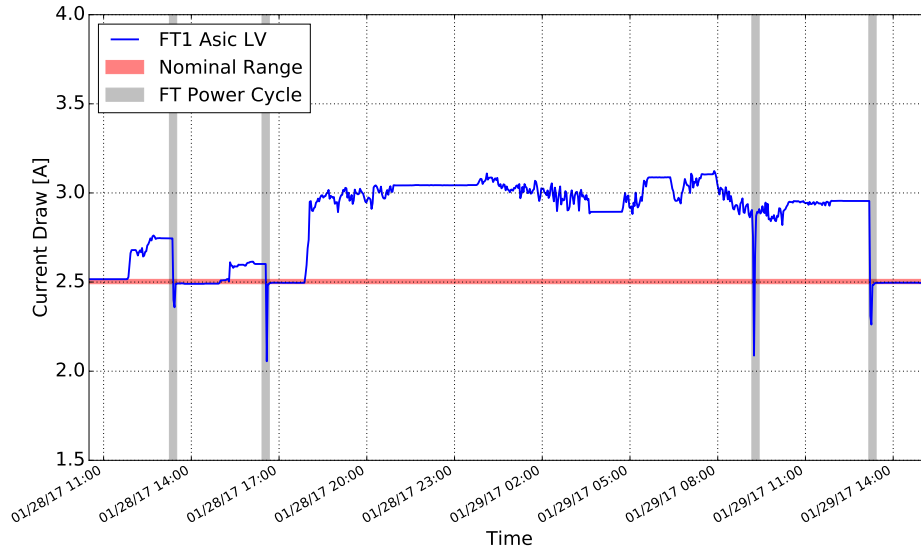
In coincidence with the large deviations of the pickoff point, MicroBooNE also observed increased current draw on a handful of power supplies for the cold electronics. Figure 2 shows the increased draw on the worst feedthrough, labeled within the detector as “FT1.” High current draws are not unusual, though this incident

48 required multiple power cycles to restore nominal operation. Additionally, the final
 49 power cycle on 1/29/17 just before 14:00 CST occurred after the detector's high volt-
 50 age had been decreased from 70kV to 65kV. After this, the current draw was stable
 51 for some time, though later attempts to ramp up the detector also caused increased
 52 current draw on this feedthrough.

Figure 2. The current for the cold electronics power supply during the same time period as Figure1.

53 The increased current draw is correlated well with a persistant noise state on
 54 the detector electronics. It is thought that the high voltage instability induces a
 55 noise state on the electronics that persists until the electronics are reconfigured or
 56 power cycled, which is why the power cycles in Figure 2 show normal current draw
 57 afterwards, at least temporarily, for 3 of the 4 power cycles shown.

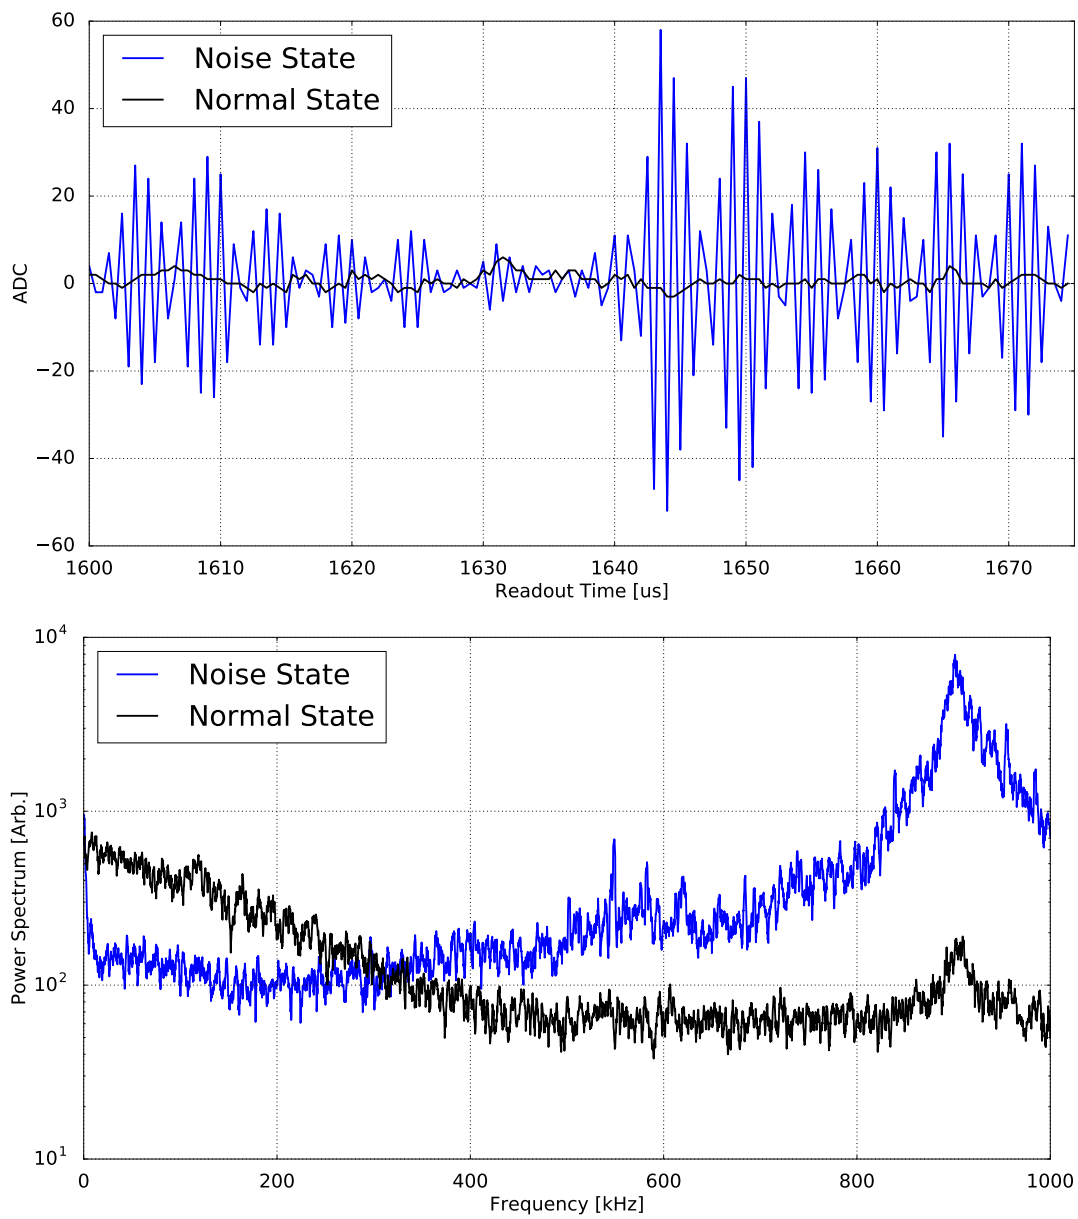
Figure 3.

58 Figure 4 shows an event display of the part of the detector impacted by the
 59 persistant noise state. Figure 3 shows a portion of a waveform from this region

60 compared to normal running conditions. The increase in noise is almost exclusively
61 at the 900kHz band, and shows a dramatic increase over the usual noise at 900kHz.

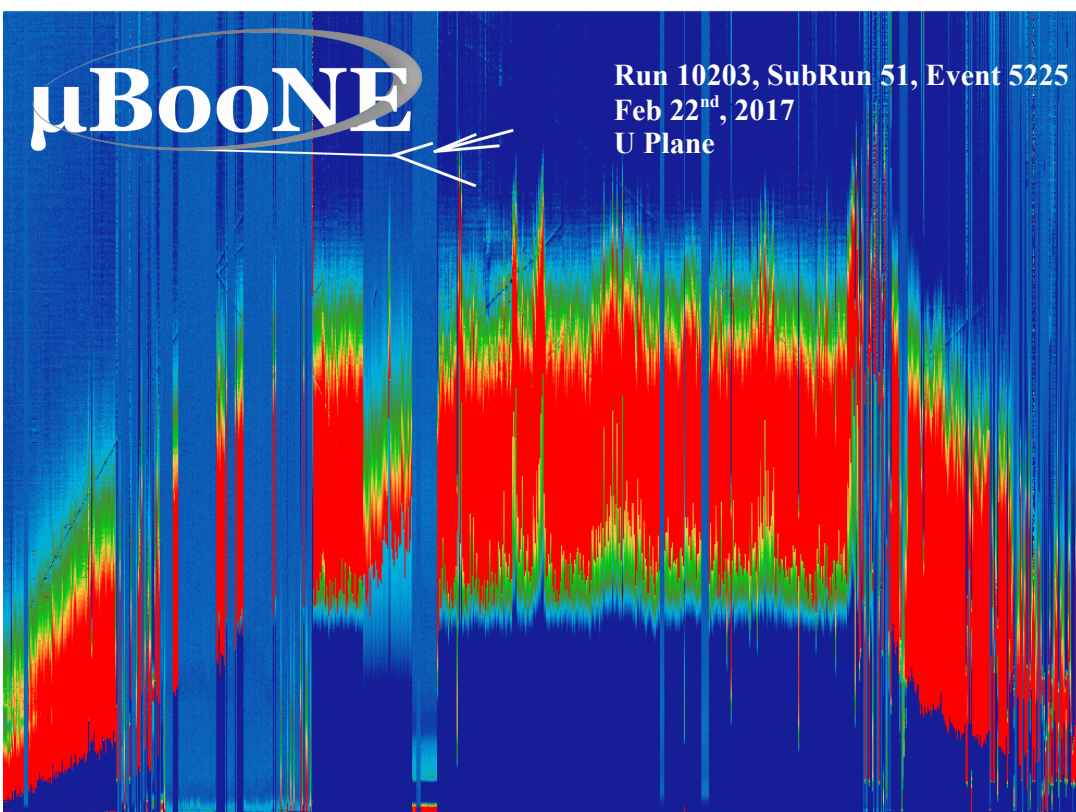
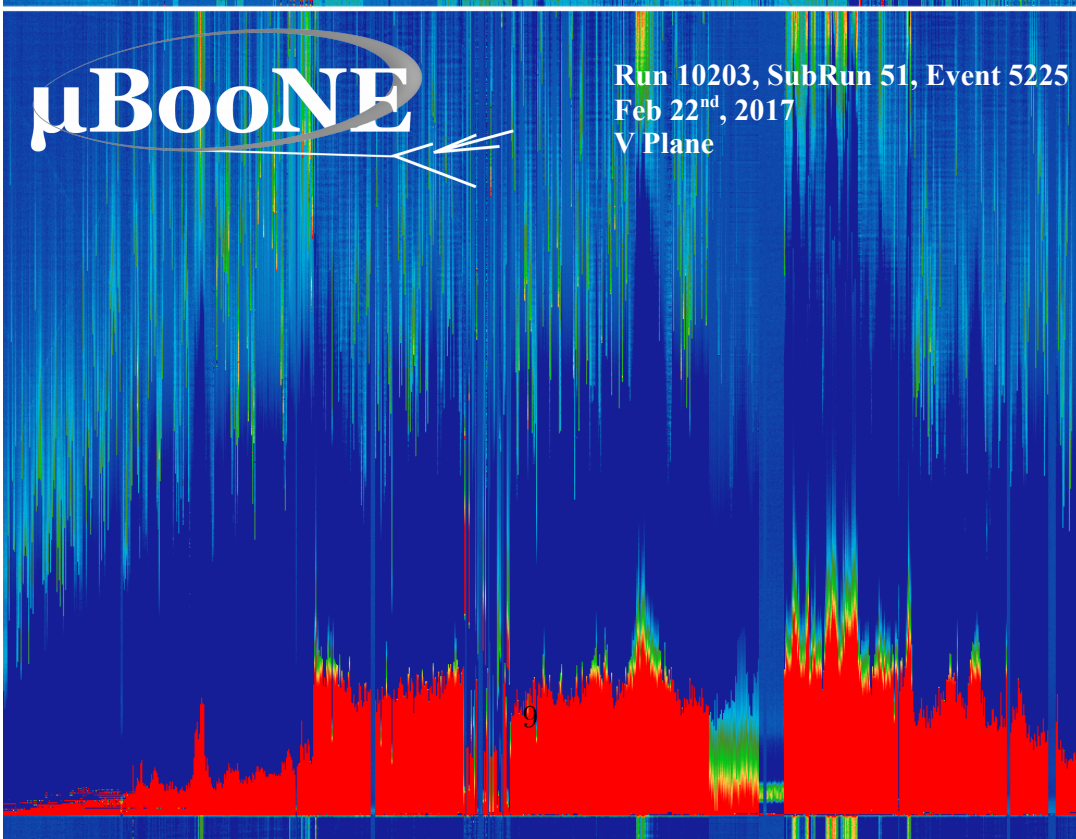
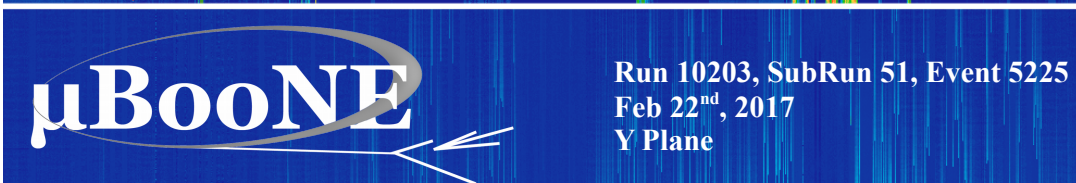
70 The last observation of high voltage instability symptoms are the “burst” events,
71 an example of which is shown in Figure ???. In these events, we see high ADC counts
72 on all channels, across all three readout planes, simultaneously. Even wires that are
73 unresponsive see these burst events, as shown in Figure 6.

74 The pulse amplitude after burst event shows a very long return to baseline after
75 the event occurs, seen in both Figures 5 and 6. There are several notable features of
76 these events:

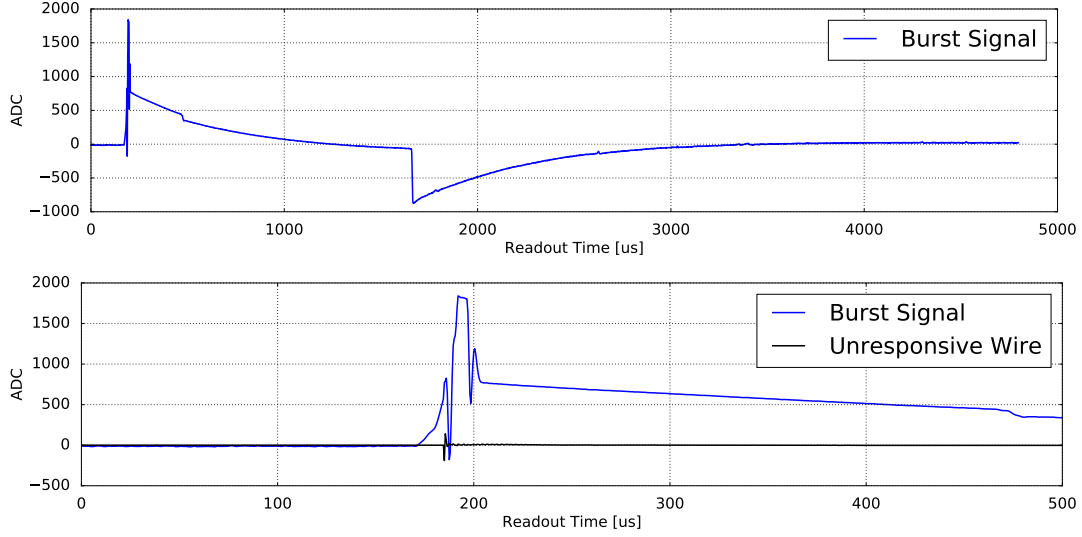
Figure 6. Burst event waveforms from U plane wires. In the top image, the entire waveform is shown, demonstrating the long return to baseline that produces the rainbow appearance in the U plane of Figure 5. In the bottom image is shown the wire response at the incidence of the burst event, as well as the response on an unresponsive channel.
