# Flanders Loft

## FY 2025 RESERVE STUDY AND MAINTENANCE SCHEDULE

**Flanders Loft Community  
Association**

**February 20, 2025**

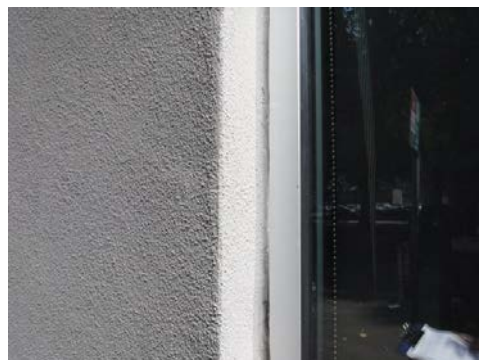
<b>Item Number</b>	4
<b>Type</b>	Common Area
<b>Category</b>	Building Components
<b>Measurement Basis</b>	Total
<b>Estimated Useful Life</b>	20 Years
<b>Basis Cost</b>	\$ 17,797.00
<b>Tracking</b>	Logistical
<b>Method</b>	Adjusted

Sealant joints were observed by Forensic to be in overall good condition. See Forensic BECA for more information.
