The old CPU09GPP card seems to use the wrong bus signals.

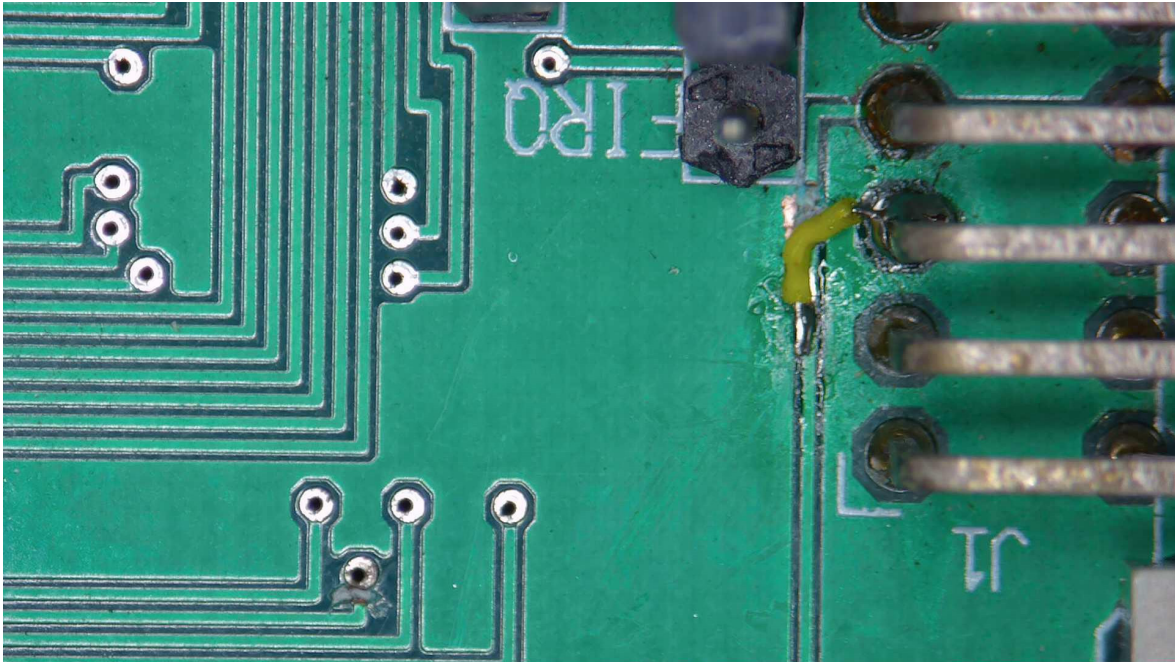
New patch

The SIG30 is not connected with AC64 pin A30 and C30 but on A29 and C29!

Just cut the trace on the part site and connect it to C30 add the bottom connect C30 to A30.

Connect C30 to A30.
