TIL # 298R1

**LOW FLOOR BATTERY DISCONNECT
MODIFICATION**

Models Affected: NFI LOW FLOOR 7101-7191 **Locations Affected:** ALL

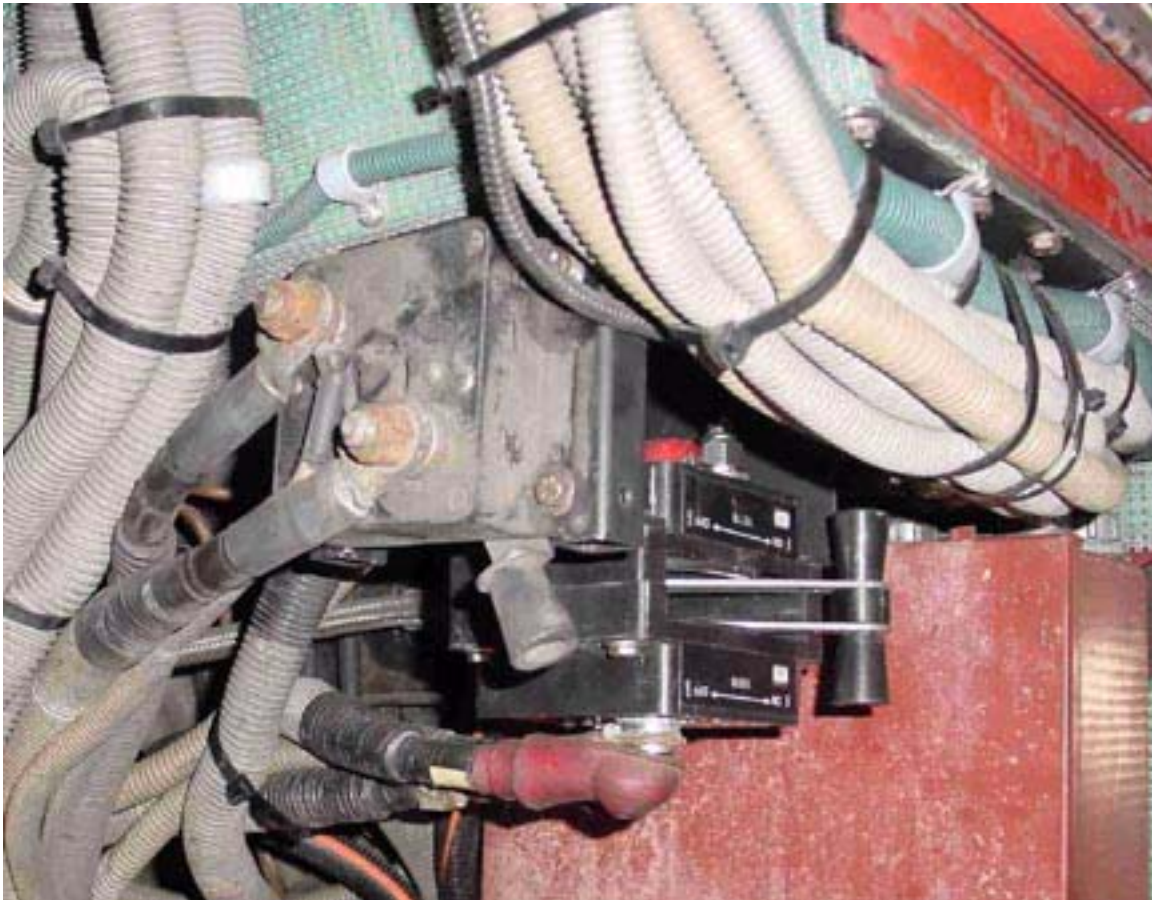
Modification Reference Picture

New Flyer Low Floor coaches #7101-7191 identified by sales release (SR) 375 and (SR) 391 require relocation of the main battery disconnect switches due to its location at road level behind the rear wheel. The reason is contamination from road debris, water/salt corrosion in the switch contacts and on their cable connection. This modification (as pictured below) will eliminate coaches from having intermittent electronic device problems, open circuits and bad grounding problems that lead to excessive road calls, unnecessary troubleshooting and electrical maintenance problems.

1. Remove old battery switches and brackets.
2. Install battery switch mounting plate by drilling and tapping 4 1/2" x 5/16" N.C. bolts. Reference picture on page 1. Approximately 8" from forward bulkhead. Also use 2 5/16" x 1" sleeves in order not to crush the 1" thick insulation.
3. Check old switches for re-use and install on battery switch mounting plate. If needing replacement, replace with double switch (part #9478670) and single switch (part #9478682).
4. Remove 4/0 cable "PS2PC" from 24V bus bar.
5. Remove 4/0 cable "PS1PC" from 12V bus bar in rear box.
6. Install new cable through water tight fittings in bottom of box. (+- 96" length each). Install (crimp & solder) 5/16 x 4/0 terminal in box end of cable. Install 1/2" x 4/0 terminal at switch end of cable.
7. Refer to diagram on page 5 of this T.I.L. for correct cable hook at switches.
