## Stellaris<sup>®</sup> LM4F120H5QR RevA1/A3 Errata

This document contains known errata at the time of publication for the Stellaris LM4F120H5QR microcontroller. The table below summarizes the errata and lists the affected revisions. See the data sheet for more details.

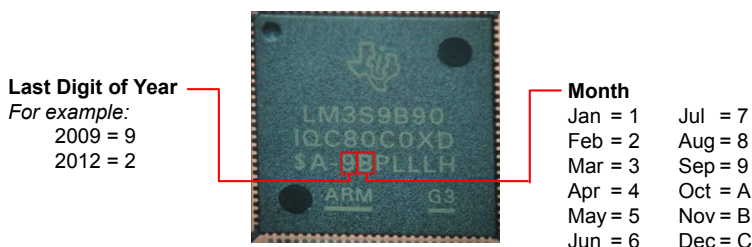
**Note:** To determine the date code of your part, look at the first two characters following the dash on the third line of the part markings (highlighted in red in the following figure). The first number after the dash indicates the last decimal digit of the year. The second character indicates the month. Therefore, the following example shows a date code of 9B which indicates November 2009.
