UNIT TRIPPING REPORT

UNIT No: 1
TUTICORIN.

STATION: NTPL,

REPORT NO: 45

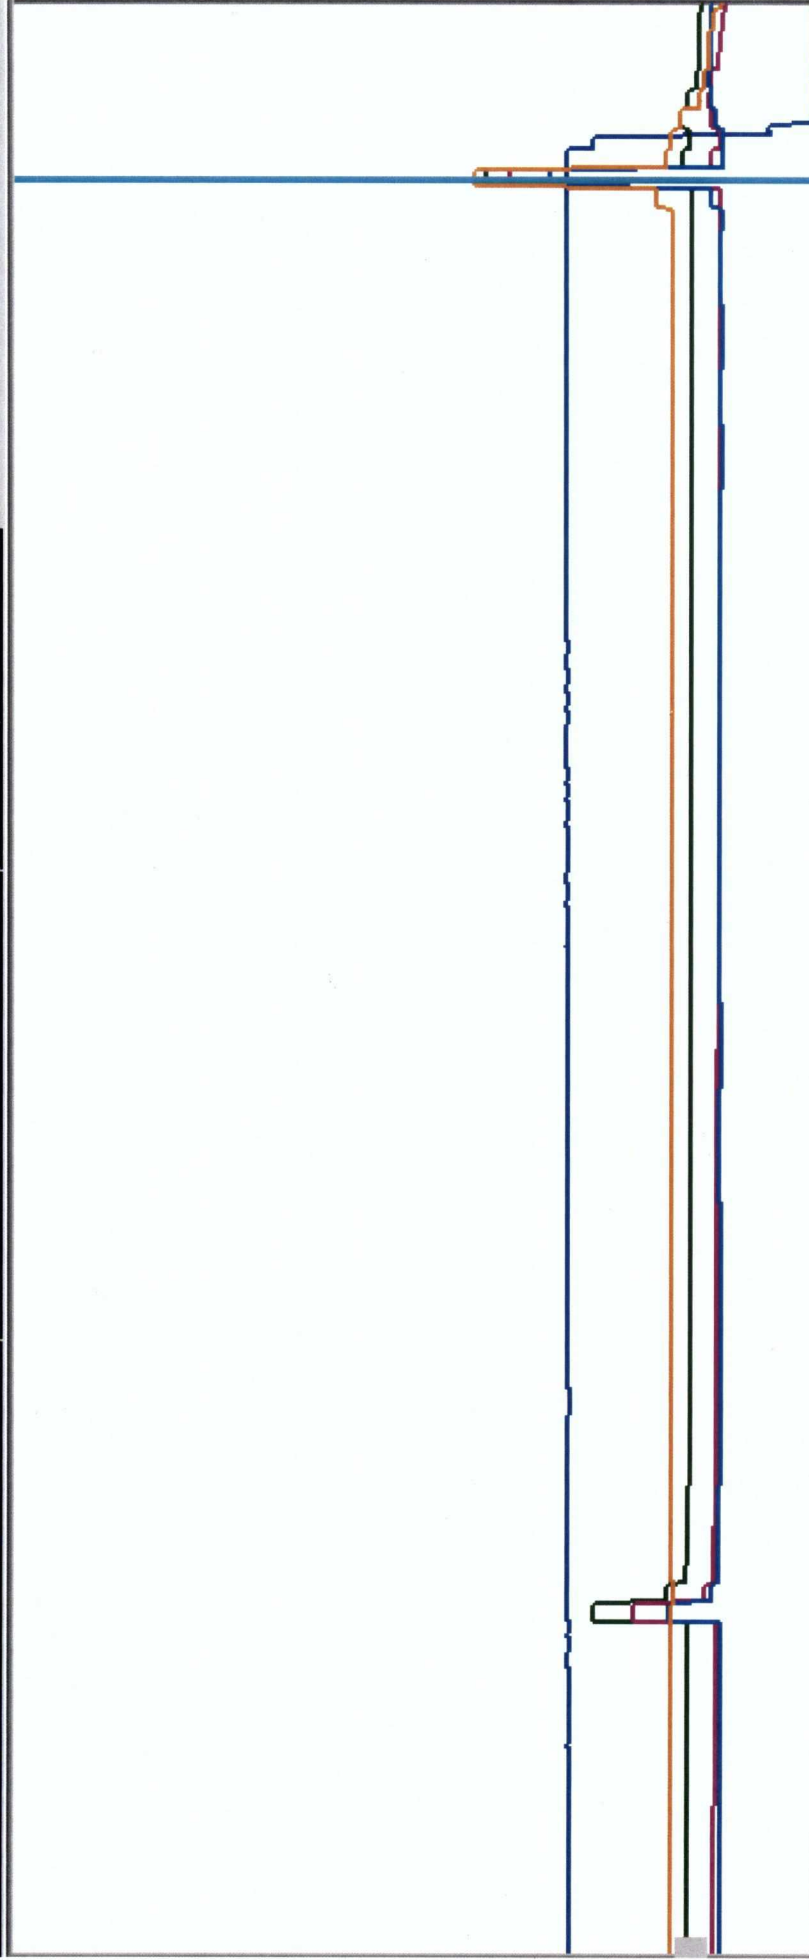
Turbine got tripped on shaft vibration high protection at 03:45:17 hrs on 13-11-2019 in U#1 while load raising was in progress, after synchronizing. Protection trip on shaft vibration was implemented in both the units following the BHEL directive on the subject. The protection has to act after a time delay of 1 second, when 2 out of the 14 of shaft vibration values exceed 300 μ .

Though the exact cause for vibration could not be ascertained at that time, it is believed to be due to the excessive differential expansion of HPT. Rate of MS temperature rise was faster and reflected in TSE as very low available HPC margin.

All available turbine supervisory parameters variations were analysed to find out the root cause for the vibration of both the HPT bearings, and also to rule out spurious signals. No direct relation could be arrived at during the period. Anyhow vibration probes were checked and replaced with new ones for the acted sensors.

HPDE reading which was not available was made ready during the AOH 2019 of Unit #1, after rectifying the instrument cable. But again it got failed while in service, making it unavailable for monitoring during rolling and load variations. This has to be retrieved during the next opportunity.

Board Engineers were sensitized on the importance of Turbine supervisory instruments, TSE and parameter raising procedures. Relieving Group Classes were conducted for all operation engineers and a Rolling Check List was formulated. Two rollers per Group were identified for imparting intensive rolling training.
