**BOILER TUBE FAILURE REPORT (C-2 FORM)**  
(C-2 FORM SHOULD BE SENT WITHIN 12 HOURS OF SYNCHRONISATION)

1) STATION:	NTPL	2) UNIT No.	II	3) LAST UNIT OUTAGE	Apr-21	4) LAST UNIT O/H	Nov-21
5) UNIT SHUTDOWN FROM	31	08	22	16	18	9) OUTAGE HOURS	36
6) WATER FILLING CLEARANCE	01	09	22	22	35	(ONLY DUE TO BTF)	18
7) CLEARANCE FOR LIGHTUP	02	09	22	00	15	10) GENERATION LOSS	
(AFTER REPAIR OF BTF)	dd	mm	yy	hh	mm	(ONLY DUE TO BTF)	MUS
8) UNIT SYNCHRONISED AT	02	09	22	04	36		
11) BTF INSPECTED BY	dd	mm	yy	hh	mm		
BTF COMMITTEE HEAD				MTP		FQA	
CHEMISTRY				OPERATION		O&C

Tube Dimension D44.5x7.1mm; T22, Divisional Panellette Superheater Coil 3, Circuit 9, Elevation - 56 Mtr Level

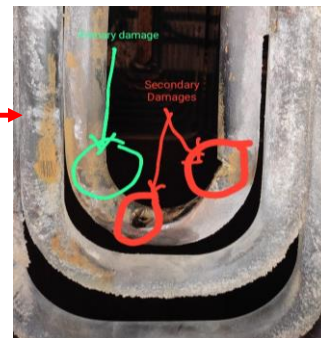
13) PHOTOGRAPHS OF LOCATION OF FAILURE BEFORE START OF REPAIR WORK

Suspected Bend stress of Tube. Tube to be sent for metal analysis.

Replacement of Bend Piece in Divisional Panellette Superheater Coil 3  
No of Spools Replaced - 1; No. of Joints welded - 2
