UNIT TRIPPING REPORT

UNIT No: 1

STATION: NTPL, TUTICORIN.

REPORT NO: 86

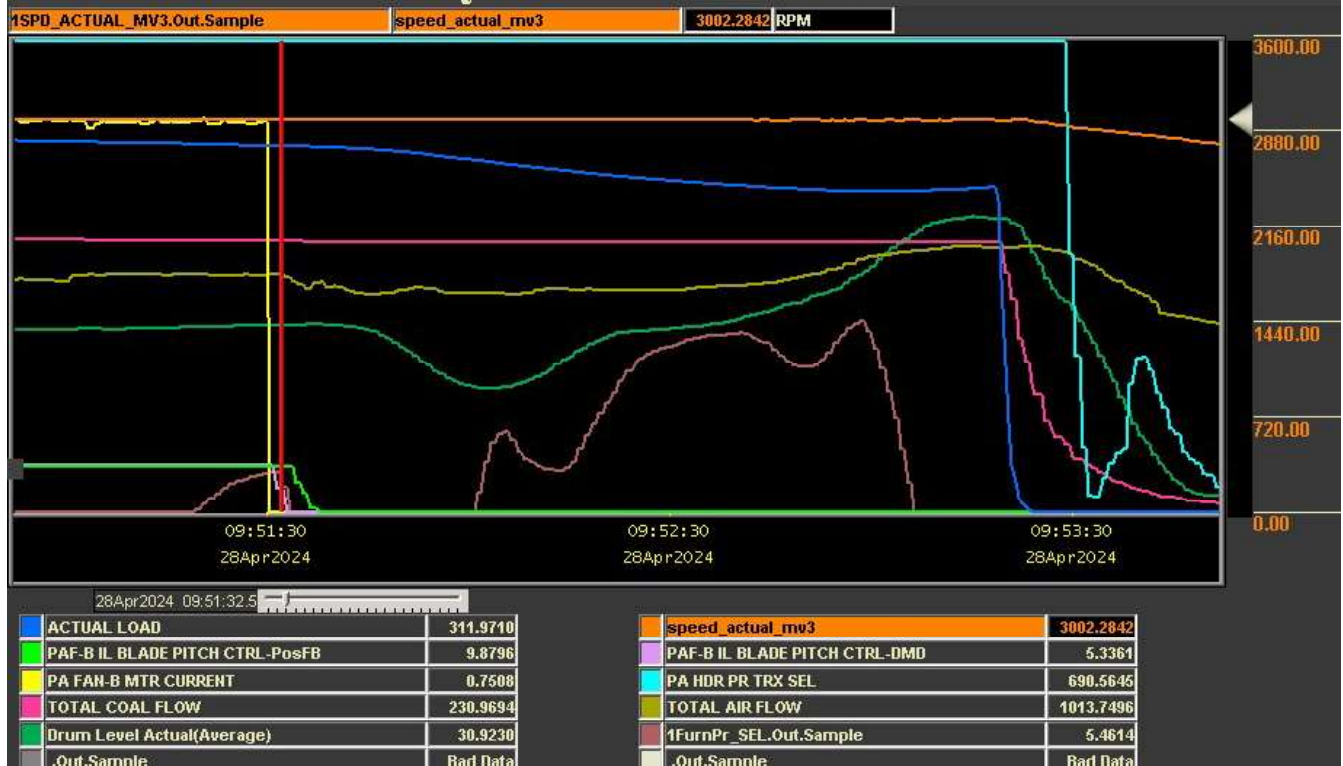
Dynamic 8 Point Trend

Unit was running at 288 MW in CMC. At 9:38 hrs PA FAN-B Current increased to 250A and both PCD demand reduced from 43% to 20%. On observation it was found that PA-B PCD got fully opened. at 9.45 hrs CD elevation 3 HFO oil guns were taken. 9:49 hrs Mill-H was stopped to reduce PA Flow. PA-A PCD opened to 84% to support PA header pressure while stopping PA Fan-B. PA-B O/L gate was closed to 50% and PA Fan-B stopped at 9:51hrs. PA header and Furness pressure fluctuated and drum level was 21mmwc at 9:52:30 hrs, high alarm (+150mm) came at 9:52:58hrs. Drum Level high (+250mmwc) acted at 9:53:06 hrs and MFT acted and unit tripped.

Atmospheric ash has contaminated the PA Fan Lube oil, which has accumulated in the Hydraulic Adjustment Device (HAD) internals. This has led to failure of HAD internals and PCD opened 100% & became Inoperative to the command.

Fugitive ash leakages in and around the fan area to be minimized. During Opportunity (shutdowns) HAD to be inspected. Lube oil quality (NAS & TAN value) to be analysed.

- i) SOP to be reviewed in detail for stoppage of PA Fan in case of failure/in operation of HAD.
- ii) In case of stoppage of fully loaded PA fan unit load shall be reduced 200 MW with oil gun support & with 3 mill condition.
- iii) The O/L gate of PA Fan to be stopped may be closed to 80% before stopping the fan.
- iv) Lube oil analysis NAS, TAN value to be checked.
- v) LSR relay healthiness to be checked in next opportunity.
