**BOILER TUBE FAILURE REPORT (C-2 FORM)**  
(C-2 FORM SHOULD BE SENT WITHIN 12 HOURS OF SYNCHRONISATION)

| 1) STATION: | NTPL | 2) UNIT No. | II | 3) LAST UNIT OUTAGE | Aug-22 | 4) LAST UNIT O/H | Nov-21 |

12) FAILED TUBE LOCATION MARKED ON UNIT MATERIAL DIAGRAM AND BOILER GENERAL ARRANGEMENT DRAWING  
(CLEARLY IDENTIFYING TUBE NO., COIL NO., TUBE DIMENSION, TUBE MATERIAL AND X,Y,Z COORDINATES)  
Tube Dimension D51x6mm; SA210 Gr.C, RHS Waterwall (52 ML), S-Panel (10 ML), Corner 4 Transition tubes (52 ML)

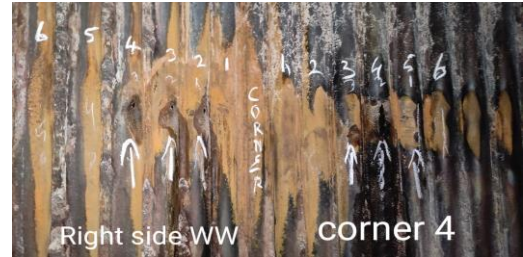
13) PHOTOGRAPHS OF LOCATION OF FAILURE BEFORE START OF REPAIR WORK

Attachment weld failure in 10 ML of Tube 3 (From RHS WW) in Front WW resulting in Fish mouth opening at 52 ML of Corner 4 Transition tubes.
