<b>BOILER TUBE FAILURE REPORT ( C-2 FORM )</b>									
<b>C2 FORM NO</b> <span style="border: 1px solid black; padding: 2px 20px;"></span>		(C-2 FORM SHOULD BE SEND WITHIN 12HOURS OF SYNCHRONISATION)

1)	STATION: <span style="border: 1px solid black; padding: 2px 20px;">T007</span>	2)	UNIT NO. <span style="border: 1px solid black; padding: 2px 20px;">U02</span>	3)	LAST UNIT OUTAGE <span style="border: 1px solid black; padding: 2px 20px;">16-09-2023</span>

16)	BOILER WATERWALL TUBE RHS TUBE 46 FROM FRONT WALL								
	EQUIPMENT NUMBER <span style="border: 1px solid black; padding: 2px 20px;">T007U02BLR00005</span>	EQUIPMENT DESCRIPTION <span style="border: 1px solid black; padding: 2px 20px;">MANHOLE DOORS</span>							
	LOCATION DETAILS <span style="border: 1px solid black; padding: 2px 20px;">T007-U02-BLR-AUX</span>	LOCATION DESCRIPTION <span style="border: 1px solid black; padding: 2px 20px;">500</span>							
	MATERIAL <span style="border: 1px solid black; padding: 2px 20px;">SA210 GR C</span>	TUBE NUMBER <span style="border: 1px solid black; padding: 2px 20px;">0046</span>	EQUIPMENT HEIGHT (MTS) <span style="border: 1px solid black; padding: 2px 20px;">016</span>						
<b>DES

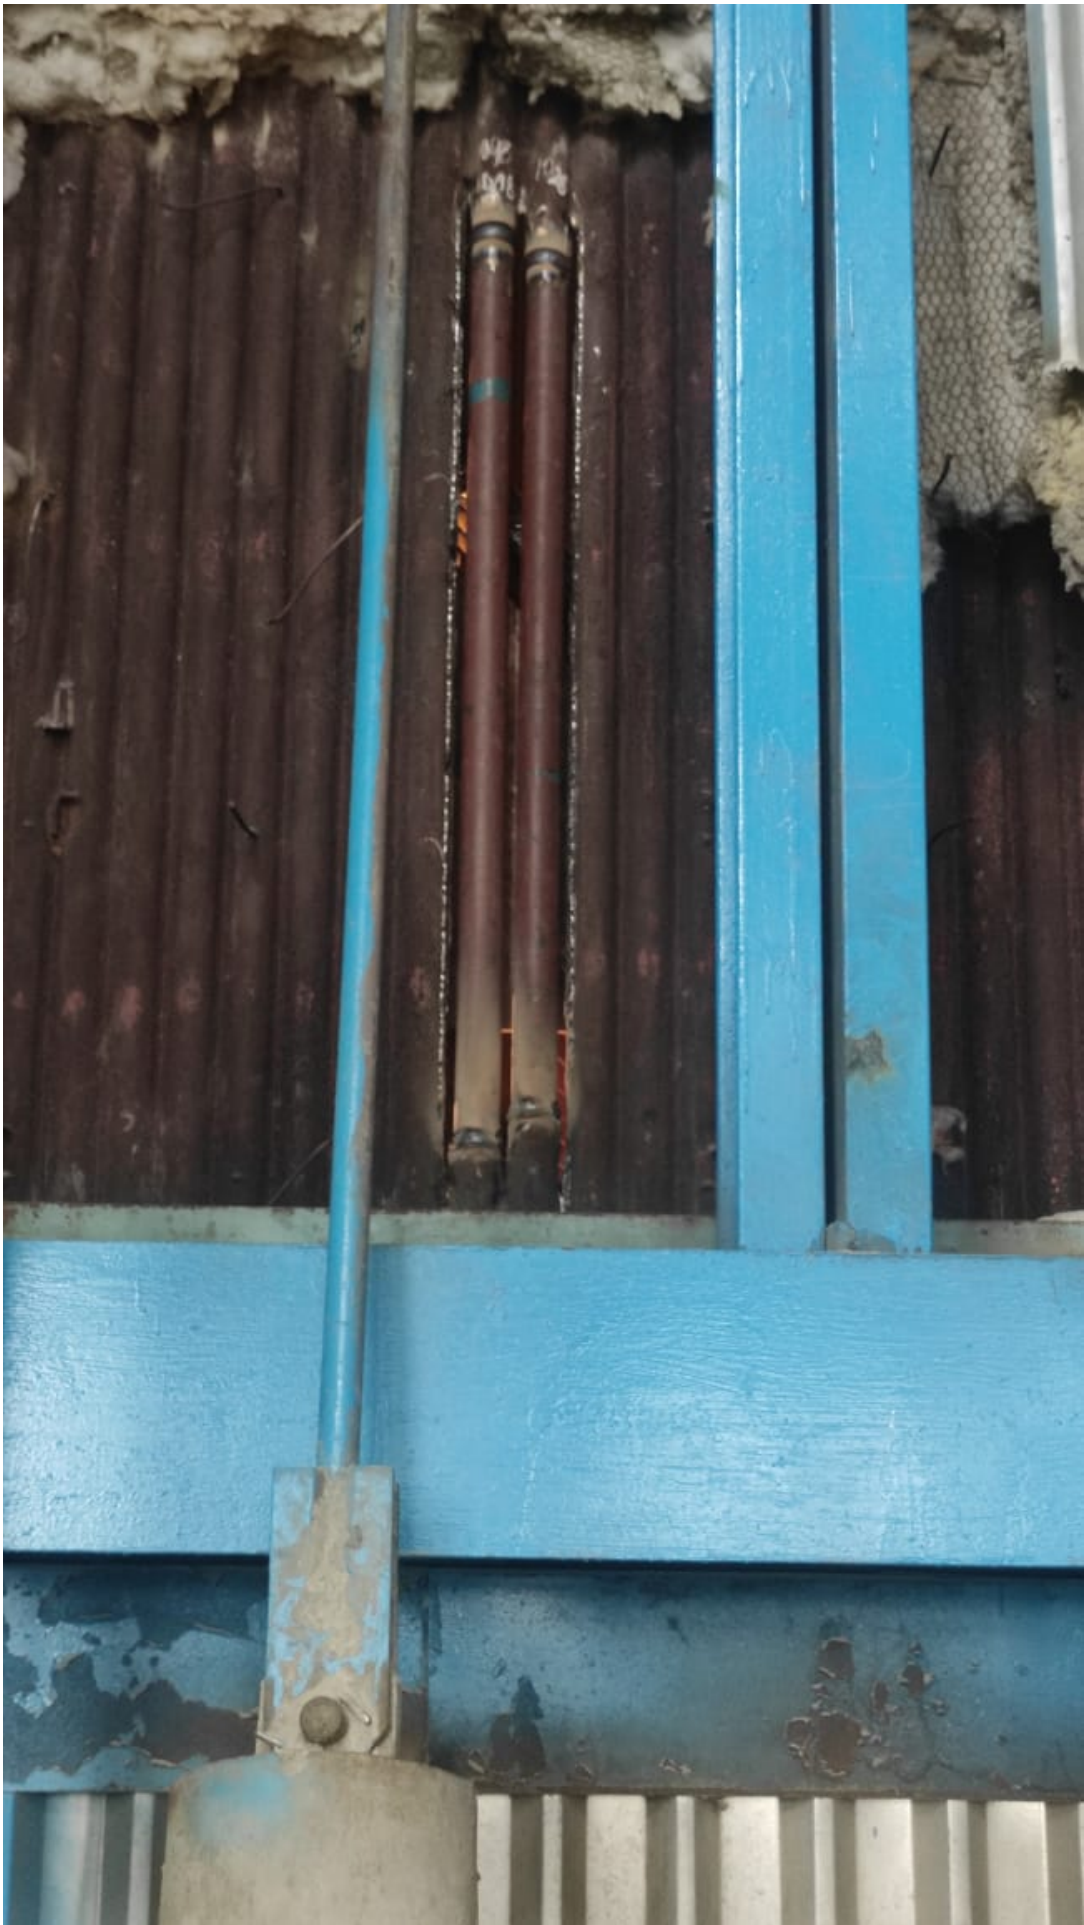
ELEVATION DRAWING

21)	<span style="border: 1px solid black; padding: 2px 20px;">Fin welding failure</span>								
<b>HISTORY OF WORK IN FAILED TUBE/COIL/LOCATION IN PAST FIVE YEARS</b>									
	Date	C2 Form Number	Tube No	Height	Material	Cause			
			0046	016	SA210 GR C				
Submitted by <span style="border: 1px solid black; padding: 2px 20px;">PRADEEP SRIKANTH A</span> Submitted on <span style="border: 1px solid black; padding: 2px 20px;">10-01-2024</span> Designation <span style="border: 1px solid black; padding: 2px 20px;"></span>

<b>DETAILS OF REPAIR WORK ( SPECIFY JOINT DETAILS, COIL NO/ TUBE NO AND RESTORATION WORK)</b>									
19)	<span style="border: 1px solid black; padding: 2px 20px;">Replacement of 2 Tubes Tube numbers 45 &amp; 46</span>								
<b>DETAILS OF INSPECTION OF ADJACENT AND IDENTICAL LOCATIONS</b>
