BOILER TUBE FAILURE REPORT (C-2 FORM)

1)	STATION: T007	2)	UNIT NO. U02	3)	LAST UNIT OUTAGE 04-07-2023
5)	UNIT SHUTDOWN FROM 06-09-2023 09:46:13	4)	LAST Unit O/H 01-12-2021		
6)	WATER FILLING CLEARANCE 07-09-2023 12:35:00	10)	OUTAGE HOURS 32 in Million Units (ONLY DUE TO BTF)		
7)	CLEARANCE FOR LIGHT-UP (AFTER REPAIR OF BTF) 07-09-2023 17:35:00	11)	GENERATION CAPACITY 500		
8)	UNIT SYNCHRONIZED AT 08-09-2023 00:44:00	12)	GENERATION LOSS 16 hrs:min:sec (ONLY DUE TO BTF)		
9)	ORDER NUMBER 100053610				
13)	CAUSE DETAILS 	14)	OBSERVATION PINHOLE PUNCTURE IN CORNER 2		
15)	BTF INSPECTED BY	BTF COMMITTEE HEAD	NO	MTP(Mtce planning)	NO
		CHEMISTRY	NO	OPERATION	NO
				FQA	NO
				O&E	NO

16)	CORNER 2 RHS WW TUBE 5 & 6 36 ML				
	EQUIPMENT NUMBER T007U02BLR08510	EQUIPMENT DESCRIPTION	NTPL UNIT-2 WATER WALLS		
	LOCATION DETAILS T007-U02-BLR-SWS-BCS	LOCATION DESCRIPTION	NTPL UNIT-2 BOILER CIRCULATION SY		
	MATERIAL SA 210 GR C	TUBE NUMBER 0005	EQUIPMENT HEIGHT (MTS)	036

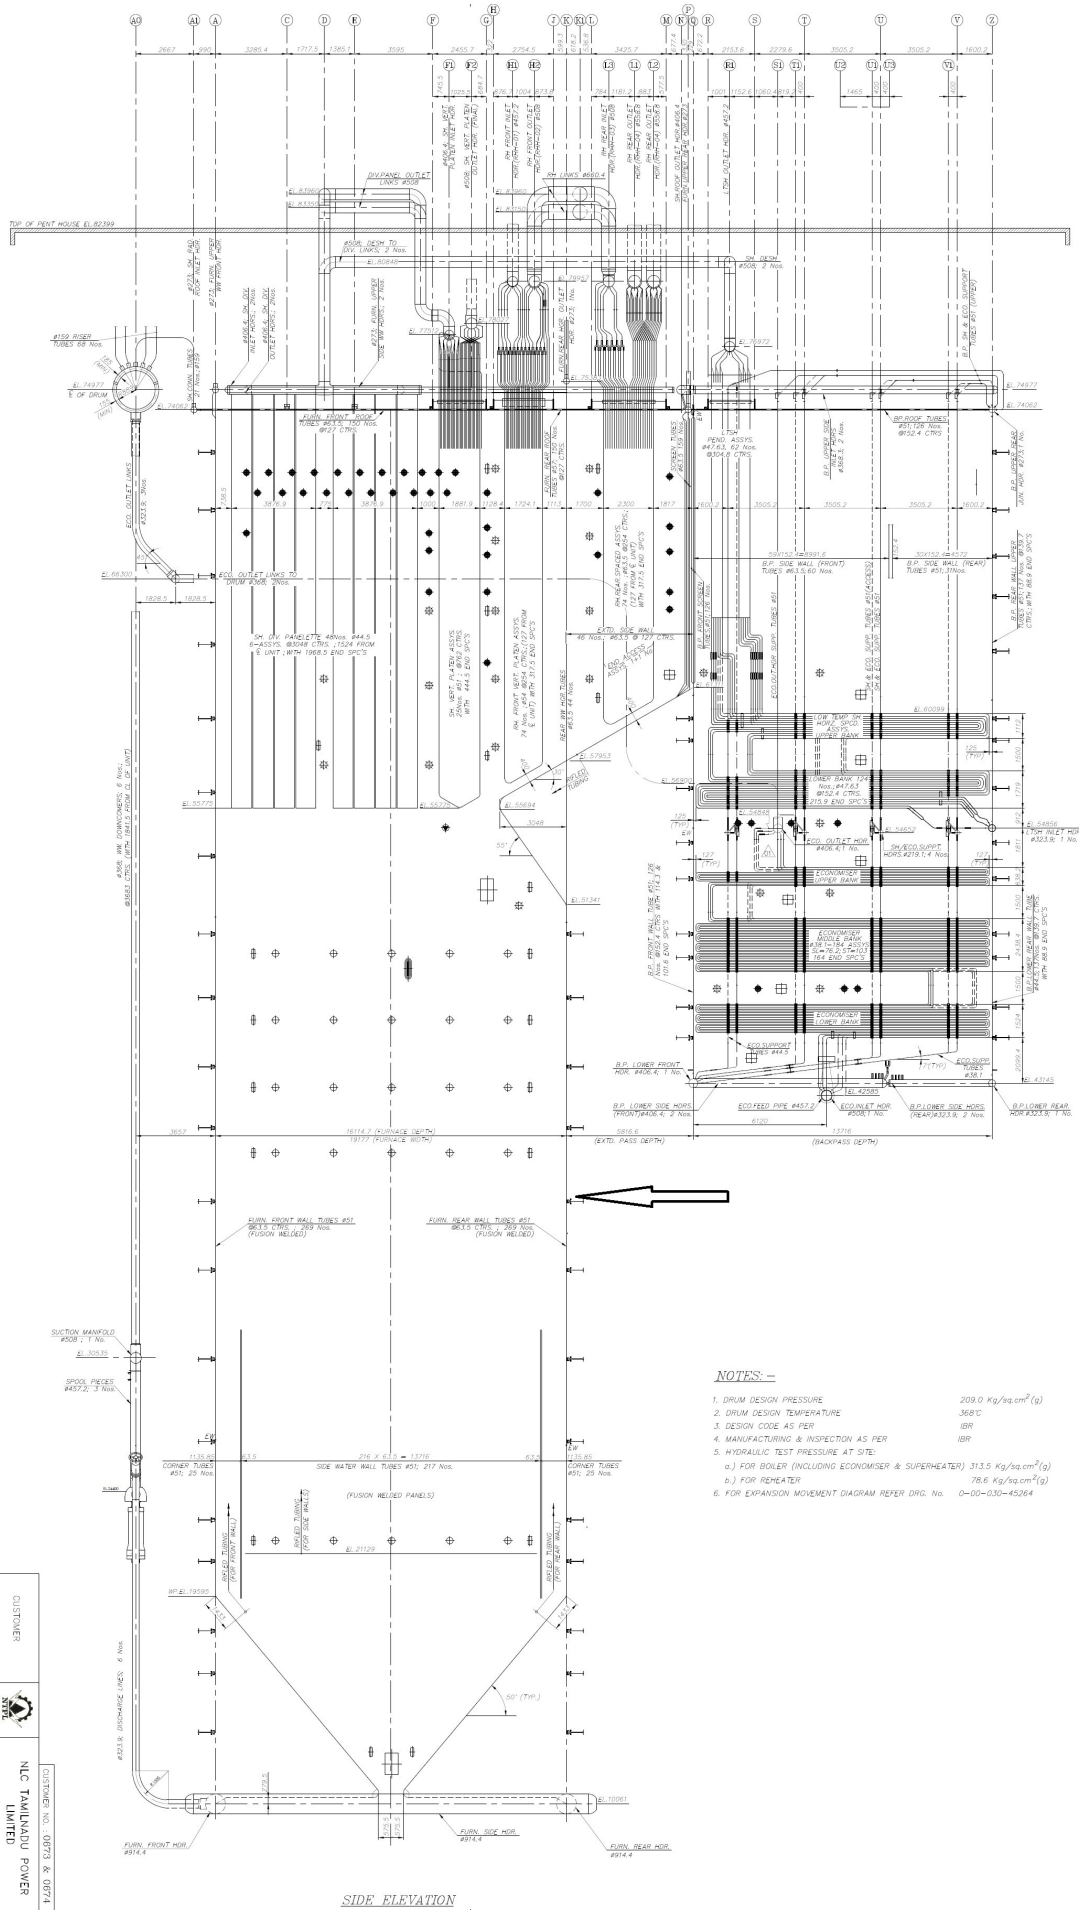
ELEVATION DRAWING

17)	Corner 2 RHS WW Tube 5 & 6 36 ML Pinhole puncture
-----	---

21)	Air based erosion of tubes through the windbox burner areas. Inspection of the areas during overhaul
-----	--

19)	Metallising the eroded tube of 5 & 6 of Corner 2 LHS WW
-----	---
