**BOILER TUBE FAILURE REPORT (C-2 FORM)**  
(C-2 FORM SHOULD BE SENT WITHIN 12 HOURS OF SYNCHRONISATION)

1) STATION:	NTPL	2) UNIT No.	I	3) LAST UNIT OUTAGE	20-05-2021	4) LAST UNIT O/H	Dec-20
5) UNIT SHUTDOWN FROM		30	09	22	00	45	9) OUTAGE HOURS
6) WATER FILLING CLEARANCE		01	10	22	04	35	34
7) CLEARANCE FOR LIGHTUP		01	10	22	08	30	55
(AFTER REPAIR OF BTF)		dd	mm	yy	hh	mm	hh
8) UNIT SYNCHRONISED AT		01	10	22	11	40	mm
11) BTF INSPECTED BY		dd	mm	yy	hh	mm	10) GENERATION LOSS
		dd	mm	yy	hh	mm	(ONLY DUE TO BTF)
BTF COMMITTEE HEAD		MTP					MUS
CHEMISTRY		OPERATION					
							FQA
							O&C

Tube Dimension D51x6mm; SA210 Gr.C, Corner 2 Burner Panel Tube 1, Elevation - 36 Mtr Level

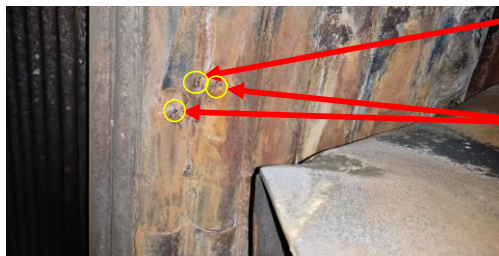
13) PHOTOGRAPHS OF LOCATION OF FAILURE BEFORE START OF REPAIR WORK

Primary Failure

Secondary Failures

Shop weld attachment failure noticed. The failure location shall be inspected during overhaul and tube replacement shall be undertaken.

Attending to Pinhole puncture and metallising the eroded areas - 3 pinholes
