BOILER TUBE FAILURE REPORT (C-2 FORM)
(C-2 FORM SHOULD BE SENT WITHIN 24 HOURS OF SYNCHRONISATION)

1) STATION: NTPL	2) UNIT No. II	3) LAST UNIT OUTAGE	Dec-22	4) LAST UNIT O/H	Nov-21
5) UNIT SHUTDOWN FROM	18 01 23	18 13		9) OUTAGE HOURS	49 41
6) WATER FILLING CLEARANCE	20 01 23	14 30		(ONLY DUE TO BTF)	hh mm
7) CLEARANCE FOR LIGHTUP	20 01 23	16 30		10) GENERATION LOSS	
(AFTER REPAIR OF BTF)	dd mm yy	hh mm		(ONLY DUE TO BTF)	MUS
8) UNIT SYNCHRONISED AT	20 01 23	19 54			
11) BTF INSPECTED BY	dd mm yy	hh mm			
BTF COMMITTEE HEAD		MTP		FQA	
CHEMISTRY		OPERATION		O&C

12) FAILED TUBE LOCATION MARKED ON UNIT MATERIAL DIAGRAM AND BOILER GENERAL ARRANGEMENT DRAWING
(CLEARLY IDENTIFYING TUBE NO., COIL NO., TUBE DIMENSION, TUBE MATERIAL AND X,Y,Z COORDINATES)
Tube Dimension D51x6mm; SA210 Gr.C, Corner 4 Burner Panel 40 ML Tube No. 5 from RHS WW

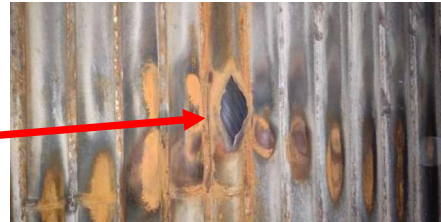
Secondary Failure

Attachment weld failure in 40 ML of Tube 5 of burner panel of Corner 4 resulting in Fish mouth opening at 52 ML of Corner 4 Transition tubes of the same tube due to starvation.

Replacement of Spool Pieces and attending to the Pinholes
No of Spools Replaced - 2 at 52 ML; No. of pinholes attended - 3 at 40 ML
