MSP430F5529 Device Erratasheet

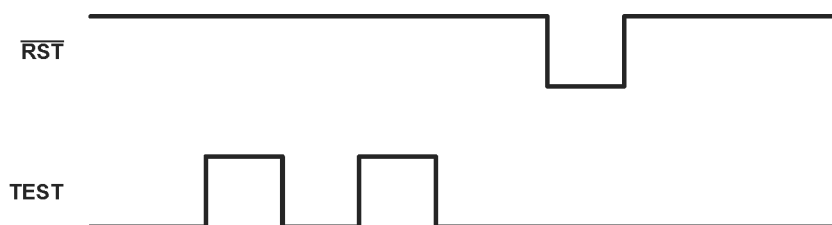
- Toggle the TEST pin twice when nRST is high and then pull nRST low.

Note: This sequence is not subject to timing constraints and the appropriate level transitions are sufficient to trigger an exit from BSL mode.

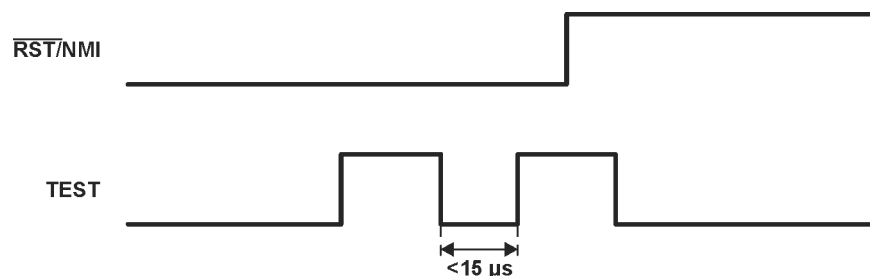
Function BSL entry sequence is subject to specific timing requirements

Description The BSL entry sequence requires that the low phase of the TEST/SBWTCK pin does not exceed 15us. This timing requirement is faster than most PC serial ports can provide, as shown in the following picture. If this requirement is not met, the entry sequence fails and the SYSBSLIND is not set.

Workaround An external hardware solution is recommended to provide the appropriate BSL entry sequence. See [http://processors.wiki.ti.com/index.php/BSL_\(MSP430\)](http://processors.wiki.ti.com/index.php/BSL_(MSP430)) for recommendations on available BSL hardware.
