## PIC32MX575/675/695/775/795 Family Silicon Errata and Data Sheet Clarification

The PIC32MX575/675/695/775/795 family devices that you have received conform functionally to the current Device Data Sheet (DS60001156H), except for the anomalies described in this document.

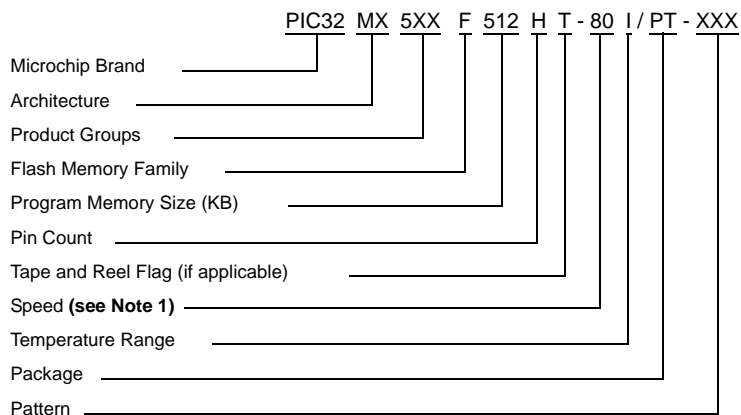
The Product Identification System information was incorrectly specified in the current version of the data sheet. The corrected information is shown in **bold type**.
