# **Final Report No. 2088**

concerning the serious incident - Airprox  
involving the Airbus A318-111 aircraft, registration F-GUGK  
operated by Air France under callsign AFR 989Z  
and the Boeing B737-8AS aircraft, registration EI-DHK  
operated by Ryanair under callsign RYR 1702  
on 8 June 2009  
over Trasadingen beacon, 15 NM north of Zurich airport

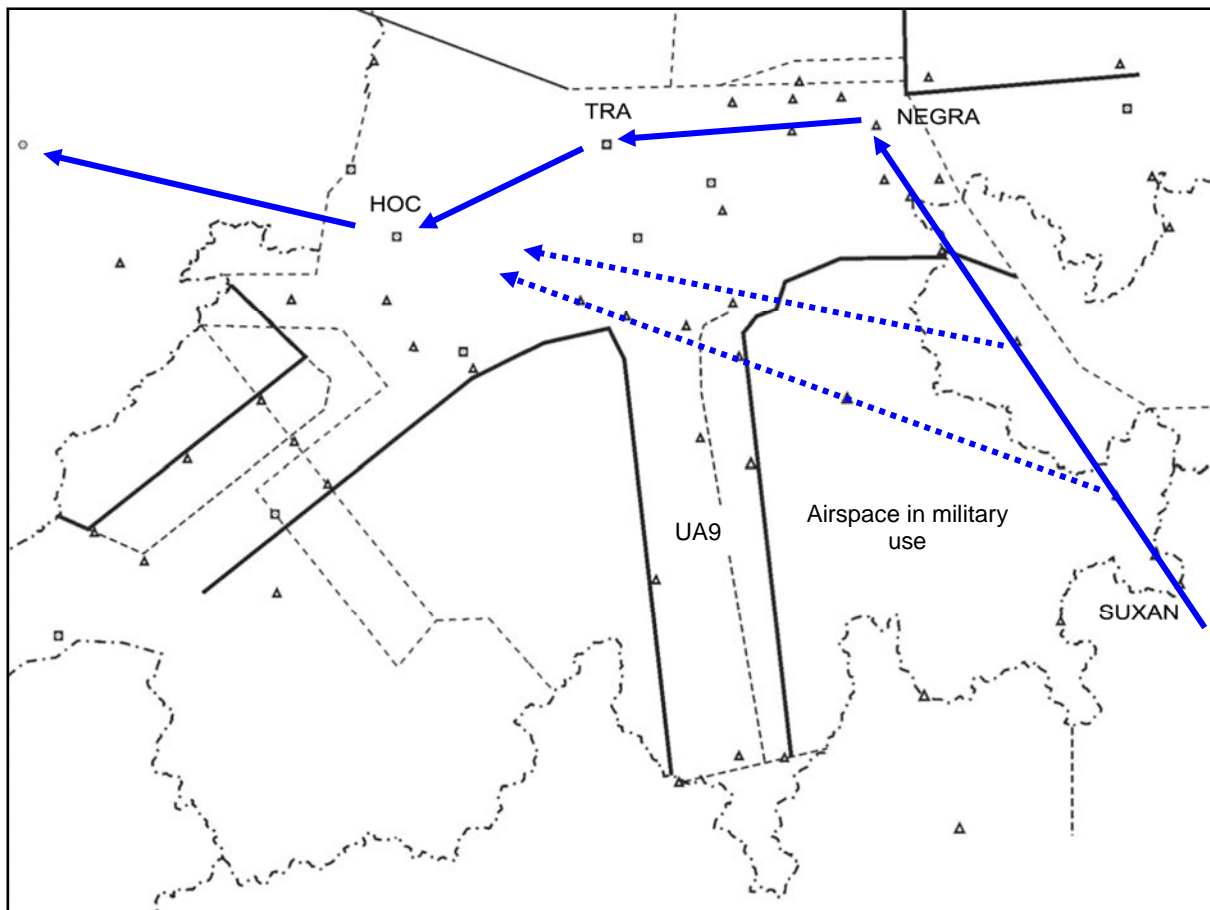
From 11:30 UTC the airspace to the east of airway UA9 was in use by the military and was therefore available to civil air traffic control only subject to restrictions. This meant that transit traffic from waypoint SUXAN in the direction of

**Figure 1:** Standard route in the event of military flight operations over waypoints SUXAN – NEGRA and the VHF beacon TRA – HOC (blue). Possible shortcut routes are shown by a blue dotted line.

Hochwald (HOC) VHF omnidirectional radio beacon (VOR) demanded a high level of coordination with military air traffic control. The RP-M4 was mainly occupied with this coordination. Depending on an agreement between Sector M4 and military air traffic control, a shortcut through the military airspace could be assigned to civil air traffic control.

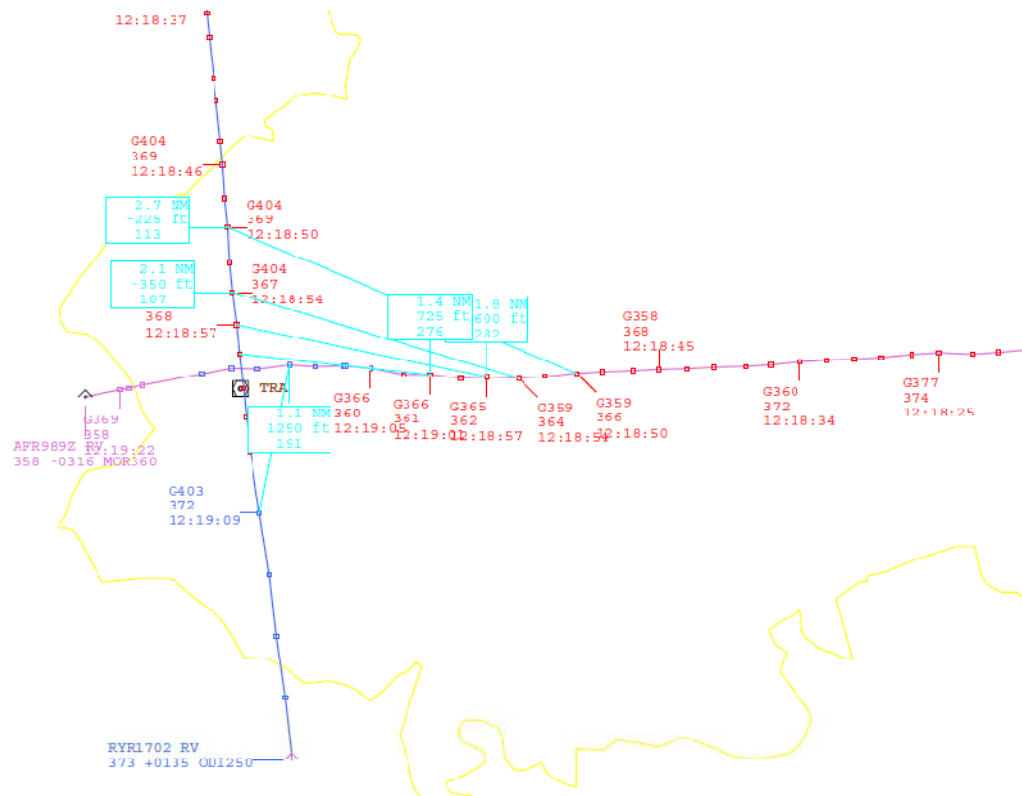
**Figure 3:** Radar recording of the crossing of AFR 989Z (red) and RYR 1702 (blue). The Trasadingen beacon (TRA) is shown in brown and the national frontiers are shown in yellow.

The radar recording shows that RYR 1702 first descended to FL 367 and then climbed back to FL 369. The two aircraft crossed above Trasadingen with a lateral distance of 1.4 NM and an altitude difference of 725 ft. Both crews continued their flights to their destinations.
