# Mitigation of Ultraviolet-Induced Glass Damage in Laser-Sustained Plasma Lamps

Joshua Wittenberg, Michael Navone, Anant Chimmalgi, Quang Giang, Laila Baniahmad, Tim Nguyen, Lauren Wilson, Rahul Yadav  
*WIN, KLA-Tencor Corp.*

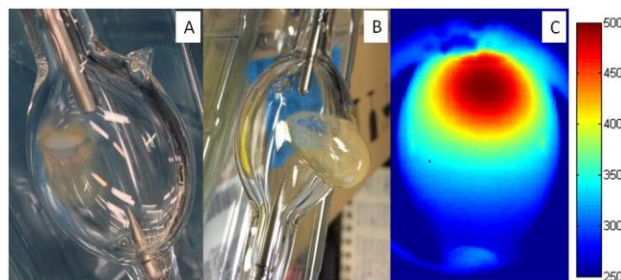
increased temperature within the glass. The higher temperature increases the rate at which damaged glass regions coalesce and a feedback loop develops whereby the temperature and the local concentration of damage centers increase in concert. While mechanisms exist within the glass to “heal” the damage centers via rearrangements that replace the original  $\text{SiO}_2$  stoichiometry, eventually the rates of damage center formation and coalescence surpass the rate of healing, and catastrophic damage results, coincident with a rapid temperature increase (Figure 1).

**Figure 1:** (A) VUV-induced “Mocca” lamp damage (opaque white and brown region). (B) Lamp deformation resulting from extreme temperature following increased UV absorption. (C) Mocca region is 150C hotter than average equatorial temperature.

The primary damage process we have observed is the “mocca effect” (Ref. 1), characterized by a reduction of the  $\text{SiO}_2$  species to Si-O and Si-Si bonding moieties, and can be identified by visual inspection well ahead of lamp rupture (Figure 1a). If allowed to progress indefinitely, severe lamp deformation (Figure 1b) and eventual burst (Figure 2) are the result. Each lamp burst requires multiple lamp house optics to be replaced or, in the case of Elise, the entire IR injection assembly. The cost of replacing these optics, combined with the cost of tool downtime, make mitigation of the lamp burst risk an indispensable program component. Additionally, without the ability to reduce lamp damage at current plasma emission levels, future generation tools generating greater radiant flux would not be possible.

Considering that the lamp glass damage is the result of the interplay between UV absorption in VUV-induced damage centers, and the increased temperature resulting from that absorption, the initial means of reducing the amount of damage was to reduce the operating temperature of the lamps. Reducing the temperature of the lamp glass, maximal at the internal surface of the glass in the equatorial plane, by  $\sim 30^\circ\text{C}$ , to below  $600^\circ\text{C}$  did decrease the frequency of burst events, though the improvement was not sufficient. Lamps still failed within their specified lifetime with a 3-4% probability, causing catastrophic damage to the lamp house optics and long tool-down periods when they did fail. It is reasonable that a reduction in temperature alone was insufficient, considering that the damage center creation is a photochemical process, not a thermally activated one. Considering that the energy required to locally create a damage center is  $> 7\text{ eV}$  (VUV), then the thermal energy ( $k_B T$ ) available at either  $500^\circ\text{C}$  or  $600^\circ\text{C}$  (66meV and 75meV, respectively) is nowhere near sufficient to influence that process. The effect of temperature is rather to alter the diffusion rates that allow the damage centers to effectively coalesce to larger domains whose greater stability (due to their lower surface to volume ratio) hampers their elimination via any healing mechanism.

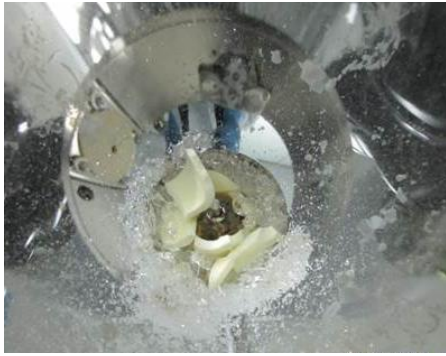
**Figure 2:** The results of a lamp burst inside a BBP lamp house. Damage to the elliptical reflector requires hardware replacement as well as tool down-time for realignment. The IR injection assembly must be completely replaced as well.

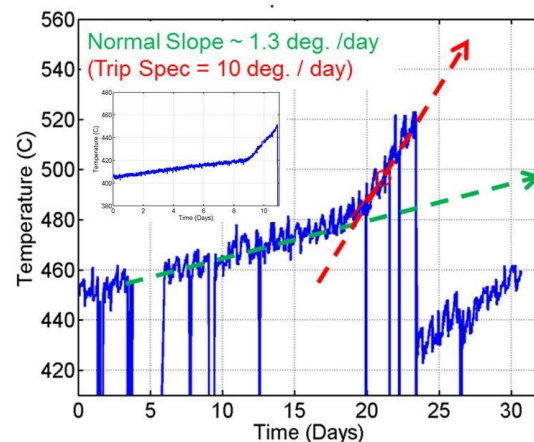
severe damage (Figure 3). An interlock algorithm based on the absolute temperature of the lamp existed previously, but did not provide evidence far enough in advance of an impending burst. For example, the temperature of the lamp whose data are depicted in Figure 3 never reached the specified interlock temperature of  $535^\circ\text{C}$  prior to bursting at  $520^\circ\text{C}$ . An adjustment of the absolute trip point was not a possible solution because, by the end of their lifetime, many lamps approach  $535^\circ\text{C}$  yet behave normally (this lamp burst before the end of its specified lifetime), and reducing the interlock limit would lead to unnecessary tool downtime for lamp replacements. The new algorithm was designed to calculate the slope of the temperature profile with time, interlocking the lamp house when the value crossed a specified threshold, determined via analysis of temperature profiles of over 100 lamps. The lamp corresponding to figure 3 would have been interlocked and replaced three days before its imminent rupture.

**Figure 3:** Temperature profile of an LSP lamp. The initial solarization-induced temperature change is normal, but the region of increased slope indicates severe damage. Note the change in slope from  $1.3^\circ\text{C/day}$  to  $10^\circ\text{C/day}$  at day 20. The lamp burst on day 23. The temperature profile from day 23 onwards is a new lamp. Inset: This lamp was protected by the algorithm and interlocked prior to bursting.

While such an algorithm did not completely eliminate lamp failures, since 3-4% of these lamps continue to exhibit mocca damage and require replacement, it did eliminate the costs associated with new hardware and optics, and with multiple days of downtime for tool recovery, amounting to multiple hundreds of thousands of dollars per event as well as significant inconvenience to the customer. By contrast, each lamp costs approximately one thousand dollars and requires one hour to replace. The lamp corresponding to the data depicted in Figure 3, inset, was interlocked well before bursting, and was replaced with minimal cost and inconvenience.

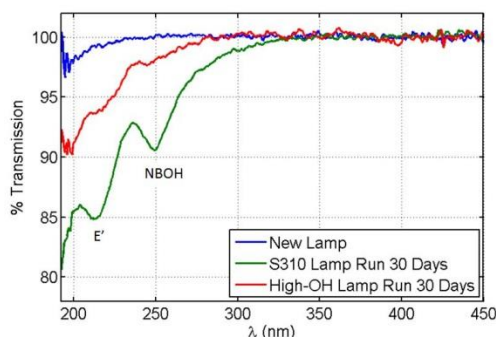
**Figure 4:** Spectra of Suprasil S-310 glass (Elise) and Spectrosil glass (Tesla, Panamera). Note the reduced E' and NBOH absorption of the newly implemented high-OH Spectrosil glass. The E' and NBOH features are not present in the new lamp, they are induced by VUV damage during operation.

The current generation lamp glass is already a high purity grade, Suprasil S-310, which has an extremely low extrinsic impurity concentration (atoms other than Si, O), and so has very high transmission from visible wavelengths down to 190nm (the shortest-wavelength limit of our next-generation tools currently under development) (Figure 4). Suprasil is a “wet glass,” synthetic silica that has been flame-fused in the presence of water vapor to increase the concentration of the Si-OH moiety in the glass material (Ref. 1). The OH loading in the Suprasil S-310 glass is 200-300ppm. Hydrogen atoms are not considered extrinsic impurities, but rather technological impurities, since they are typically added by design. OH loading is known to reduce the intrinsic defects generated by VUV irradiation, via thermally activated reactions that recover the SiO<sub>2</sub> stoichiometry (Ref. 2). The primary defect centers observed that deviate from the native SiO<sub>2</sub> stoichiometry observed are the three-fold coordinated silicon  $\equiv\text{Si}\cdot$  referred to as the E' center, with an absorption peak centered at 215nm, and the non-bridging oxygen hole (NBOH)  $\equiv\text{Si}-\text{O}\cdot$ , with an absorption peak centered at 265nm (Figure 4). These are almost non-existent in the as-produced lamps, but they

appear as the lamp ages. The increased UV absorption from 190nm-300nm leads to higher lamp operating temperatures as the lamps age, and eventual coalescence of Si-rich regions corresponding to mocca damage (Figure 5). It also means less transmission from 190nm-260nm, which is exactly the wavelength band of the Tesla tool (Figure 4).

For the next-generation Tesla and Panamera lamps we have chosen a glass with a higher OH concentration, Spectrosil, and specified an OH loading of at least 1000ppm. We have additionally required that the glass be annealed for at least 40 hours prior to lamp fabrication. Annealing has been shown to remove both Si-H impurities as well as to relax strained bonds, both of which are believed to facilitate the solarization of SiO<sub>2</sub> (Ref. 1, 2). The much more gradual temperature increase of the Spectrosil lamps (Figure 6) during operation is our primary evidence that the lamps are solarizing more slowly, as well as our primary in-situ diagnostic of lamp health. The end result has been lamps that exhibit much less VUV damage (Figure 4), leading to lower temperature operation as the lamps age (Figure 6) as well as lower stress (Figure 7).

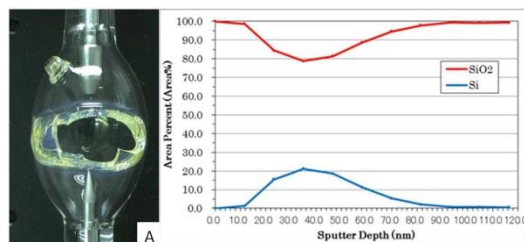
**Figure 5:** (A) Burst Suprasil lamp (B) Si concentration as a function of depth from the lamp wall inner surface, localized to the “mocca” discolored regions, as measured by X-Ray Photoelectron Spectroscopy.

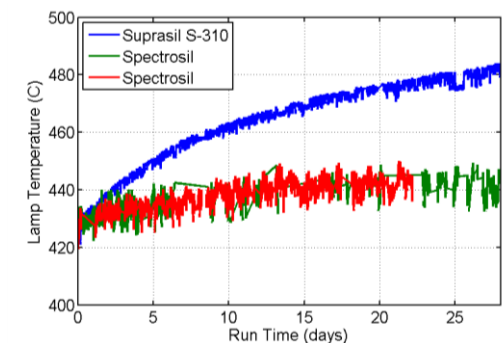
**Figure 6:** Typical temperature profiles observed during the course of the lamps' lifetime. Note the much more rapid temperature increase of the Suprasil S-310 lamps as compared to two different Spectrosil lamps. This is the result of increased UV absorption. (The difference in the noise levels is the result of different tool configurations, not due to the lamps).

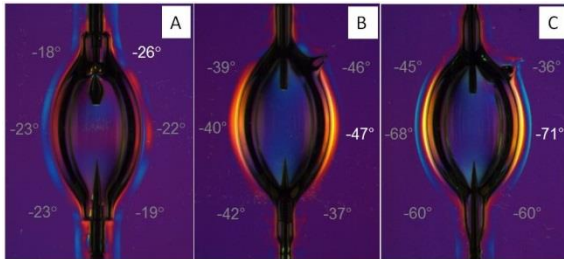
Regardless of the root cause, the increased mechanical stress in the glass is the direct precursor of catastrophic failure. An S-310 lamp run for the same amount of time as a Spectrosil lamp exhibits an increase in stress approximately 75% higher. Note that an unused lamp nevertheless exhibits non-zero stress on account of the 10atm of pressure contained within (Figure 7). The reduced stress in Spectrosil lamps suggests that they could potentially be operated for even longer durations prior to replacement.

**Figure 7: Photoelasticity measurement, to determine change in birefringence resulting from stress in glass material. Larger magnitude (degrees) indicates increased stress. Compared to a new lamp (A), there is increased stress in a used Spectrosil High-OH lamp (B), and still higher stress in a used Suprasil S-310 lamp (C), each run for 30 days.**
