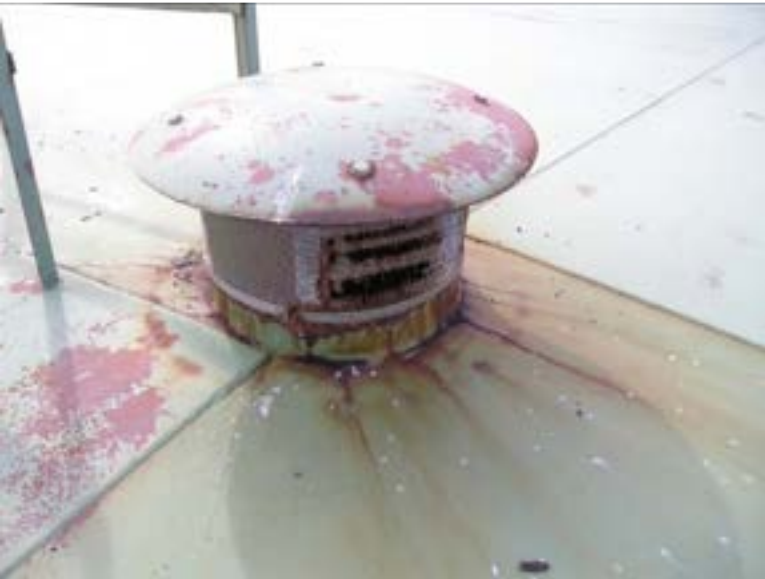
DP#01.JPG

Roof vent screen badly corroded and crumbling.

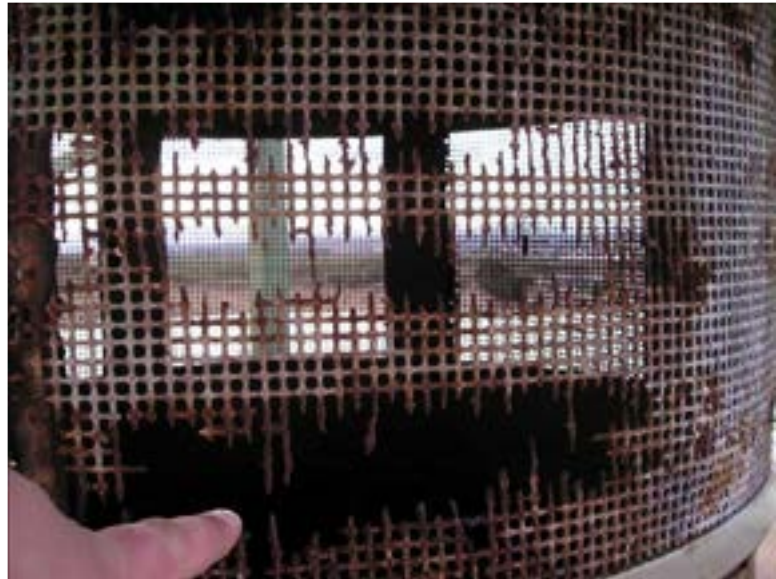
DP#02.JPG

Hole in vent screen

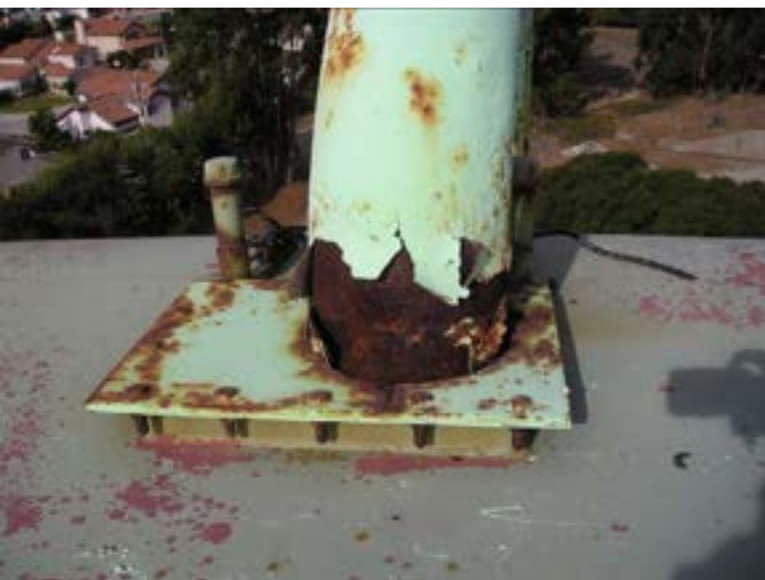
DP#03.JPG

Inlet pipe coating failure and active corrosion

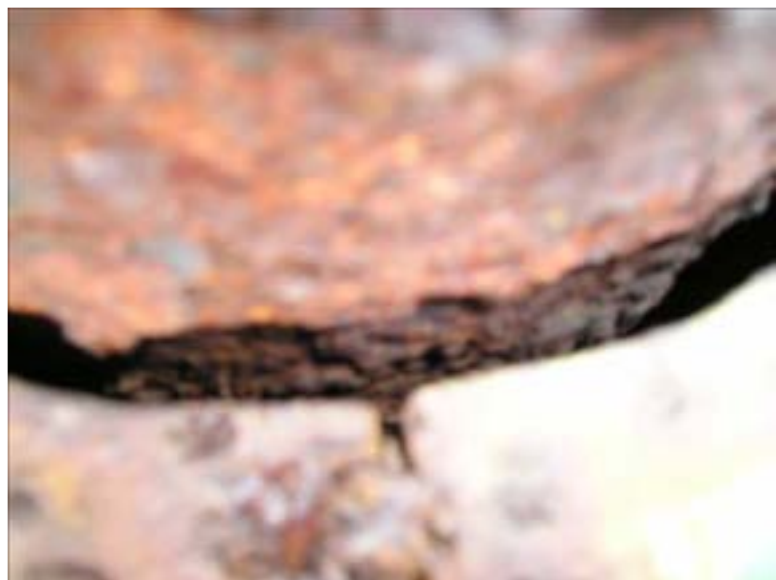
DP#04.JPG

Inlet pipe - bad picture - opening in inlet pipe DP#05.JPG

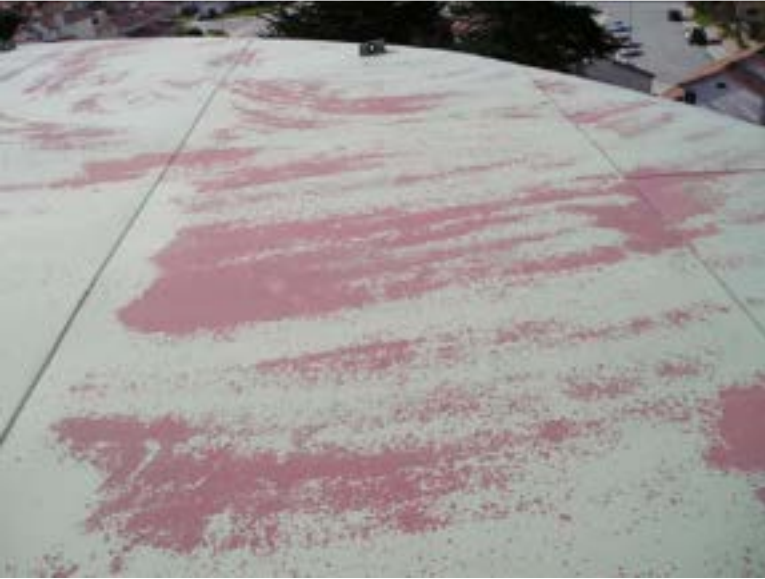
DP#06.JPG

Top coat failure on roof plate

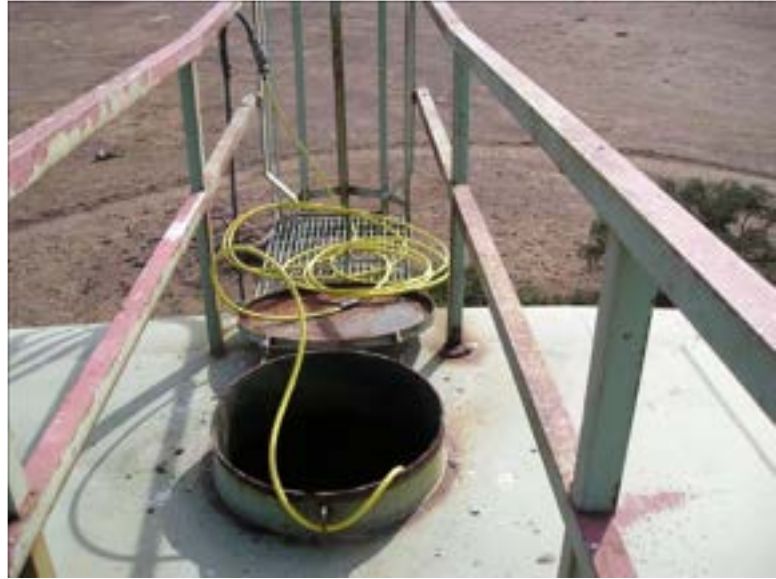
Roof hatch with corrosion on edges

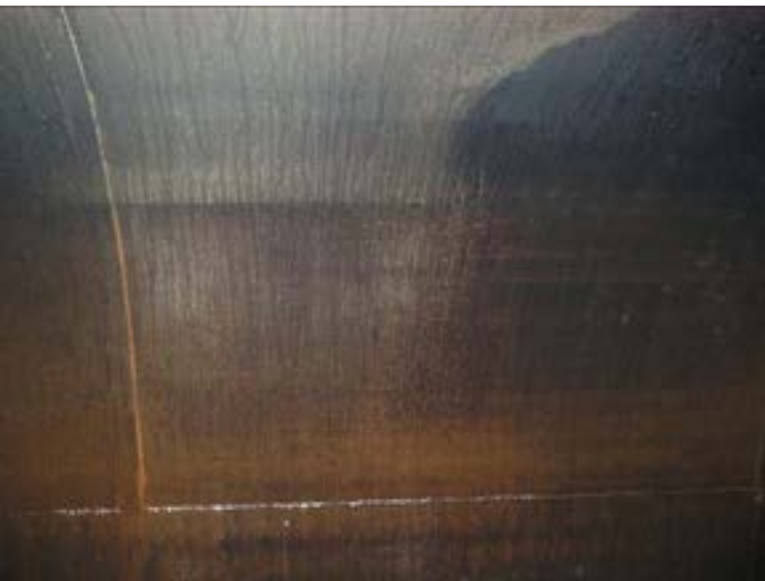
DP#07.JPG

Internal shell - cracks in coating

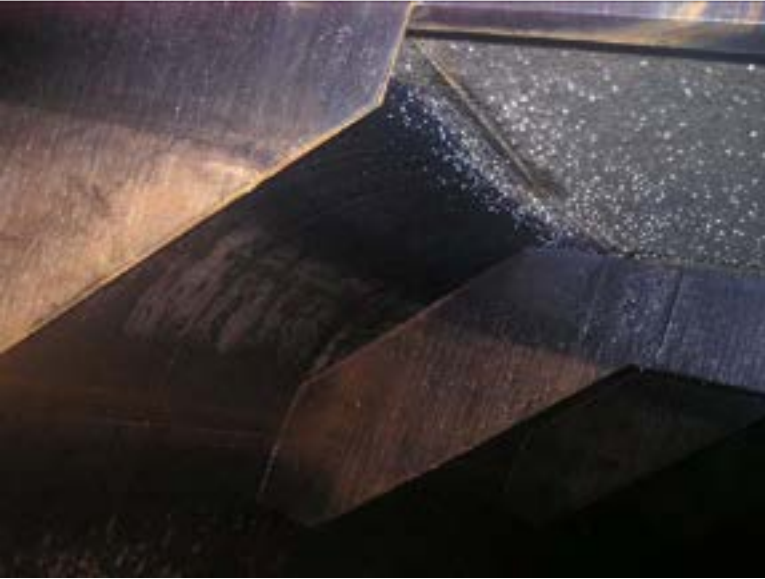
Roof rafters with edge corrosion

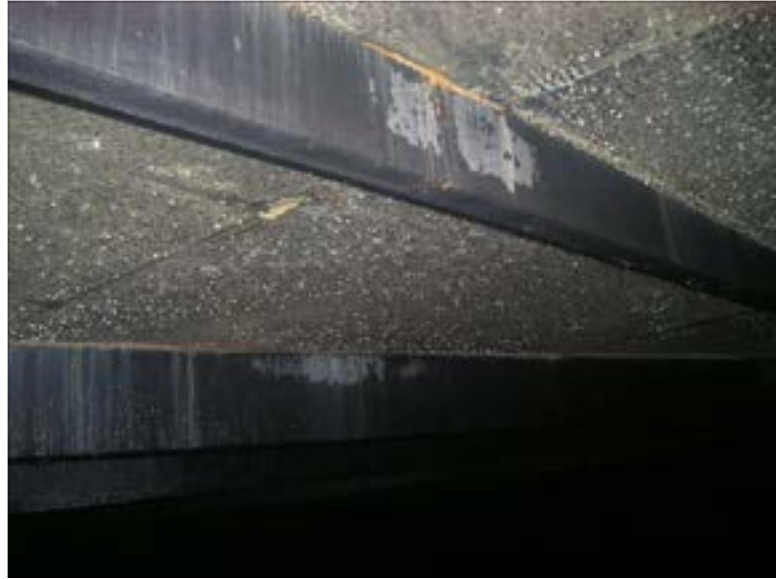
Roof rafter with edge corrosion

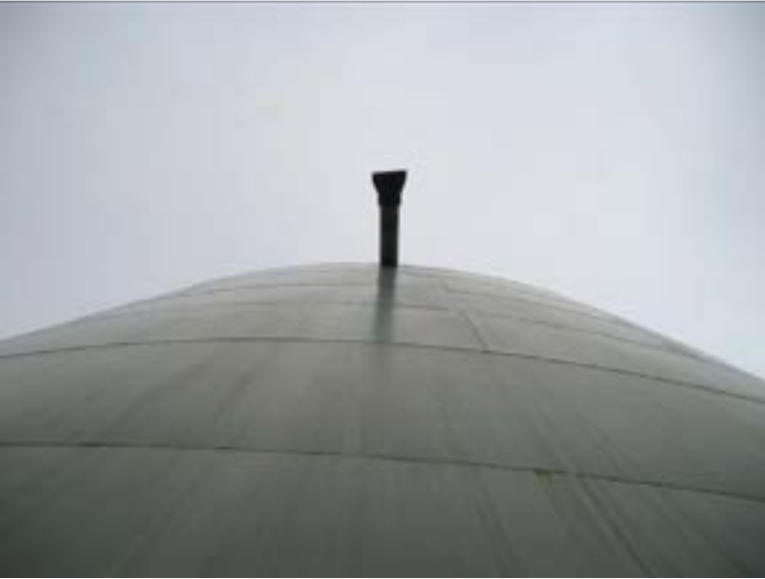
Roof plate and hand rail active corrosion

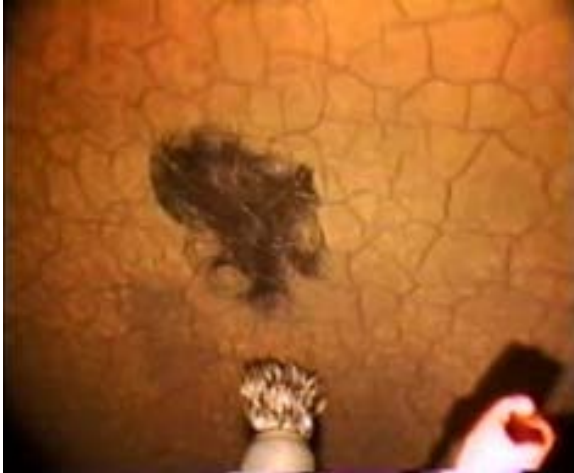
VS #1. Heavy iron buildup and cracks in coating.
(Time: 2:09)

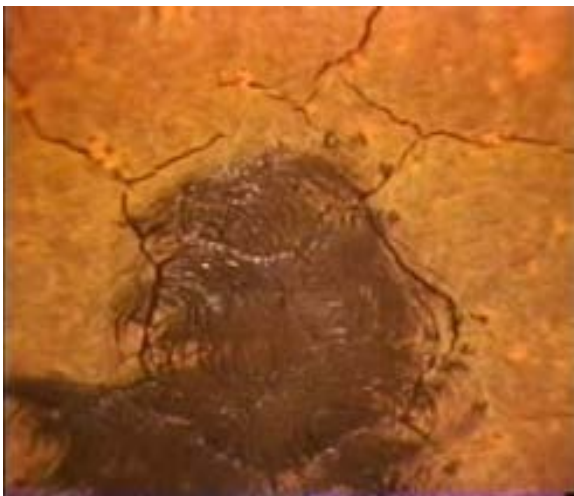
VS #2. Cracks in internal coating.
(Time: 4:28)

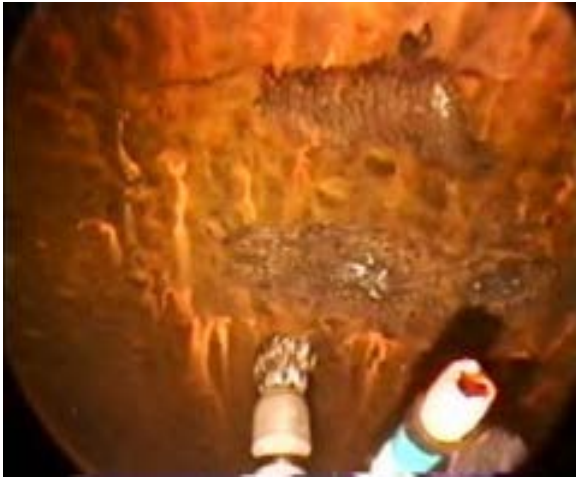
VS #3. Coating has failed, active corrosion, exposed steel upper shell at 8'oclock position. (Time: 6:57)

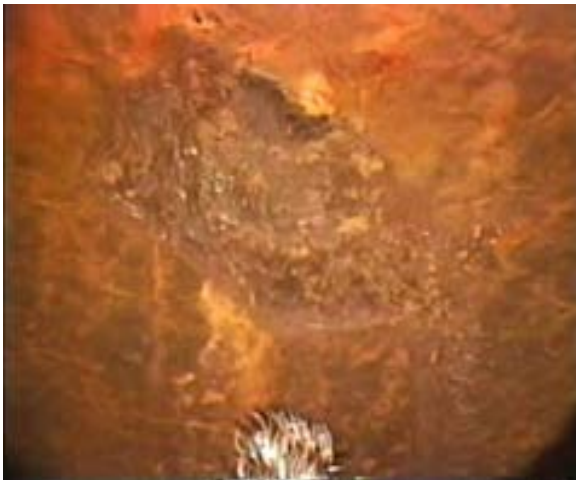
VS #4. Coating has failed to steel substrate 2nd shell 6'oclock position.
(Time: 10:20)

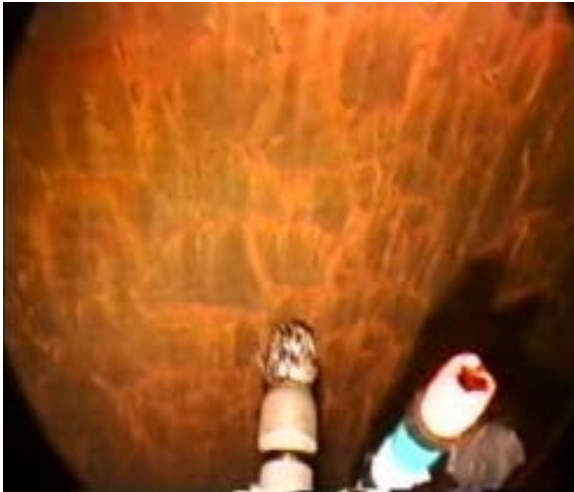
VS #5. Cracked coating and active corrosion.
(Time: 10:46)

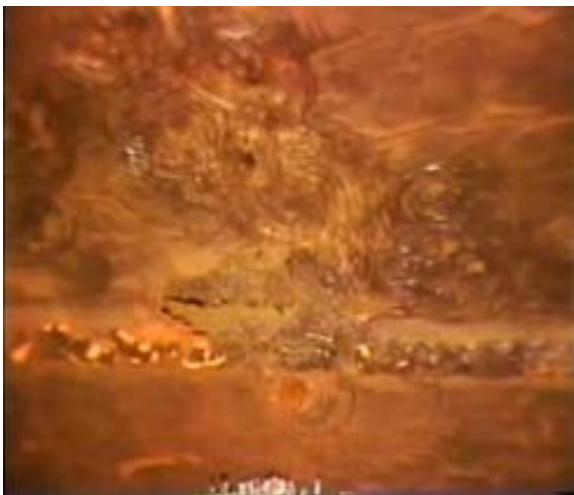
VS #6. Coating failure on horizontal weld.
(Time: 15:47)

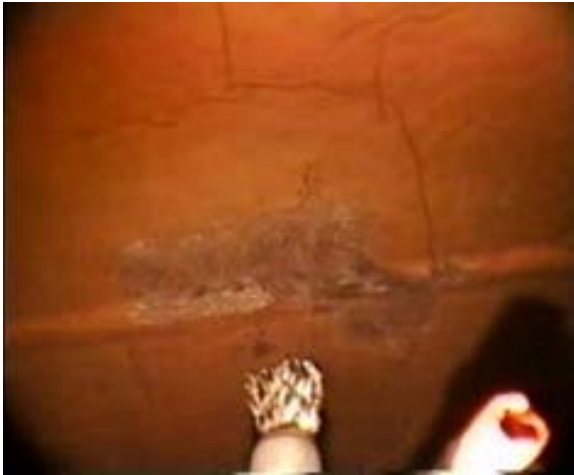
VS #7. Exposed steel substrate mid-shell corrosion. (Time: 21:35)

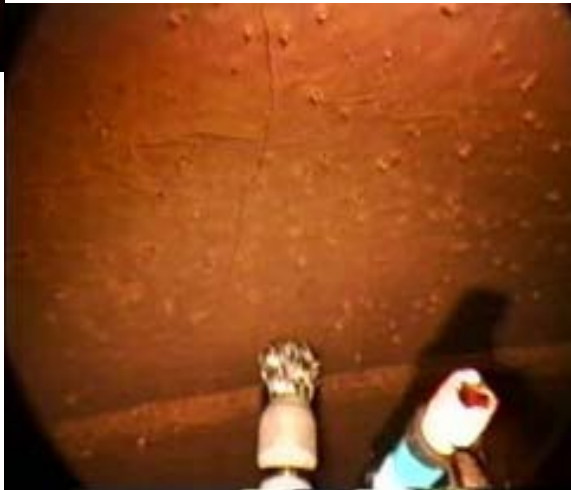
VS #8. Micro blisters in coating.
(Time: 26:12)

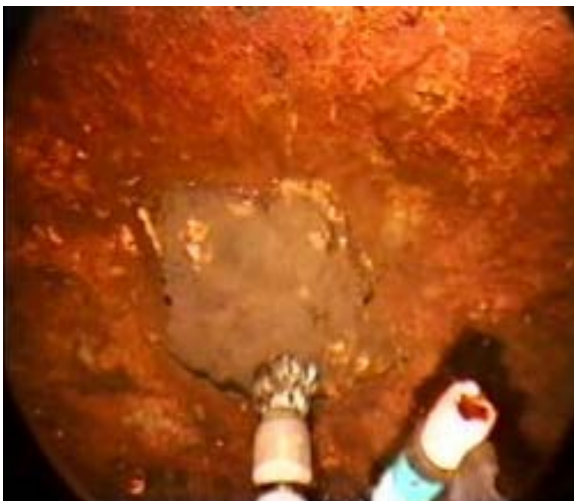
VS #9. Coating failure bare steel – upper section when shell at 9'oclock position.
(Time: 33:48)

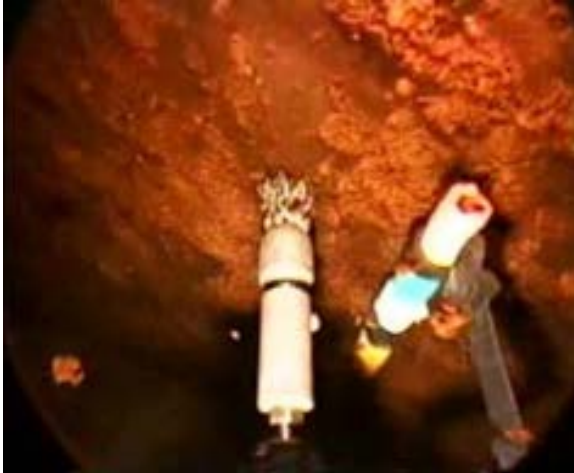
VS #10. 1 ½ -inch sediment.
(Time: 36:14)

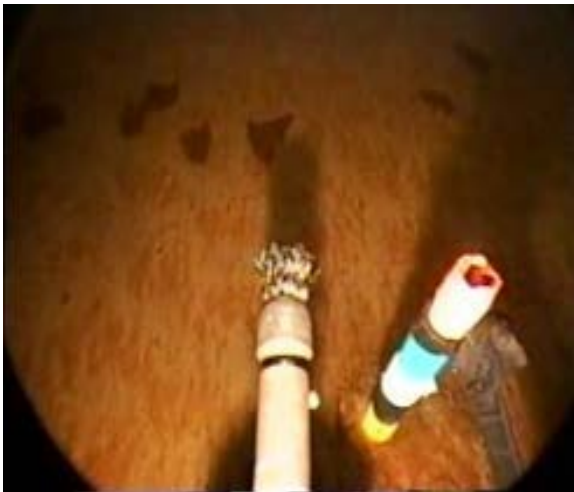
VS #11. 2-inches sediment.
(Time: 41:50)

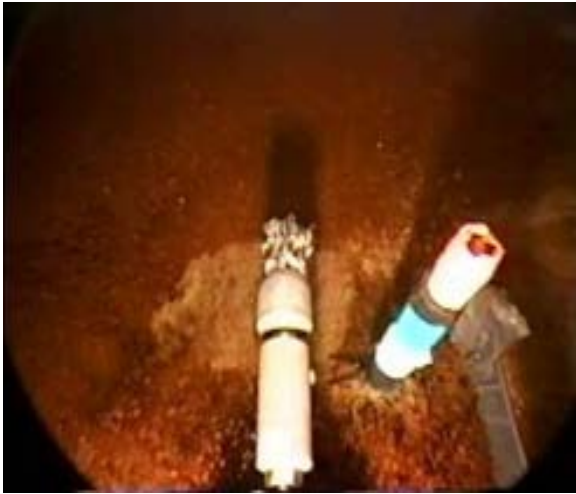
VS #12. 3-inches sediment at center of tank.
(Time: 47:41)
