WATER TANK INSPECTION REPORT

***Coast Water Distribution
Marina, CA***

Steel Tank #00033

October 26, 2020

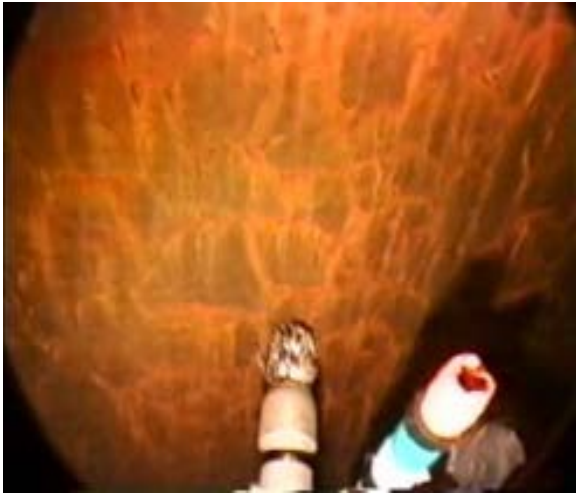
VS #5. Cracked coating and active corrosion.
(Time: 10:46)

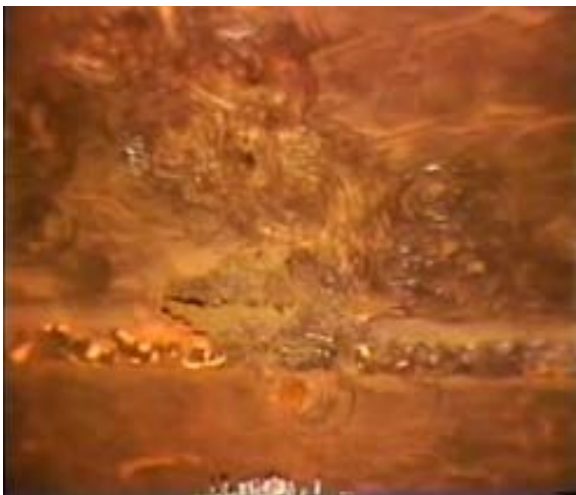
VS #6. Coating failure on horizontal weld.
(Time: 15:47)

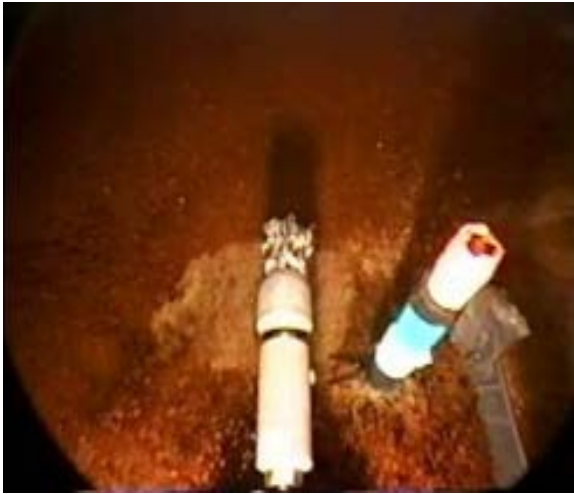
VS #12. 3-inches sediment at center of tank.
(Time: 47:41)
