# Reconnaissance Report of Boundary Fences on New Lands, Navajo Nation

Office of Navajo-Hopi Indian Relocation

April 30, 2014

## **NEW LANDS FENCING ASSESSMENT OF PERIMETER AND SELECTED INTERIOR SECTIONS**

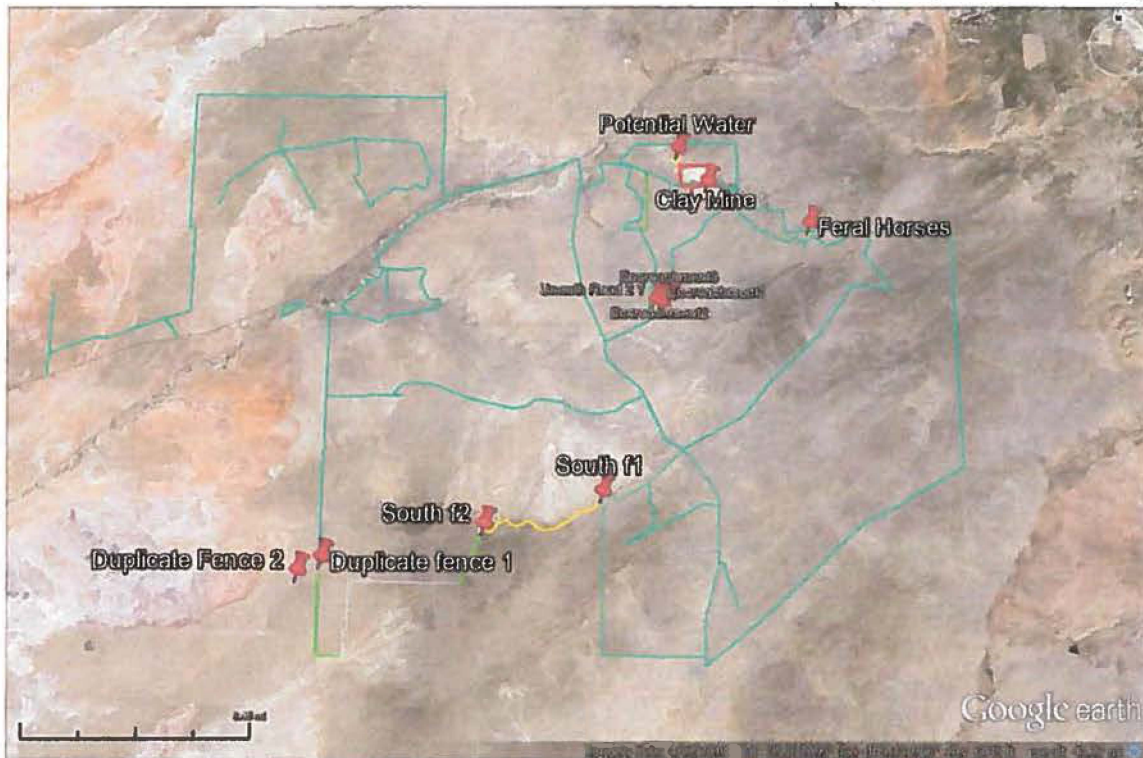
The exterior boundary of New Lands is intact and in good –fair condition, with the exception of the southern boundary of Rim and East Well units. Figure 1 shows the routes traveled and fences examined. Exceptions to the rule are listed below.

2. The south-western boundary fence (County Rd 7230) is in relatively good condition with the exception of treated line posts that will require replacement in the near future (Figure 1). Many posts are rotted at their base. Replacement with cedar posts is recommended. Fence wire is still serviceable for another 15-20 years.

3. Duplicate boundary fence was observed on a couple of sections that border private land and the BASF right of way on sections of County road 7230 (southwestern boundary fence), which is bounded by boundary fences on the east and west (Figure 1). This strategy is unclear for fencing these sections of the western boundary. Possible boundary discrepancy (?). Note: advice from ONHIR staff that latter was the case and second fences were not removed from private land.

4. The lower section of north-western boundary fence (common with NPS) is in relatively good condition with the exception of treated line posts. Pasture use of the Pinta Unit is occasional and repair is not a priority at this time (Figure 1).

5. The upper section of north-western boundary fence (common with NPS) is in relatively good condition with the exception of a few treated line posts. Fence wire appears serviceable for 20+ years (Figure 1).

7. The north-western fence is common to US-191 and is in good condition. A few treated posts may require replacement with cedar posts to retain full functionality (Figure 1).

2. Feral horses were observed in the Blue Bird unit at the location indicated on Figure 1. Feral horses present a high risk and threat to New Lands both from within and exterior. The occupation by feral livestock presents difficult social, political and legal problems when allowed to remain for any period of time. It's recommended that feral livestock be removed immediately upon discovery. There is additional threat from feral stock near communities, where horses are penned in small enclosures and adjacent ONHIR lands are overgrazed. One can reasonably assume that the overgrazing may be due to livestock trespass.

3. Encroachment appears to a problem in the community indicated in Figure 1. There a 3 instances where homeowners have placed corral inside the interior boundary fence. In addition, there a 2 presumably unauthorized roads that provide expedient access outside the community boundary using the range roads (Figures 15-17).

Figure 1. This map displays the routes travelled and fences examined. Areas of special interest are highlighted in red and pinned.

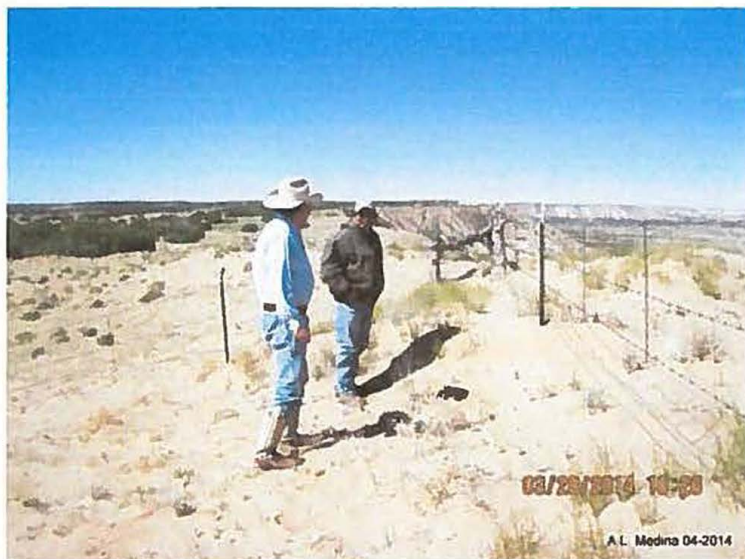
1. The southern boundary of Rim and East Well units are bounded by an escarpment, which presently forms somewhat of a deterrent to use by livestock. However, the area is subject to use by wild ungulates and horses through existing trails that permit access across the boundary. Fencing is recommended to reduce the risk of entry by feral livestock and other private stock from neighboring ranches (Figures 2-5). Fences of the southern boundary are relatively new and in good condition.

Figure 3. This photo shows the existing corner on the east side of the escarpment.

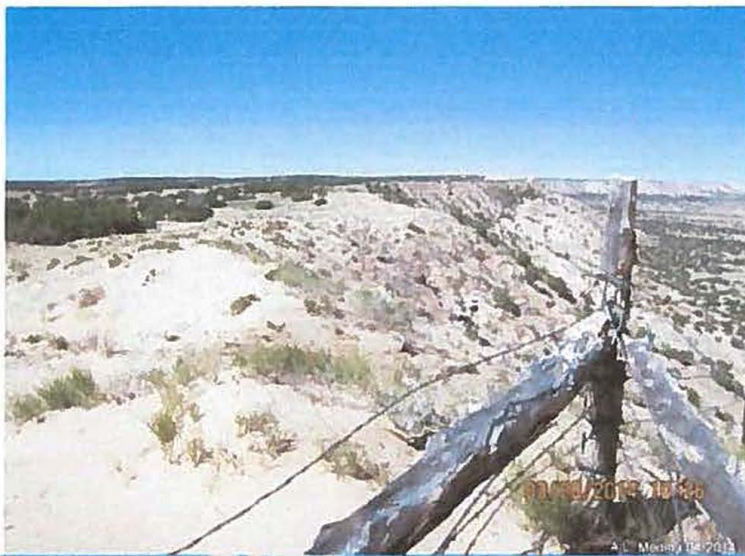
Figure 4. This photo shows the westerly view of the approximate location of the boundary. The boundary is seemingly the rim edge of the escarpment. There are existing roads for access.

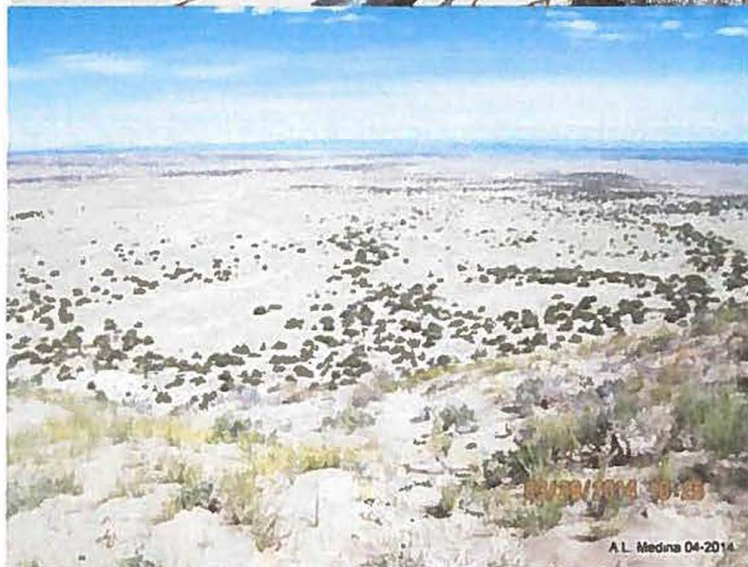
Figure 5. This photo looks north from the escarpment and illustrates the relative ease with which feral and trespass stock can access News Lands.

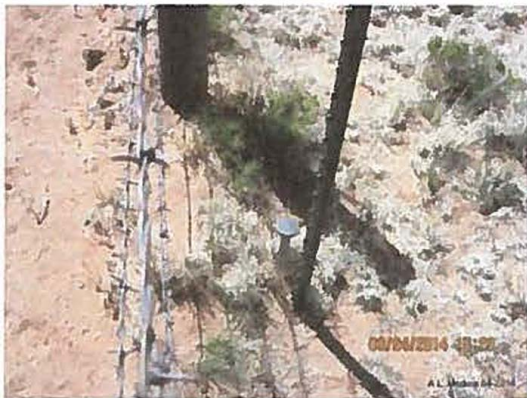
6. The north boundary fence of Padres Mesa is new and in good condition. A couple of locations had broken upper strands where elk had jumped. Recommend installing elk jumps at these and other similar locations where elk have demonstrated a preference for crossing. The replacement of boundary fence appeared unnecessary given that boundary discrepancies were minor and insignificant considering it's all Navajo Nation lands. In some cases the discrepancies were inches different (Figures 6-9). There were several areas where the tractor blade made close contact with the fence posts, thereby

Figure 8. This photo shows the USGS boundary marker, the proposed realignment and the existing fence line.

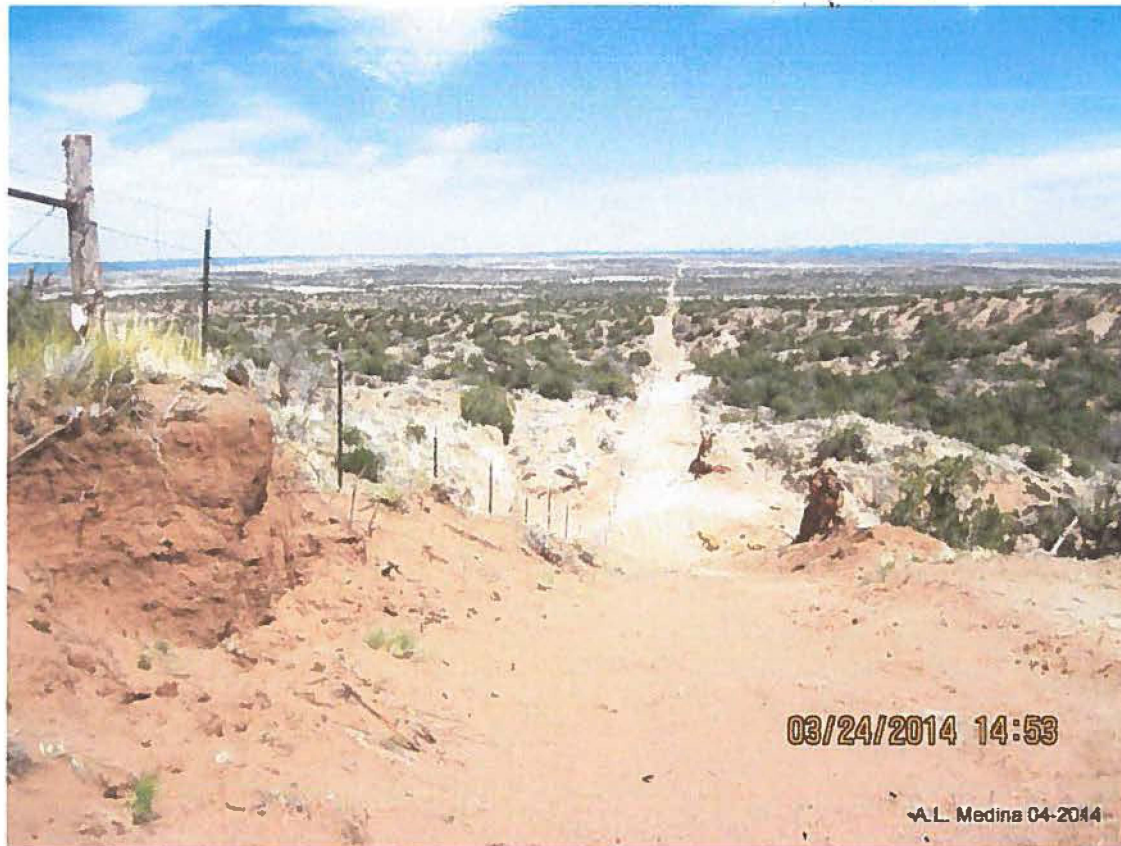
weakening their footing and likely will need reinforcement or replacement in very near future.

Figure 9. This photo shows the bladed area where the fence was realigned. The action resulted in several areas where the blade made too close contact with the fence and compromised their footing.

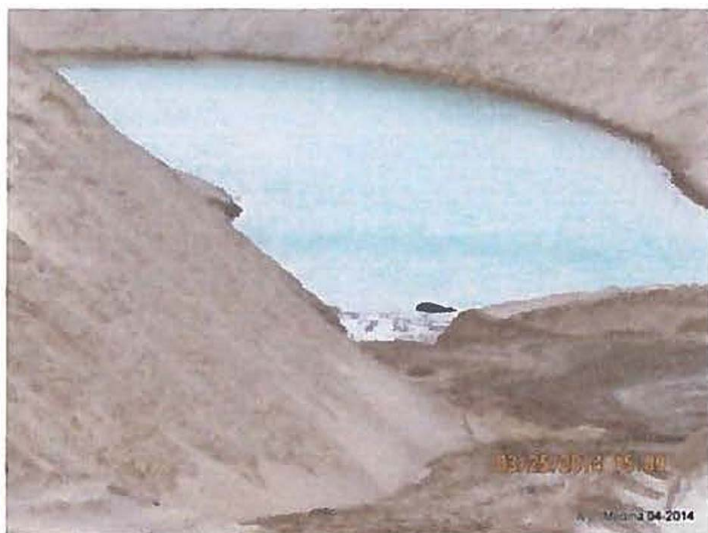
1. Clay Mine (Figures 11-14) – This area is outlined in red to bring attention to the priority need to provide a security fence that both excludes livestock and human entry. The entire mine areas, both north and south of Clay Mine Road, should be secured likewise. This area is a high risk-high danger area. Recommendations include high security perimeter fencing coupled with locked access gates on the east and west entry points. The fence breach on the eastern flank presents an immediate high risk to livestock, and inhibits use by the operator. An updated restoration and management plan by the mine owners should reflect the protective measures to protect human, animal and natural resources of the immediate area.

Figure 11. This photo shows the presence of a (drowned) cow that entered from the east side unto the mine area. The fence is entirely absent and submerged under overburden.

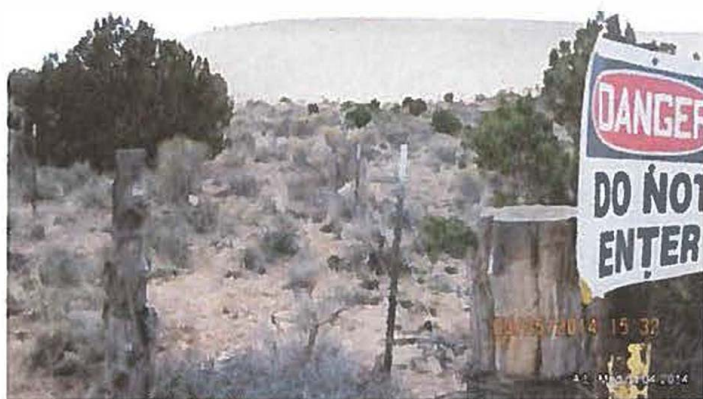
Figure 12. This view of the mine shows the limited signing and security fencing.

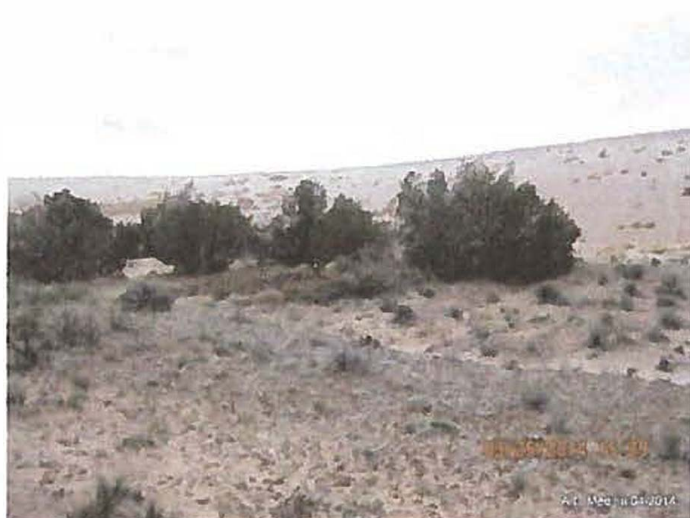
Figure 13. This photo shows the overburden that continues to migrate easterly and encroach upon New Lands.
