Visual Property Inspection Report

Complies with Australian Standard AS 4349.1-2007 & AS 4349.3-2010

14 Habitat Place, Marsden Park.

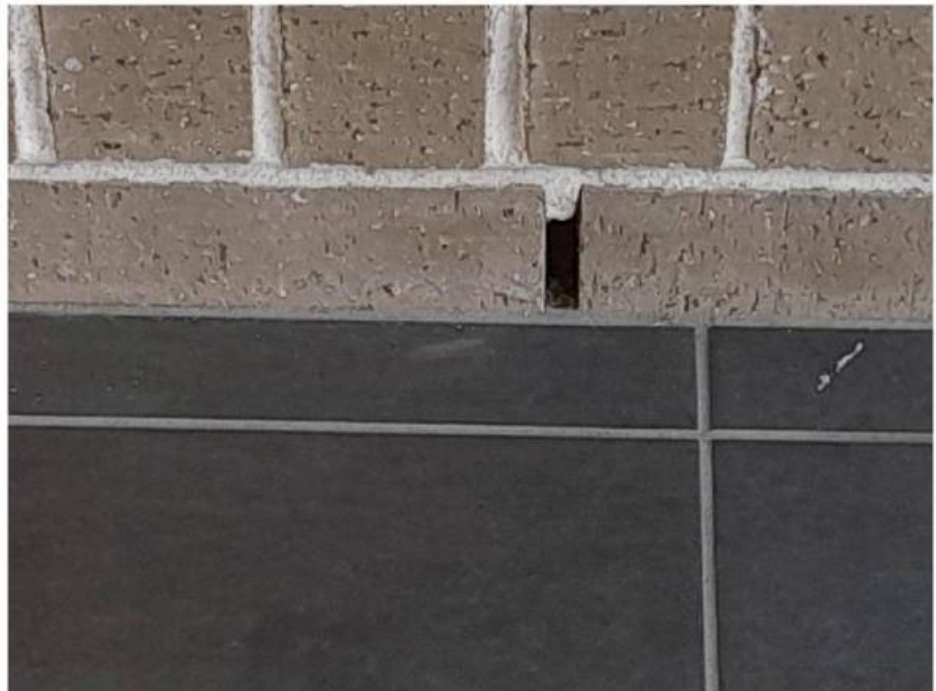
3.8 Weepholes And Vents:

Weep holes to the base of the brick walls are blocked or partly blocked by gardens, soil or pathway heights and should be cleared to help prevent moisture and pest problems.

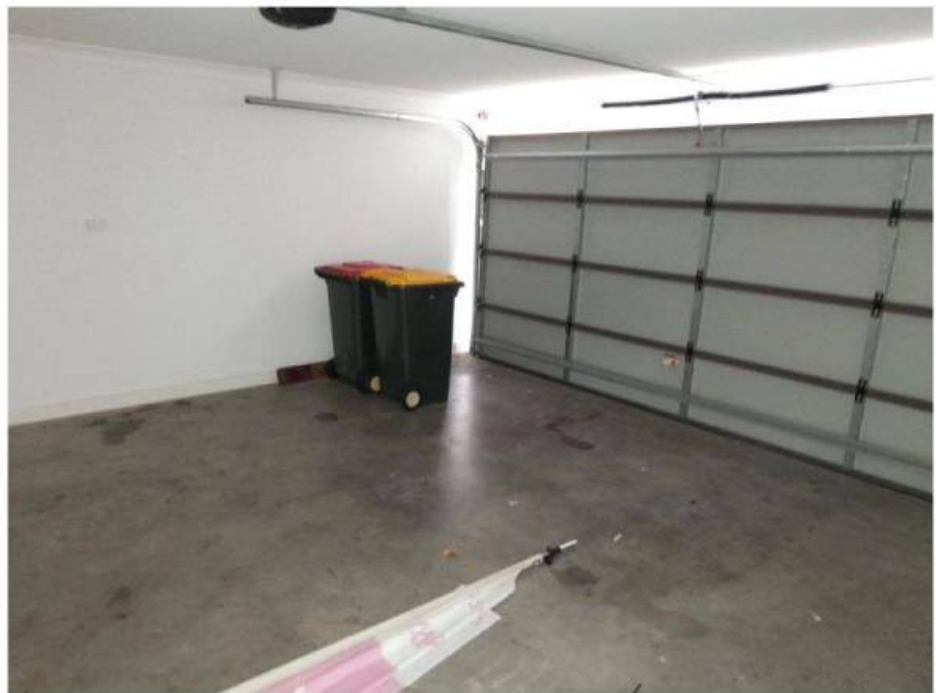
5.1 Restrictions:

The structure is fully lined preventing inspection to all framing timbers.

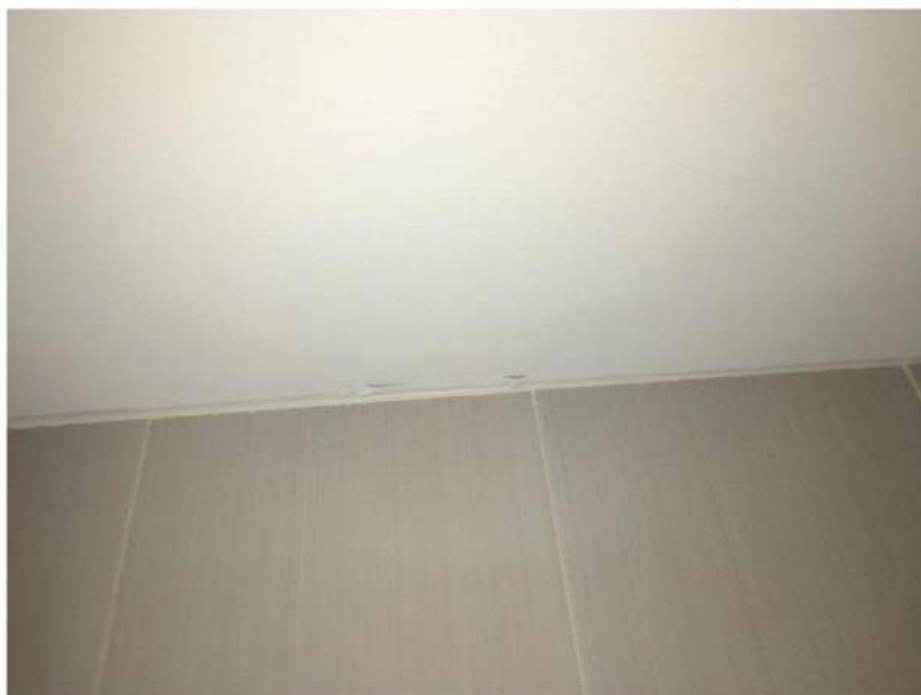
6.1 Ceiling Condition:

Peeling paint was noted to ceilings. Defective or poor surfaces were noted to ceiling materials and repair will be required prior to next painting.

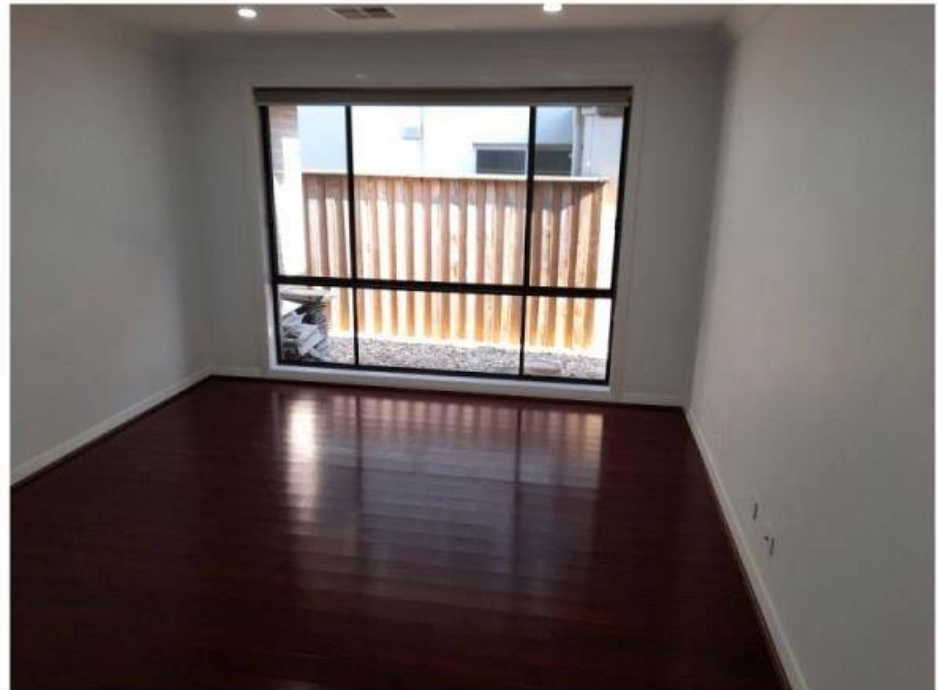
6.6 Location/Area:

Main bedroom. Bedroom two. Bedroom three. Bedroom four. Lounge room. Dining room. Family room.

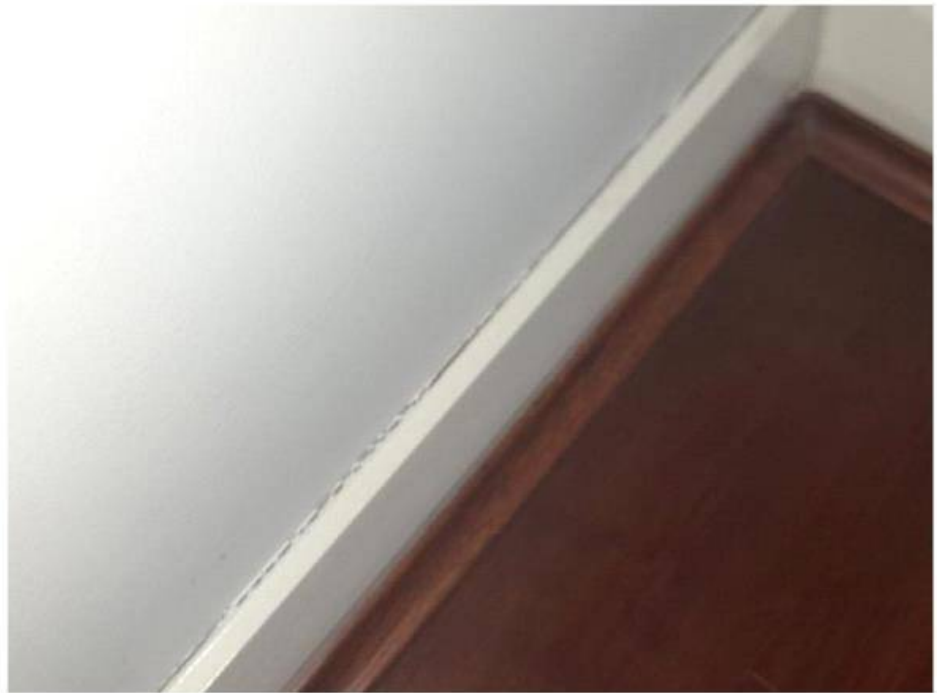
6.9 Woodwork:

Minor maintenance and or repairs required prior to next repainting.

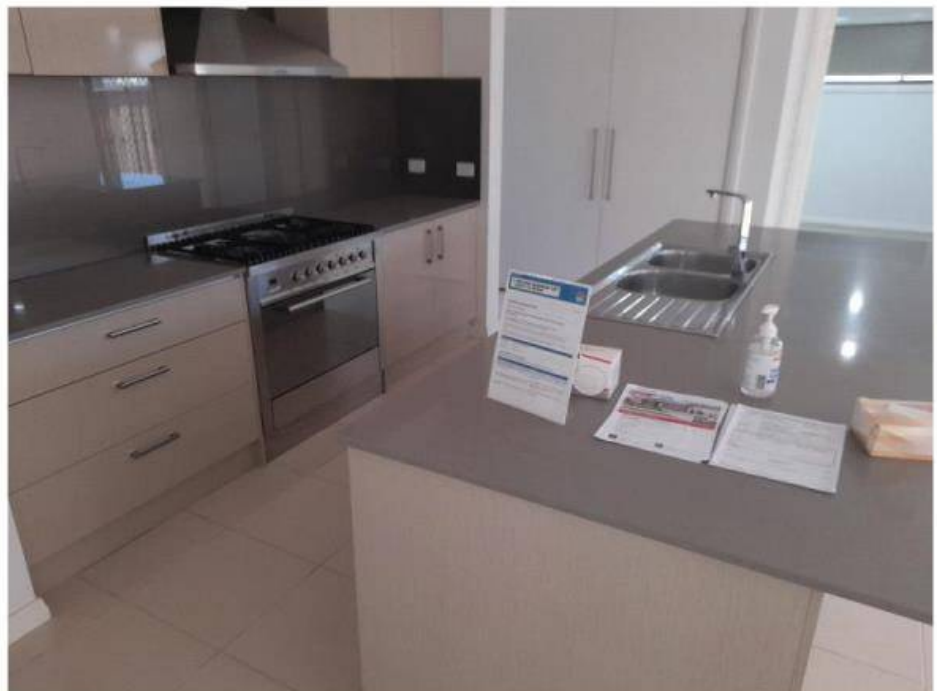
7.1 Kitchen Fixtures:

Maintenance and adjustments should be considered to doors/drawers to provide

smooth operation. A glass splashback is located over the benchtop area. Glass appears to be in serviceable condition.

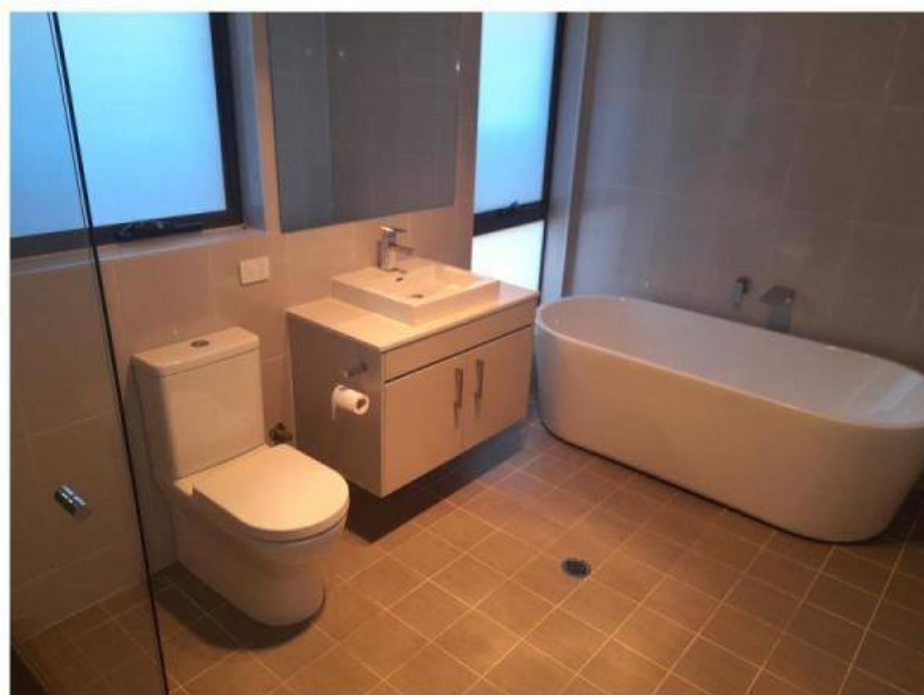
7.3 Room Location:

The shower recess was tested and found to be leaking. The water proofing membrane may have failed or there is a plumbing leak. Recommend a waterproofing contractor and or plumber evaluate further. Where framing timbers are present and damaged, replacement may be required. Silicone sealant has been applied to the interface of the floor and walls in the shower recess in an apparent attempt to prevent water penetration to surrounding areas. This method of repair can only be considered to be temporary. Further waterproofing may be necessary.

Chipped tiles were noted in this area. Consider repair or replacement of damaged tiles.

Water damage is noted to vanity cabinet and repair or replacement of affected areas is required.

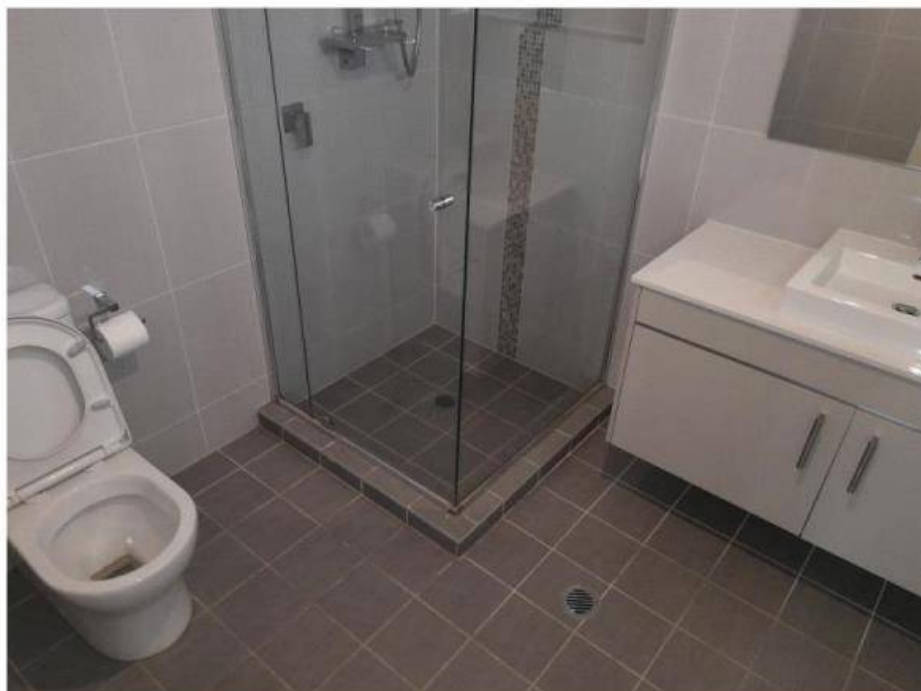
7.10 Room Location:

The shower recess was tested and found to be leaking. The water proofing membrane may have failed or there is a plumbing leak. Recommend a waterproofing contractor and or plumber evaluate further. Where framing timbers are present and damaged, replacement may be required. Silicone sealant has been applied to the interface of the floor and walls in the shower recess in an apparent attempt to prevent water penetration to surrounding areas. This method of repair can only be considered to be temporary. Further waterproofing may be necessary.

Some cracked tiles were noted in this area. Consider repair or replacement of damaged tiles.

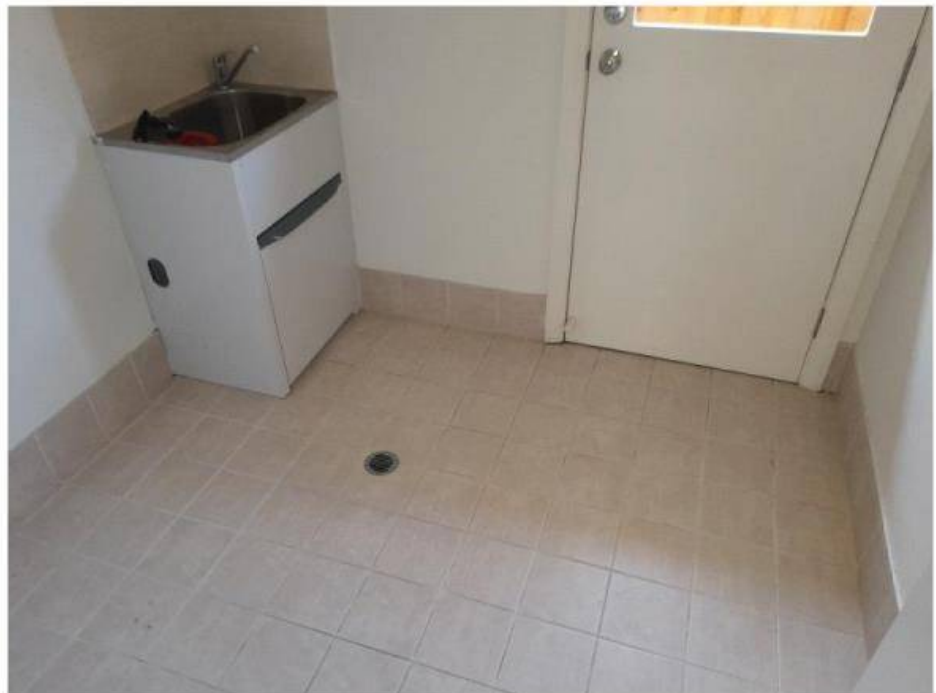
7.18 Room Location:

A licensed Master plumber should be called to make further evaluation and repairs as needed.

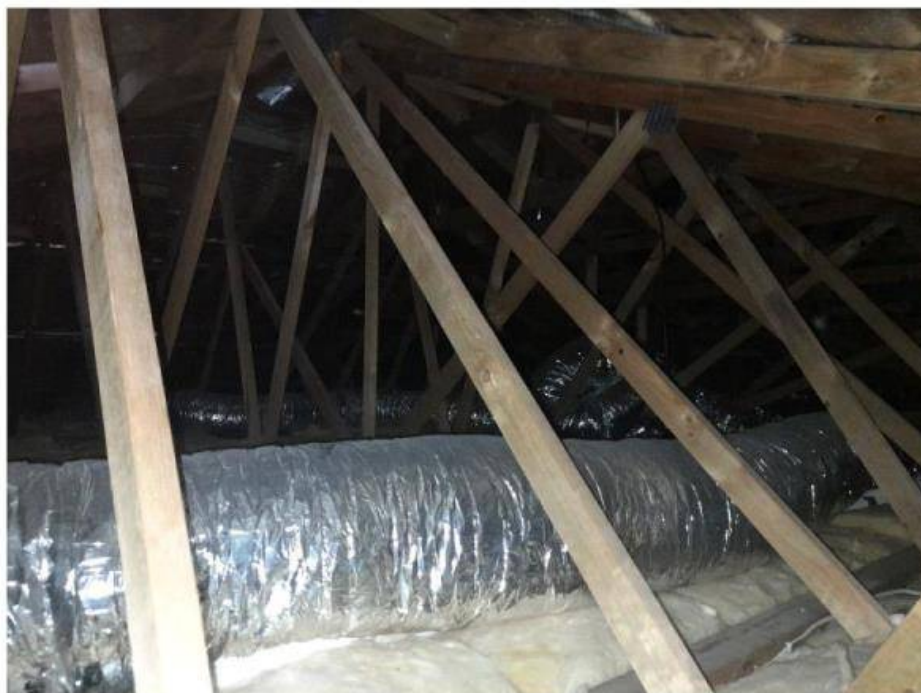
9.4 Roof Supports - Type And Condition:

The truss roof system appear to provide adequate support in areas that were accessible. Additional access is required to determine all roof support status.

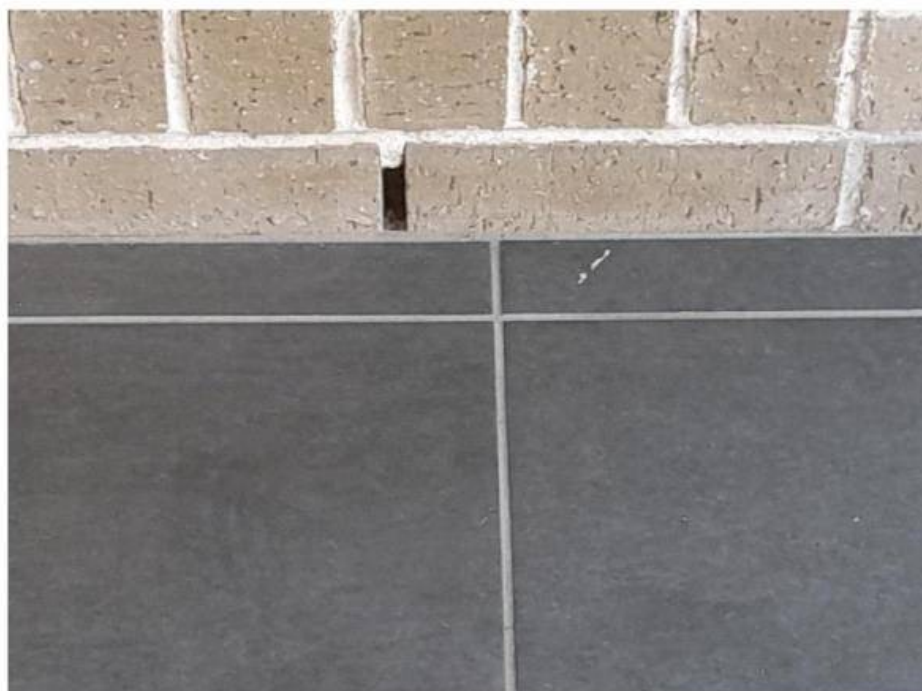
14.2 Description

The external vents/weep holes are either covered completely or partly concealed. This can allow concealed termite entry and we recommend that all vents/weep holes be exposed and kept clear of soil, foliage, debris, stored items or other obstructions. Some gutters and/or downpipes appear to discharge rainwater directly adjacent to the foundations of the structure. These should be connected to a stormwater dispersal system. The fence or fence posts are in direct contact with the building structure. This situation can allow termites to enter the structure and we recommend that suitable modifications be made so that fences are not in direct contact with the structure.

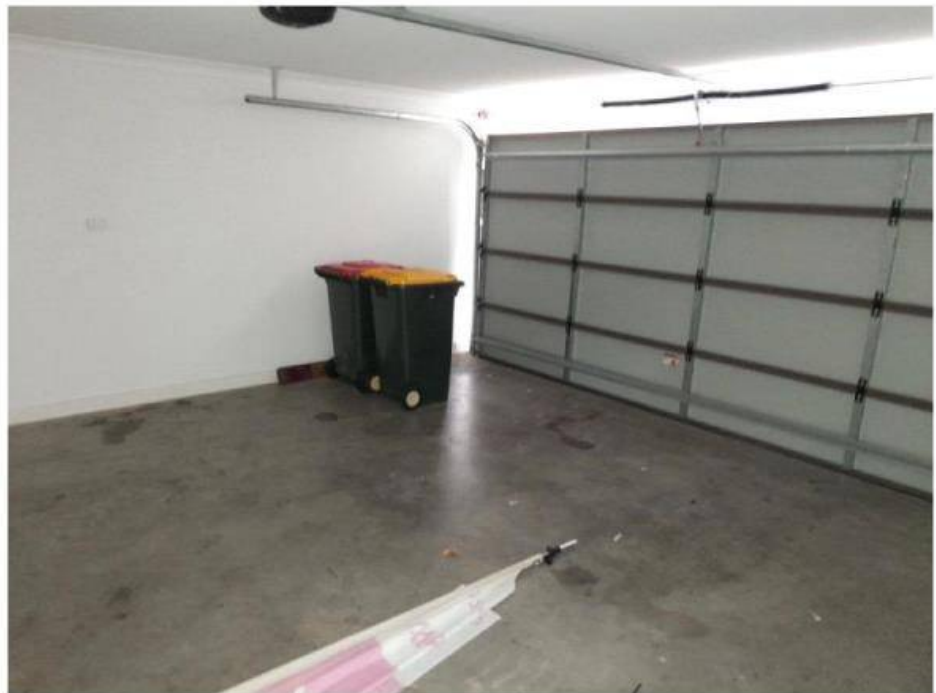
15.2 Garaging

The structure is fully lined preventing inspection to all framing timbers.

Active termites or other timber damaging pests may be present and not detected in areas where inspection was limited, obstructed or access was not gained. Recommend access be gained.

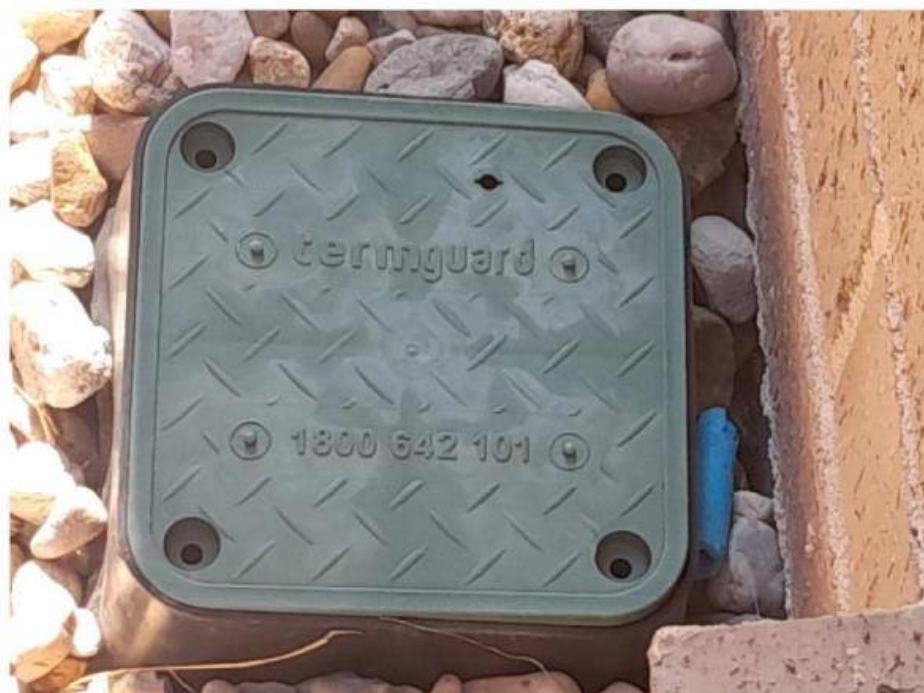
19.1 Description

A notice is present indicating that a reticulation system may be present. Termite reticulation systems installed during or after construction to assist in the protection of the structure against subterranean termite attack. We strongly recommend any prospective purchaser attempt to verify these findings.
