# Detection of inefficiencies in a solar plant

Daniel Sánchez Gómez

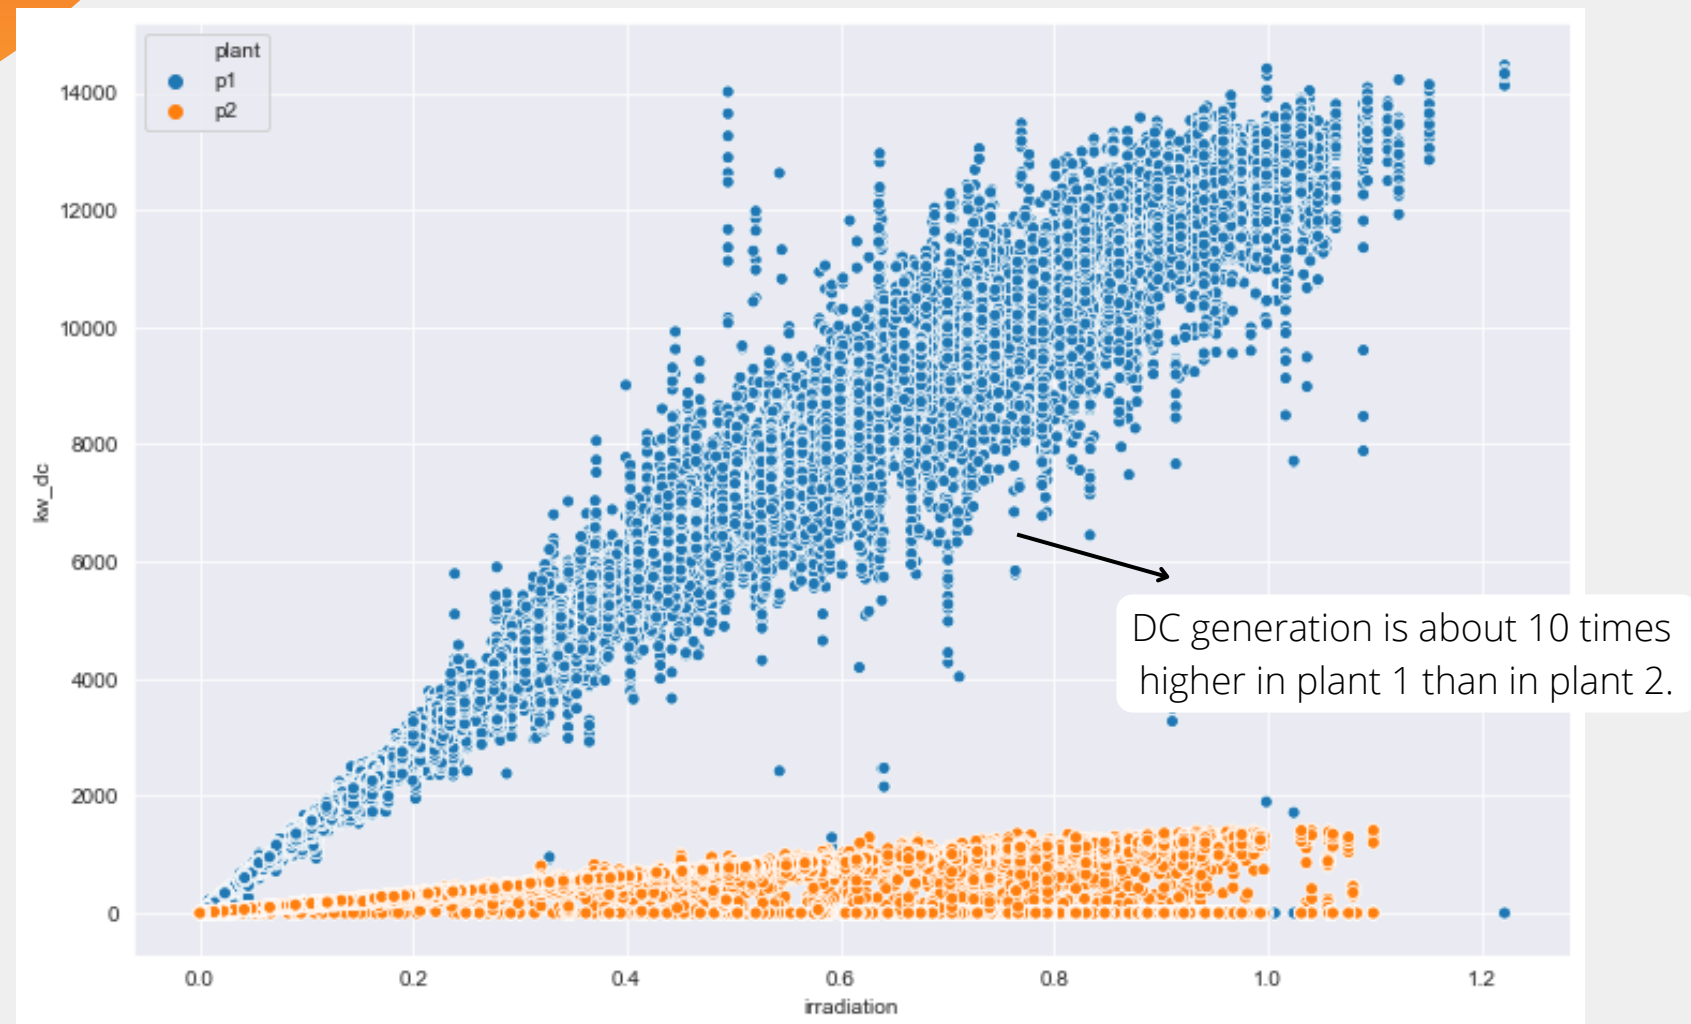
Direct current (Kw) energy generated by plants

# Data quality problems have been detected that suggest treating the conclusions to be presented as temporary.

A new extraction of the data from the meters should be requested to check whether there may indeed have been data quality problems.

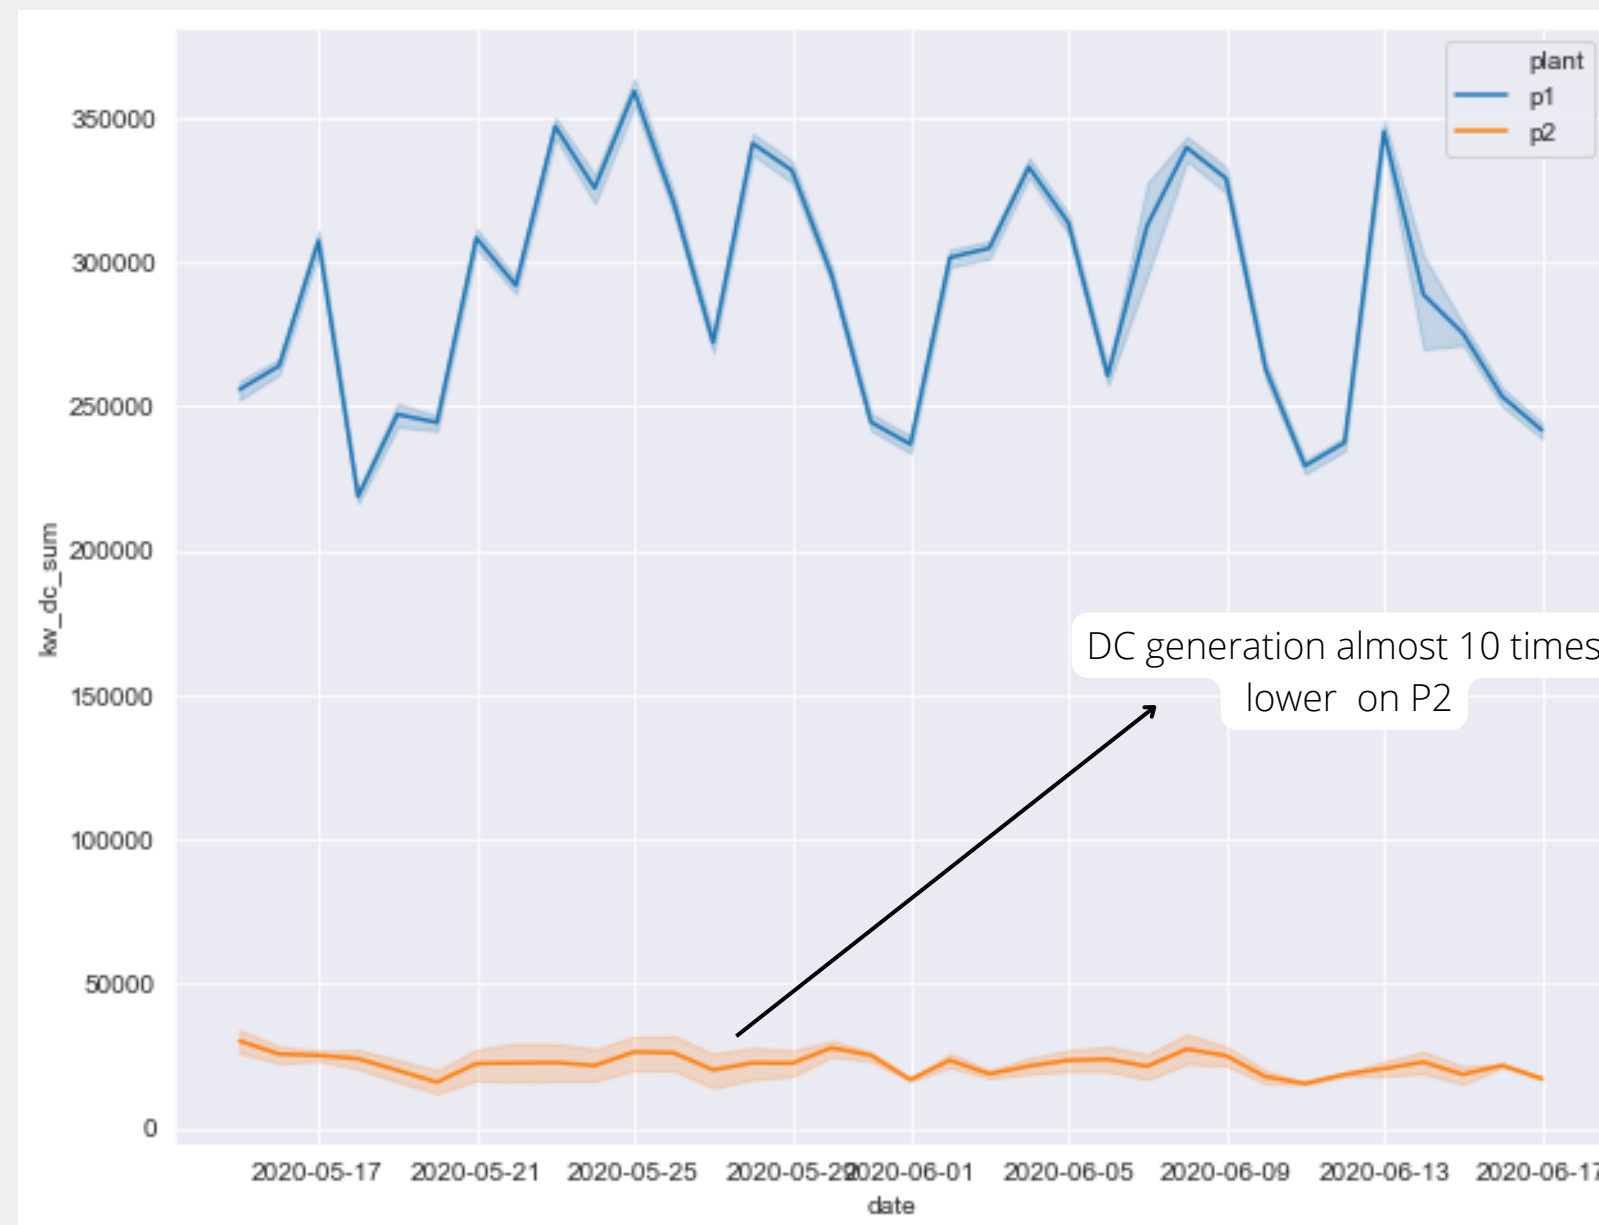
**Generation of DC per plant (Kw/day)**

**DC generation of plant 1 is correct, modules seem to carry DC to inverters. DC generation of plant 2 does NOT work well, modules carry too little DC to inverters**

**A revision of the plant 2 modules, which are generating too little DC power, is recommended.**

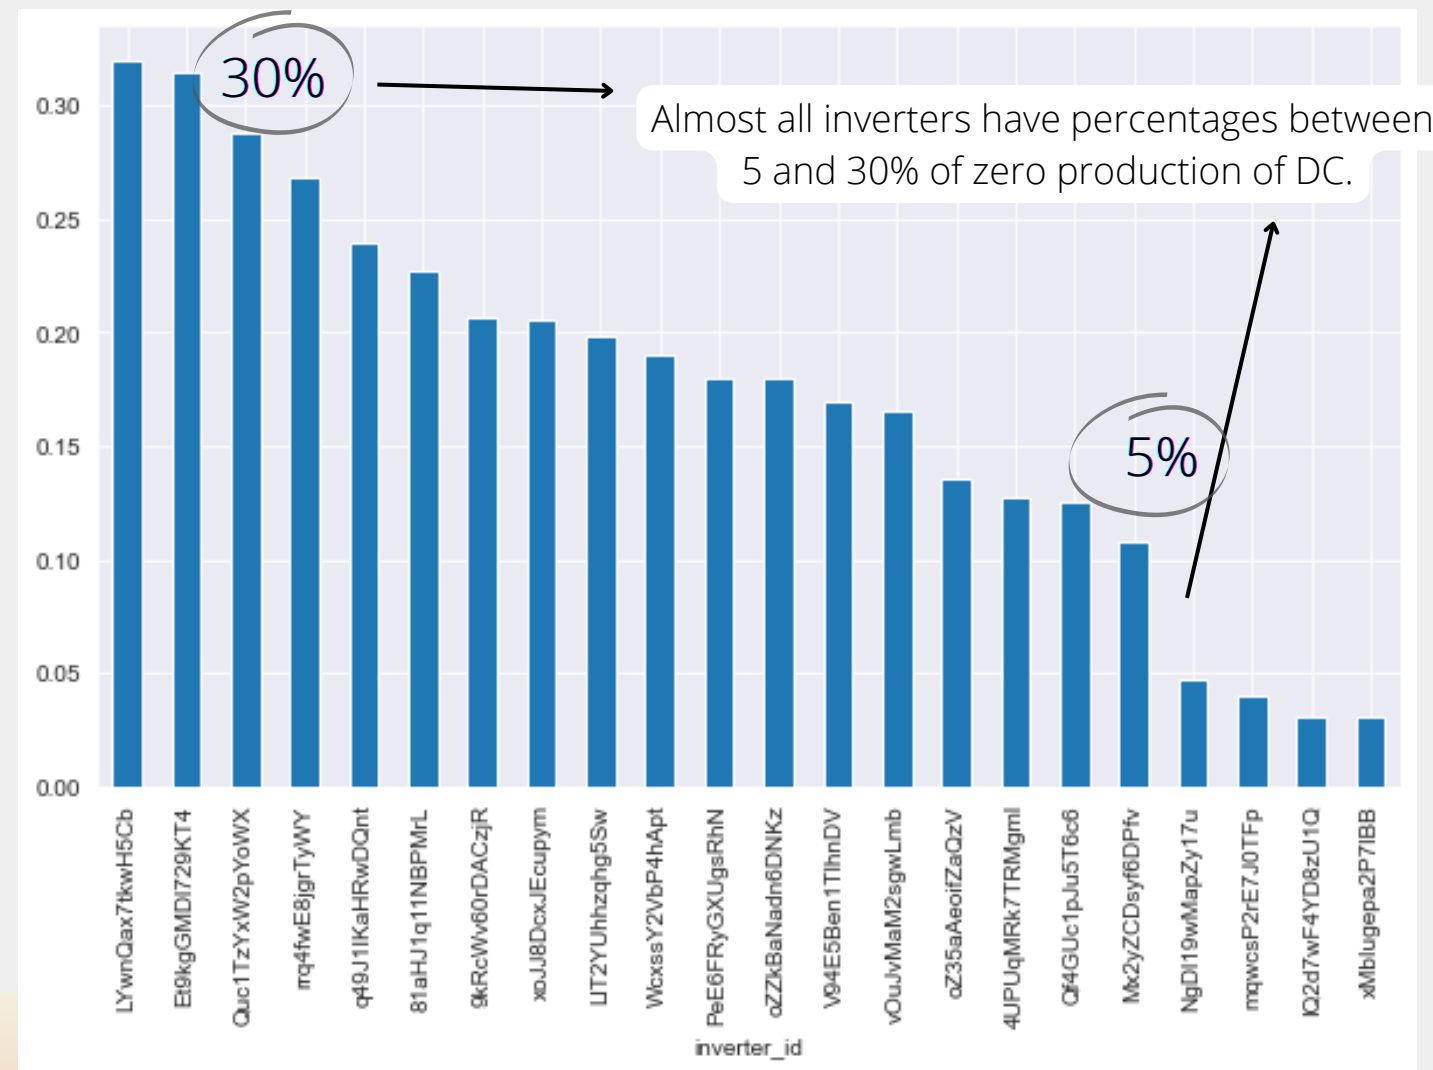
Percentage of zero DC production per inverter (%)

# In plant 2 there are several inverters that are not getting enough DC production, and therefore their modules need to be overhauled.

Inverters may be prioritized for review by those with the highest percentage of zero DC production.

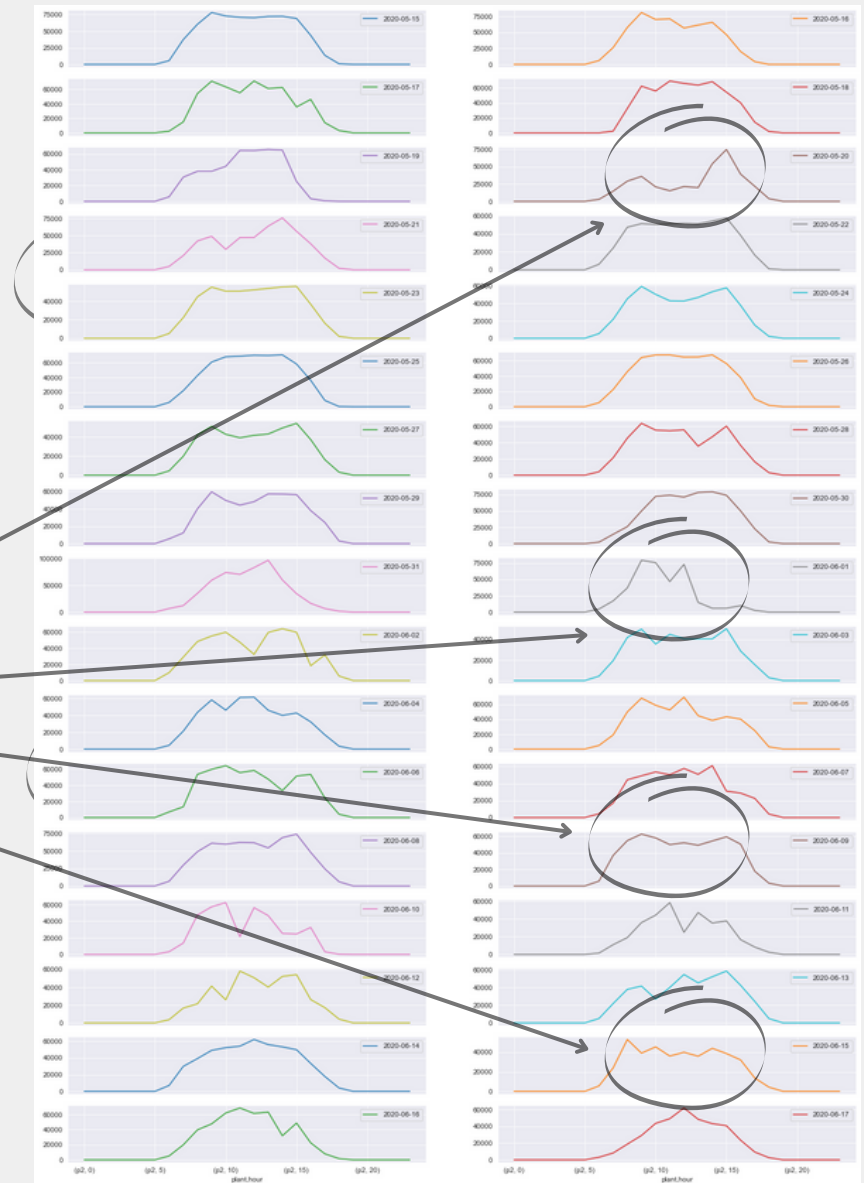
Average DC output (Kw/h) of the inverters per day

Modules carry little DC even at peak irradiation hours.

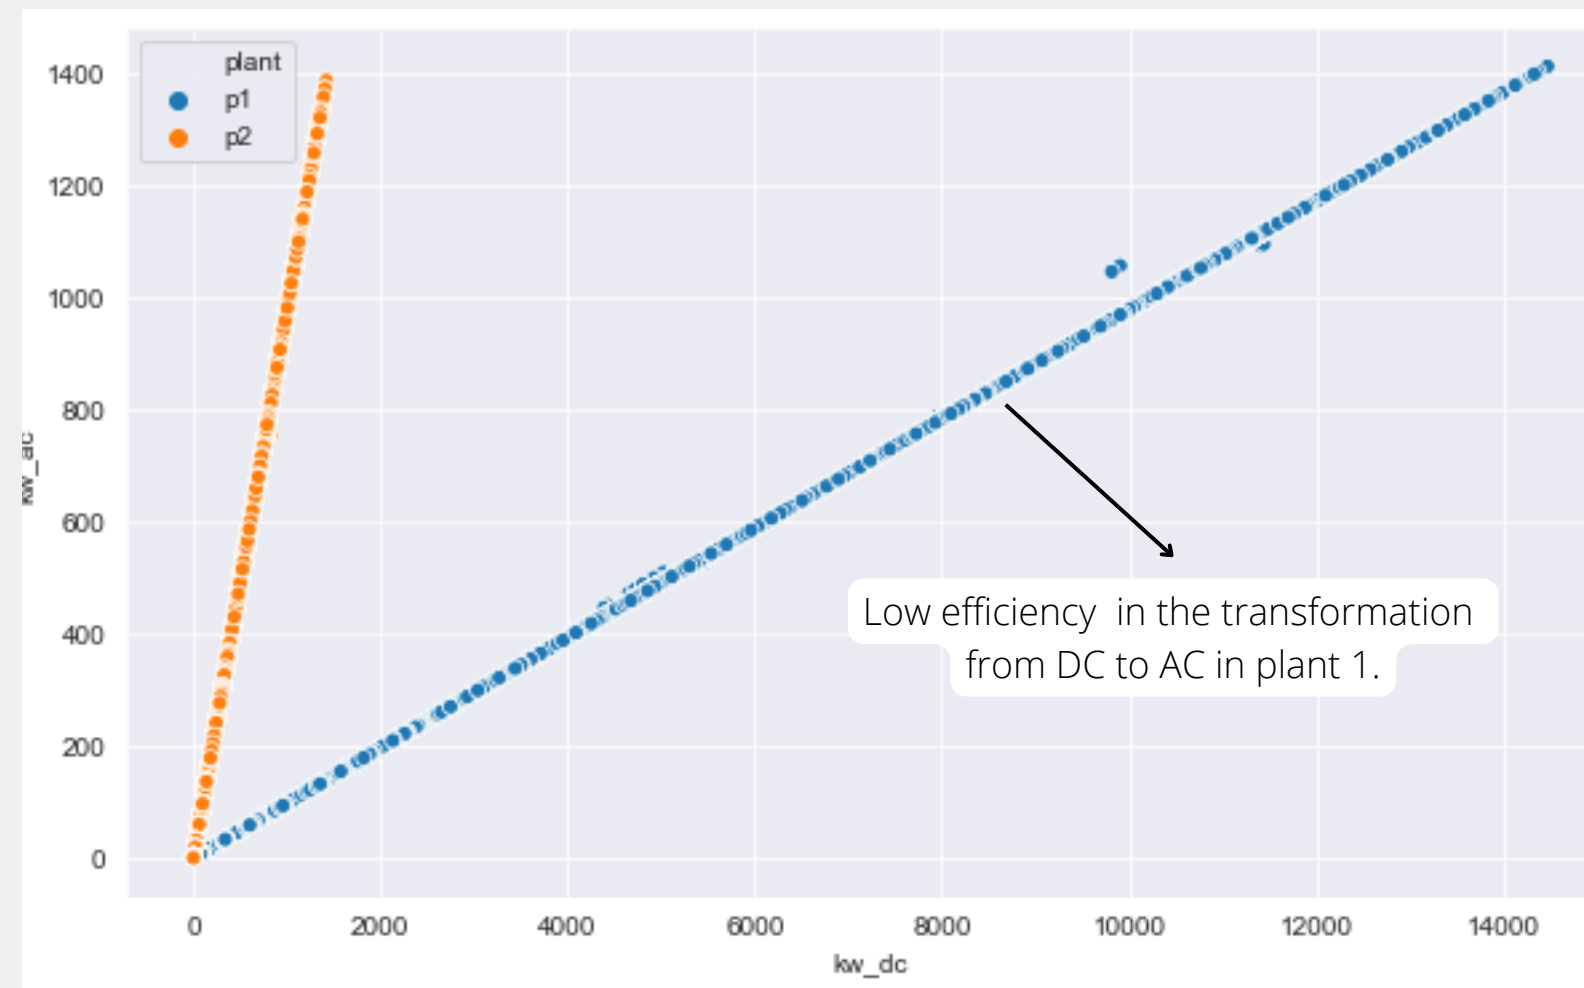
DC to AC conversion rate per plant (Kw)

# A malfunction of the inverters in plant 1 has been detected, which only manage to transform around 10% of DC to AC.

The inverters of plant 1, which are used for DC to AC transformation, should be overhauled.

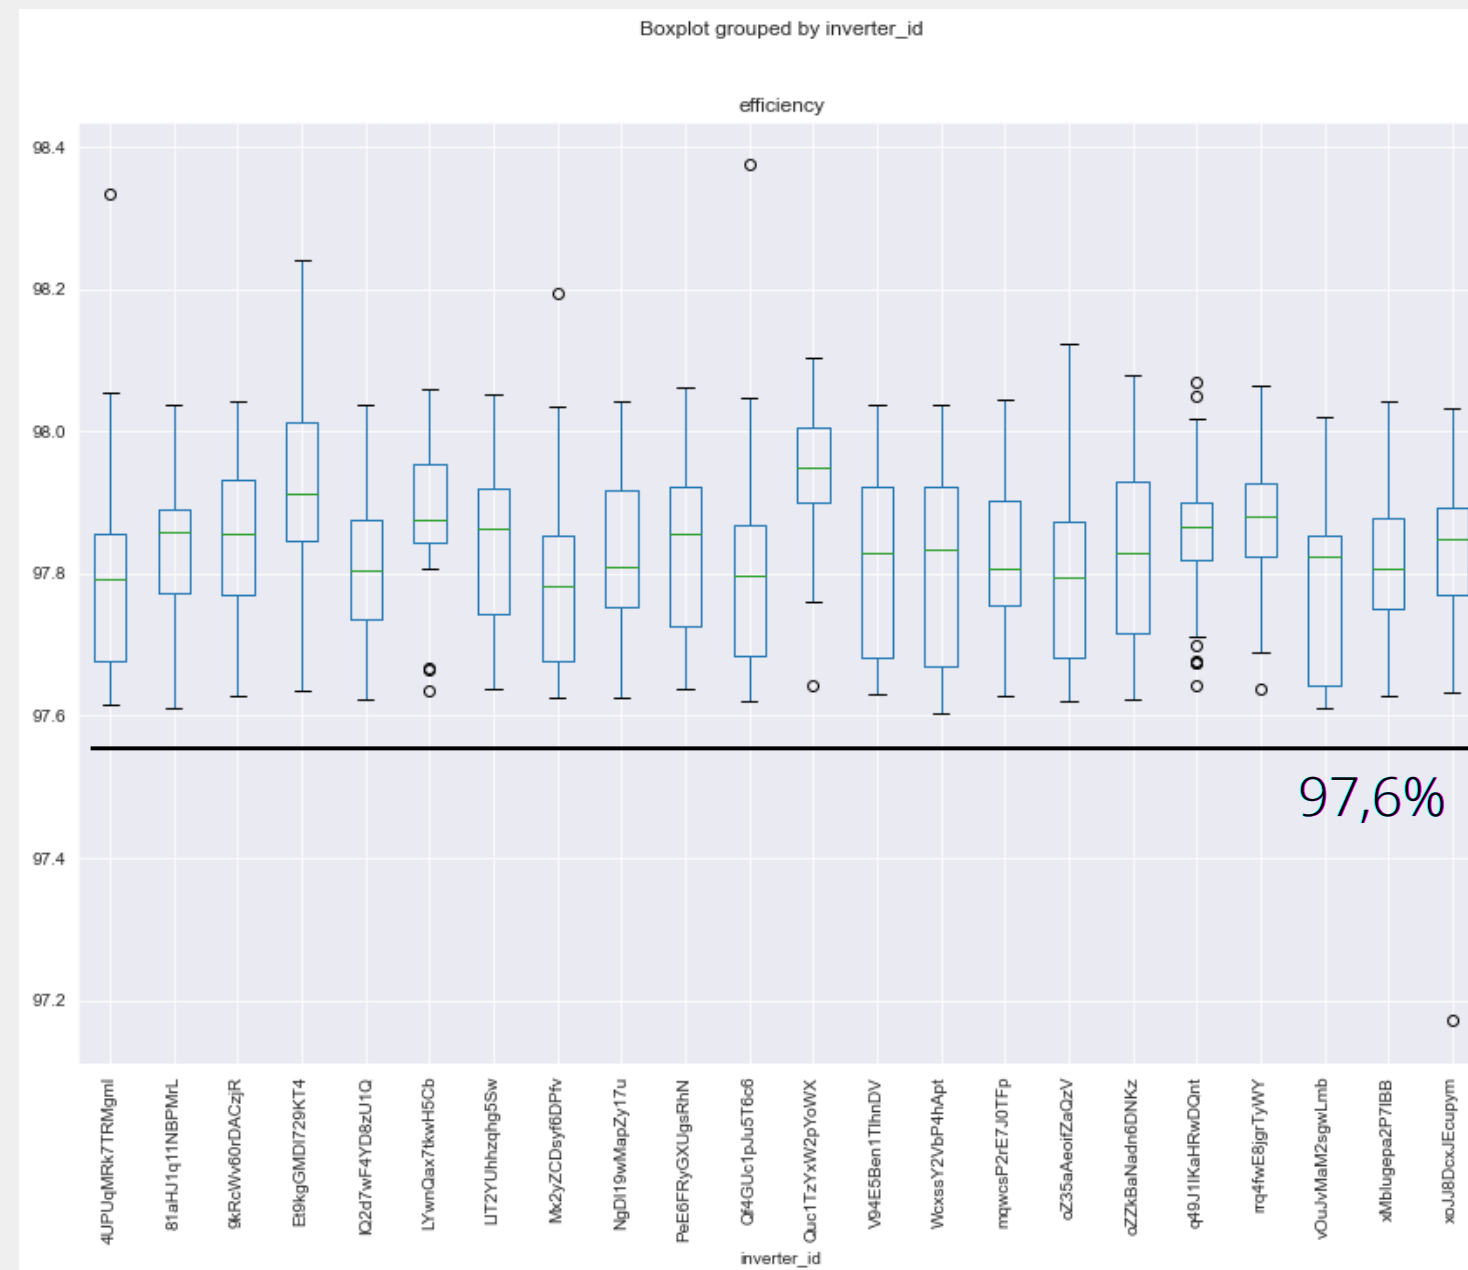
Inverter efficiency of plant 2 (%)

# The DC to AC transformation of plant 2 is correct, the inverters achieve an efficiency of more than 97%

High efficiency of all inverters.

Compare the features of the inverters of plant 2 with those of plant 1.
