## Inventory of Hydraulic Structure

<b>Structure ID :</b>	2324003/STR0001	<b>Year of Construction:</b>		
<b>Name of Structure :</b>	R-1 (Shikar Mangal khal)	<b>Name of Scheme :</b>	Kalkini North FCDI Sub-Project	
<b>Name of Division :</b>	Madaripur O&M Division	<b>Name of Sub Division :</b>	Madaripur Pouro-2	
<b>GPS Position Easting(m):</b>	217981	<b>GPS Position Northing(m) :</b>	2552324	
<b>District :</b>	Madaripur	<b>Upazila :</b>	Kalkini	
<b>Union :</b>	Kalkini Paurashava	<b>Village :</b>	Shikar Mangal	
<b>Type of Structure:</b>	Drainage Regulator			
<b>No of Vent/Barrel :</b>	2	<b>Size(WxH) / Diameter:</b>	1.52 X 1.83	
<b>Civil Component :</b>	<b>Deck Slab :</b>	Good	<b>Operation Deck Slab :</b>	Good
	<b>Wing Wall U/S :</b>	Good	<b>Wing Wall D/S :</b>	Good
	<b>Loose Apron U/S :</b>	Good	<b>Loose Apron D/S :</b>	Good
	<b>Adequacy In Opening :</b>	Adequate	<b>Boatpass :</b>	Not Applicable
	<b>Invert Level :</b>		<b>Source of Invert Level:</b>

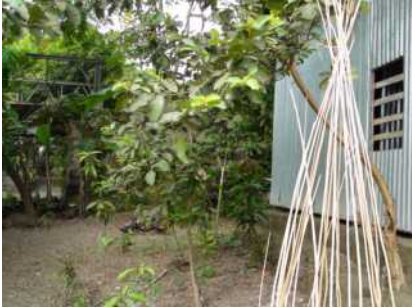
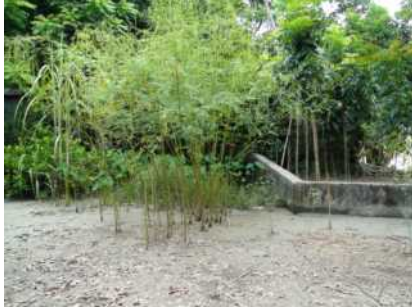
<b>U/S Approach Channel Condition:</b>	Silted Up, Encroachment	<b>D/S Approach Channel Condition:</b>	Silted Up, Encroachment
<b>Mechanical Component :</b>	<b>Gate Location :</b>	Downstream		
	<b>U/S Gate Type :</b>	0	<b>D/S Gate Type :</b>	Vertical
	<b>U/S Gate Condition:</b>		<b>D/S Gate Condition:</b>	Good
	<b>Hoist Condition:</b>	Non-Functional	<b>Maintenance/Painting:</b>	Bad
	<b>Gate Operation :</b>	Not Operated	<b>Operational conflict:</b>	No
	<b>Comments on Gate:</b>			
<b>Physical Condition and Functionalty :</b>	<b>Workable :</b>	No	<b>Required :</b>	No
	<b>Repairable :</b>	No	<b>Adverse:</b>	No
	<b>Abandoned :</b>	Yes	<b>To be Dismantled:</b>	No
	<b>Status :</b>	<b>Non-Functional</b>

<b>Upstream</b>		<b>Downstream</b>		
<b>Public Opinion :</b>	It is not required.			
<b>Comments of BWDB :</b>	Local people demand for boat-pass instead of regulator.			
<b>Recommendation of IWM :</b>	<p>This structure is supposed to drain out water to River Torki or River Palorti, a branch of River Arial Khan, through a channel, Shikar Mangal khal flowing by the side of the structure. Since construction during 1984-93, the river stage (water level) started gradually lowering and no water was flowing through structure or delivery channel of this structure. Finding no other way, the people removed the closure/X-dam that was put over the natural channel, Shikar Mangal khal to drain out water. Now-a-days people draining out water through the natural channel, Shikar Mangal khal and the regulators remained useless.</p> <p>In a discussion on 04/01/2017, People opined to keep this project at present status.</p>

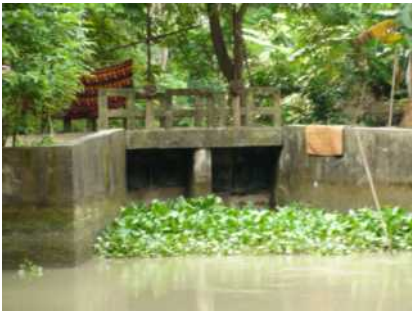
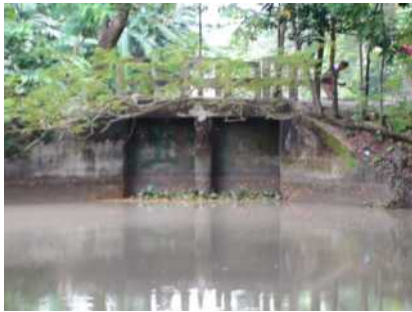
<b>Mechanical Component :</b>	<b>Gate Location :</b>	Upstream		
	<b>U/S Gate Type :</b>	Vertical	<b>D/S Gate Type :</b>	
	<b>U/S Gate Condition:</b>	Good	<b>D/S Gate Condition:</b>	
	<b>Hoist Condition:</b>	Functional	<b>Maintenance/Painting:</b>	Good
	<b>Gate Operation :</b>	Not Operated	<b>Operational conflict:</b>	No
	<b>Comments on Gate:</b>			
<b>Physical Condition and Functionalty :</b>	<b>Workable :</b>	No	<b>Required :</b>	No
	<b>Repairable :</b>	No	<b>Adverse:</b>	No
	<b>Abandoned :</b>	Yes	<b>To be Dismantled:</b>	Yes
	<b>Status :</b>	<b>Non-Functional</b>

<b>Upstream</b>		<b>Downstream</b>		
<b>Public Opinion :</b>	It is not required.			
<b>Comments of BWDB :</b>	Local beneficiaries demanded for boat-pass instead of regulator.			
<b>Recommendation of IWM :</b>	<p>This structure is supposed to drain out water to River Torki or River Palorti, a branch of River Arial Khan, through a channel, Shikar Mangal khal flowing by the side of the structure. Since construction during 1984-93, the river stage (water level) started gradually lowering and no water was flowing through structure or delivery channel of this structure. Finding no other way, the people removed the closure/X-dam that was put over the natural channel, Shikar Mangal khal to drain out water. Now-a-days people draining out water through the natural channel, Shikar Mangal khal and the regulators remained useless.</p> <p>In a discussion on 04/01/2017, People opined to keep this project at present status.</p>

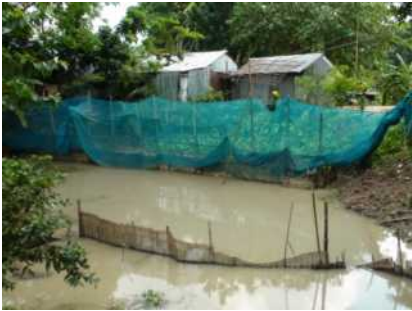
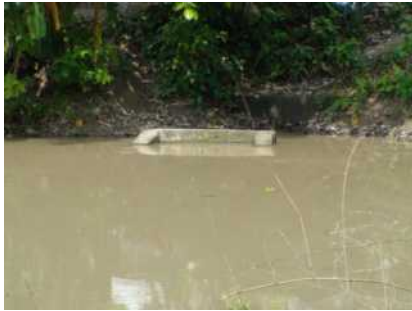
<b>U/S Approach Channel Condition:</b>	Aquatic Weed, Vegetation, Encroachment	<b>D/S Approach Channel Condition:</b>	
<b>Mechanical Component :</b>	<b>Gate Location :</b>	Upstream		
	<b>U/S Gate Type :</b>	Vertical	<b>D/S Gate Type :</b>	
	<b>U/S Gate Condition:</b>	Good	<b>D/S Gate Condition:</b>	
	<b>Hoist Condition:</b>	Functional	<b>Maintenance/Painting:</b>	Poor
	<b>Gate Operation :</b>	Local People	<b>Operational conflict:</b>	No
	<b>Comments on Gate:</b>			
<b>Physical Condition and Functionalty :</b>	<b>Workable :</b>	Yes	<b>Required :</b>	Yes
	<b>Repairable :</b>	Yes	<b>Adverse:</b>	No
	<b>Abandoned :</b>	No	<b>To be Dismantled:</b>	No
	<b>Status :</b>	<b>Functional</b>

<b>Upstream</b>		<b>Downstream</b>		
<b>Public Opinion :</b>	Beneficiaries demanded for repair and maintenance.			
<b>Comments of BWDB :</b>	Some repair works are required.			
<b>Recommendation of IWM :</b>	Suggested for repair and maintenance to render benefit to the stakeholders.

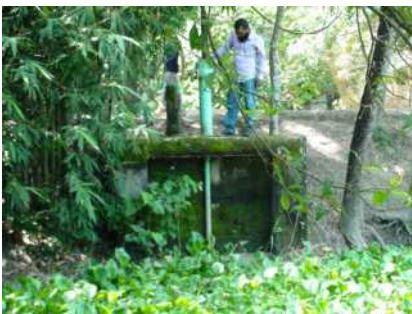
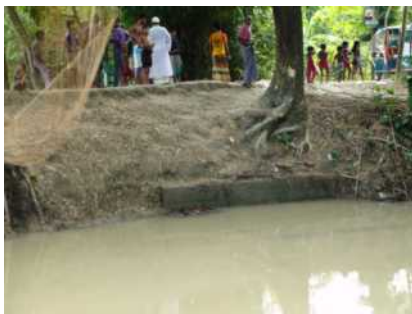
<b>Structure ID :</b>	2324003/STR0004	<b>Year of Construction:</b>		
<b>Name of Structure :</b>	FG-2 (Purbo Alipur)	<b>Name of Scheme :</b>	Kalkini North FCDI Sub-Project	
<b>Name of Division :</b>	Madaripur O&M Division	<b>Name of Sub Division :</b>	Madaripur Pouro-2	
<b>GPS Position Easting(m):</b>	224728	<b>GPS Position Northing(m) :</b>	2557278	
<b>District :</b>	Madaripur	<b>Upazila :</b>	Kalkini	
<b>Union :</b>	Enayetnagar	<b>Village :</b>	Purbo Alipur	
<b>Type of Structure:</b>	Flushing Sluice			
<b>No of Vent/Barrel :</b>	1	<b>Size(WxH) / Diameter:</b>	1.00 X 1.20	
<b>Civil Component :</b>	<b>Deck Slab :</b>	Good	<b>Operation Deck Slab :</b>	Good
	<b>Wing Wall U/S :</b>	Good	<b>Wing Wall D/S :</b>	Good
	<b>Loose Apron U/S :</b>	Good	<b>Loose Apron D/S :</b>	Good
	<b>Adequacy In Opening :</b>	Adequate	<b>Boatpass :</b>	Not Applicable
	<b>Invert Level :</b>		<b>Source of Invert Level:</b>	
	<b>U/S Approach Channel Condition:</b>	Inadequate	<b>D/S Approach Channel Condition:</b>	Aquatic Weed,Vegetation, Inadequate, Encroachment

<b>Mechanical Component :</b>	<b>Gate Location :</b>	Upstream		
	<b>U/S Gate Type :</b>	Vertical	<b>D/S Gate Type :</b>	
	<b>U/S Gate Condition:</b>	Good	<b>D/S Gate Condition:</b>	
	<b>Hoist Condition:</b>	Functional	<b>Maintenance/Painting:</b>	Poor
	<b>Gate Operation :</b>	Local People	<b>Operational conflict:</b>	No
	<b>Comments on Gate:</b>			
<b>Physical Condition and Functionalty :</b>	<b>Workable :</b>	Yes	<b>Required :</b>	Yes
	<b>Repairable :</b>	Yes	<b>Adverse:</b>	No
	<b>Abandoned :</b>	No	<b>To be Dismantled:</b>	No
	<b>Status :</b>	Functional

<b>Upstream</b>		<b>Downstream</b>		
<b>Public Opinion :</b>	Beneficiaries demanded for repair and maintenance.			
<b>Comments of BWDB :</b>	Some repair works are required.			
<b>Recommendation of IWM :</b>	Suggested for repair and maintenance to render benefit to the stakeholders.

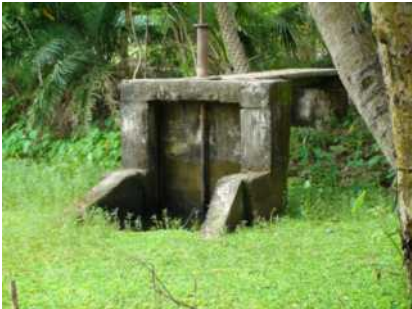
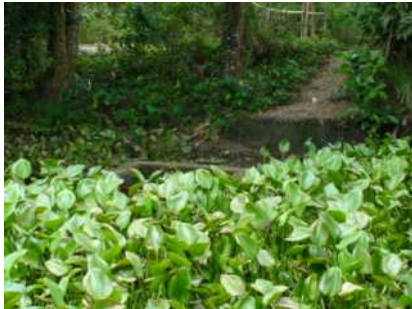
<b>U/S Approach Channel Condition:</b>	Aquatic Weed,Vegetation, Water Hyacinth	<b>D/S Approach Channel Condition:</b>	Aquatic Weed,Vegetation, Water Hyacinth
<b>Mechanical Component :</b>	<b>Gate Location :</b>	Upstream		
	<b>U/S Gate Type :</b>	Vertical	<b>D/S Gate Type :</b>	
	<b>U/S Gate Condition:</b>	Good	<b>D/S Gate Condition:</b>	
	<b>Hoist Condition:</b>	Functional	<b>Maintenance/Painting:</b>	Poor
	<b>Gate Operation :</b>	Local People	<b>Operational conflict:</b>	No
	<b>Comments on Gate:</b>			
<b>Physical Condition and Functionalty :</b>	<b>Workable :</b>	Yes	<b>Required :</b>	Yes
	<b>Repairable :</b>	Yes	<b>Adverse:</b>	No
	<b>Abandoned :</b>	No	<b>To be Dismantled:</b>	No
	<b>Status :</b>	<b>Functional</b>

<b>Upstream</b>		<b>Downstream</b>		
<b>Public Opinion :</b>	Beneficiaries demanded for repair and maintenance.			
<b>Comments of BWDB :</b>	Some repair works are required.

<b>Recommendation of IWM :</b>	Suggested for repair and maintenance to render benefit to the stakeholders.

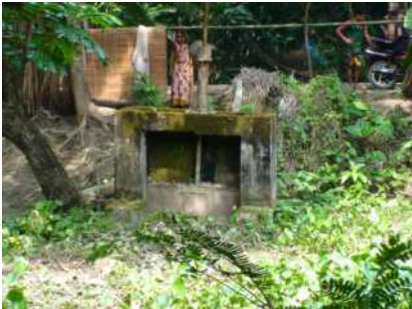
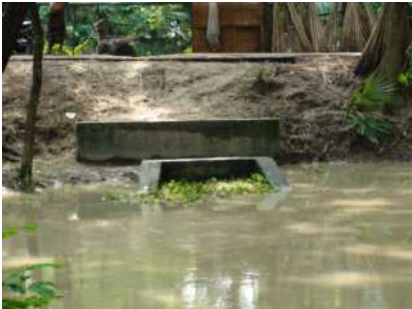
<b>U/S Approach Channel Condition:</b>	Water Hyacinth	<b>D/S Approach Channel Condition:</b>	Aquatic Weed,Vegetation, Water Hyacinth
<b>Mechanical Component :</b>	<b>Gate Location :</b>	Upstream		
	<b>U/S Gate Type :</b>	Vertical	<b>D/S Gate Type :</b>	
	<b>U/S Gate Condition:</b>	Good	<b>D/S Gate Condition:</b>	
	<b>Hoist Condition:</b>	Functional	<b>Maintenance/Painting:</b>	Poor
	<b>Gate Operation :</b>	Local People	<b>Operational conflict:</b>	No
	<b>Comments on Gate:</b>			
<b>Physical Condition and Functionalty :</b>	<b>Workable :</b>	Yes	<b>Required :</b>	Yes
	<b>Repairable :</b>	Yes	<b>Adverse:</b>	No
	<b>Abandoned :</b>	No	<b>To be Dismantled:</b>	No
	<b>Status :</b>	<b>Functional</b>

<b>Upstream</b>		<b>Downstream</b>		
<b>Public Opinion :</b>	Beneficiaries demanded for repair and maintenance.			
<b>Comments of BWDB :</b>	Regular maintenance is required to keep the structure functional.

<b>Recommendation of IWM :</b>	Suggested for repair and maintenance to render benefit to the stakeholders.

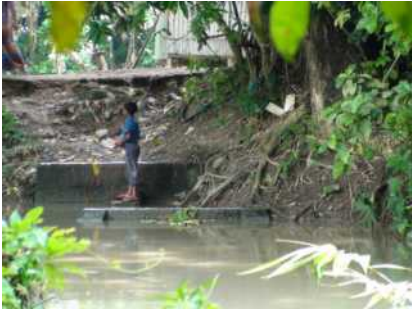
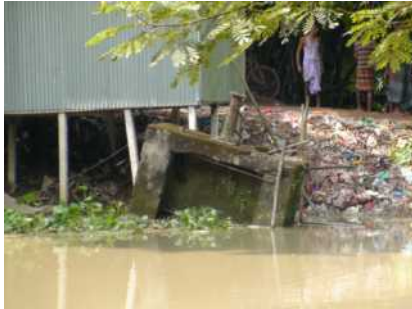
<b>U/S Approach Channel Condition:</b>		<b>D/S Approach Channel Condition:</b>	Encroachment
<b>Mechanical Component :</b>	<b>Gate Location :</b>	Downstream		
	<b>U/S Gate Type :</b>	0	<b>D/S Gate Type :</b>	Vertical
	<b>U/S Gate Condition:</b>		<b>D/S Gate Condition:</b>	Poor
	<b>Hoist Condition:</b>	Functional	<b>Maintenance/Painting:</b>	Bad
	<b>Gate Operation :</b>	Local People	<b>Operational conflict:</b>	No
	<b>Comments on Gate:</b>			
<b>Physical Condition and Functionalty :</b>	<b>Workable :</b>	Yes	<b>Required :</b>	Yes
	<b>Repairable :</b>	Yes	<b>Adverse:</b>	No
	<b>Abandoned :</b>	No	<b>To be Dismantled:</b>	No
	<b>Status :</b>	Partly Functional

<b>Upstream</b>		<b>Downstream</b>		
<b>Public Opinion :</b>	Beneficiaries demanded for repair and maintenance.			
<b>Comments of BWDB :</b>	Reconstruction of the structure is required.			
<b>Recommendation of IWM :</b>	Headwall (separately constructed) fell down due to bed scour.Suggested for repair and maintenance to render benefit to the stakeholders.Suggested for repair and maintenance to make the structure functional.

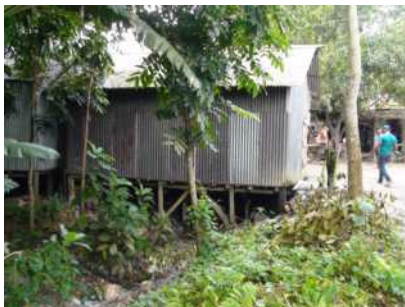
Name of Scheme :	Kalkini North FCDI Sub-Project			
Structure ID:	2324003/STR0008			
Structure Name:	SDO -1(Karimganj Khal)			
Type of Structure :	Drainage Outlet			
Easting(m):	219221	Northing(m) :	2556037	
District :	Madaripur	Upazila :	Kalkini	
Union :	Enayetnagar	Village :	Karimganj Khal	
Size(WxH) / Diameter(m):	0.60	Repairable :	Yes	
Required :	Yes	Status :	Non-Functional	
<hr/>				
Name of Division :	Madaripur O&M Division

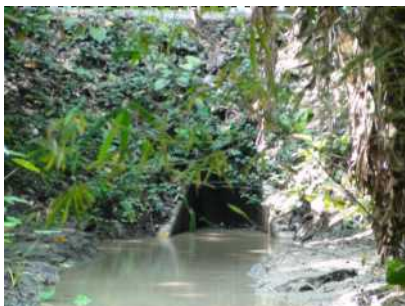
Name of Scheme :	Kalkini North FCDI Sub-Project			
Structure ID:	2324003/STR0009			
Structure Name:	SDO -3 (Chakidar Bari)			
Type of Structure :	Drainage Outlet			
Easting(m):	218059	Northing(m) :	2553315	
District :	Madaripur	Upazila :	Kalkini	
Union :	Shikar Mangal	Village :	Shikar Mangal	
Size(WxH) / Diameter(m):	0.60	Repairable :	Yes	
Required :	Yes	Status :	Functional	
<hr/>				
Name of Division :	Madaripur O&M Division

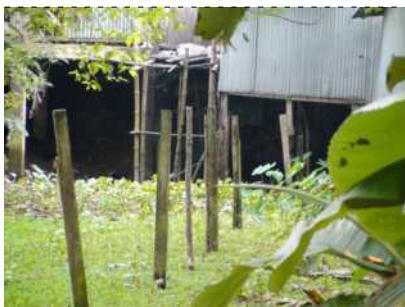
Name of Scheme :	Kalkini North FCDI Sub-Project			
Structure ID:	2324003/STR0010			
Structure Name:	SDO-4 (Jurgao Bazar)			
Type of Structure :	Drainage Outlet			
Easting(m):	217247	Northing(m) :	2550890	
District :	Madaripur	Upazila :	Kalkini	
Union :	Kalkini Paurashava	Village :	Jurgao Bazar	
Size(WxH) / Diameter(m):	1.00 X 1.22	Repairable :	No	
Required :	No	Status :	Non-Functional

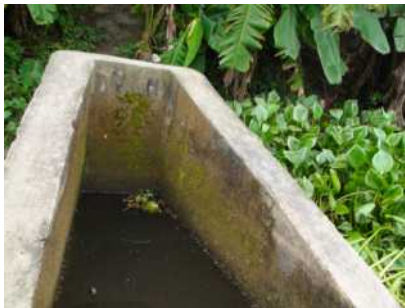
Name of Scheme :	Kalkini North FCDI Sub-Project			
Structure ID:	2324003/STR0011			
Structure Name:	SDO-4A (Jurgao Bazar)			
Type of Structure :	Drainage Outlet			
Easting(m):	217671	Northing(m) :	2550408	
District :	Madaripur	Upazila :	Kalkini	
Union :	Kalkini Paurashava	Village :	Jurgao Bazar	
Size(WxH) / Diameter(m):	0.60	Repairable :	Yes	
Required :	Yes	Status :	Functional	
<hr/>				
Name of Division :	Madaripur O&M Division

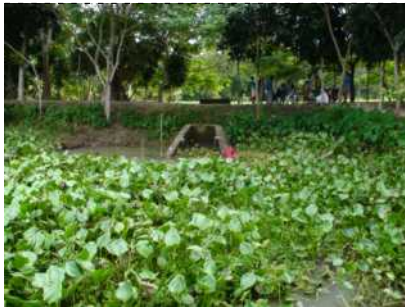
Name of Scheme :	Kalkini North FCDI Sub-Project			
Structure ID:	2324003/STR0012			
Structure Name:	SDO -5 (Dhakikandi)			
Type of Structure :	Drainage Outlet			
Easting(m):	218882	Northing(m) :	2550492	
District :	Madaripur	Upazila :	Kalkini	
Union :	Kalkini Paurashava	Village :	Dhakikandi	
Size(WxH) / Diameter(m):	0.60	Repairable :	Yes	
Required :	Yes	Status :	Partly Functional	
<hr/>				
Name of Division :	Madaripur O&M Division

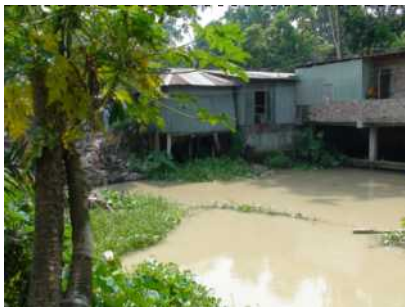
Name of Scheme :	Kalkini North FCDI Sub-Project			
Structure ID:	2324003/STR0013			
Structure Name:	SDO -6 (Miarhat)			
Type of Structure :	Drainage Outlet			
Easting(m):	221487	Northing(m) :	2552446	
District :	Madaripur	Upazila :	Kalkini	
Union :	Shikar Mangal	Village :	Char Fate Bahadur	
Size(WxH) / Diameter(m):	0.60	Repairable :	Yes	
Required :	Yes	Status :	Functional

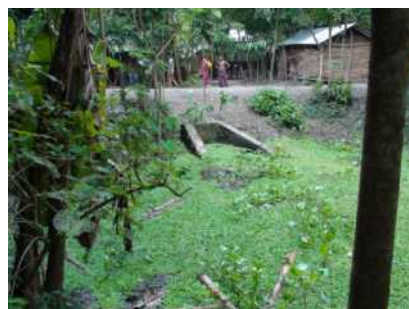
<b>Name of Division :</b>	Madaripur O&M Division		
<b>Name of Scheme :</b>	Kalkini North FCDI Sub-Project		
<b>Structure ID:</b>	2324003/STR0014		
<b>Structure Name:</b>	SDO -8 (Talukdar Bari)		
<b>Type of Structure :</b>	Drainage Outlet		
<b>Easting(m):</b>	222172	<b>Northing(m) :</b>	2558778
<b>District :</b>	Madaripur	<b>Upazila :</b>	Kalkini
<b>Union :</b>	Alinagar	<b>Village :</b>	Sasthal
<b>Size(WxH) / Diameter(m):</b>	0.60	<b>Repairable :</b>	Yes
<b>Required :</b>	Yes	<b>Status :</b>	Functional
