P.T. ISPAT INDO	INCIDENT INVESTIGATION REPORT	Number : SMK3L-En/ISP/FR-13-03
		Revision : 06
		Date : March 14, 2019

The main store canopy collapsed when it was used as a foothold for painting work in the main store

Location: Main Store

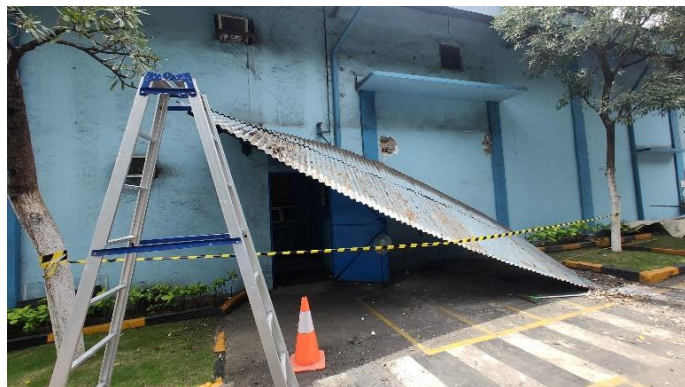
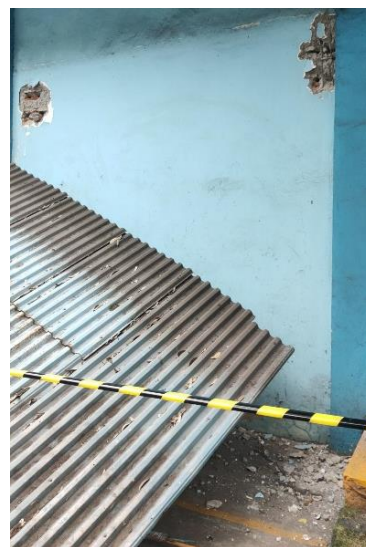
When carrying out painting work on the outer walls of the main store, the civil team cleaned the walls and painted using bamboo tools as sticks to reach the high walls. When cleaning a wall with a canopy, the victim could not reach it, so he used a ladder. Because it was considered difficult to reach it, the victim climbed onto the canopy roof and suddenly the canopy roof frame collapsed and the victim held on to the canopy frame so he didn't fall to the floor.

The walls of the Central store are not strong enough to withstand the excess weight that supports the canopy because the anchors are not in the position of the concrete walls.

- Not carrying out work permit procedures by applying for height work permits
- Not wearing Full body harness or fall prevention

Tools / material	Medication	Lost days / down time	Total cost
The canopy collapses Use Used Materials			7.000.000
Corrective action	Responsible Department	Solution Plan	Date of completion
1. Give warnings and sanctions to contractors by giving a penalty	<u>SHE</u>	5 Jan 2023	
2. Conducting briefings to contractors on this incident and high-risk work to comply with existing regulations	<u>SHE & CVL</u>	6 Jan 2023	
3. Make a platform / footrest on top of the canopy that will be reassembled	<u>CVL</u>	Tentative	
Prepared by: M. Arif Setiawan Position: SHE Engineer Department: SHE	Investigation Team : 1. M, Arif S 2. Dwi P 3. Herry 4. Dudik 5. Sutoyo	Corrective Action by Responsible Dept. Name : Mr Vijay Date :
