# Aviation Investigation Final Report

<b>Location:</b>	Milton, Florida	<b>Accident Number:</b>	ERA23LA124
<b>Date &amp; Time:</b>	February 6, 2023, 14:32 Local	<b>Registration:</b>	N330PC
<b>Aircraft:</b>	CANTON PAUL A RV-6	<b>Aircraft Damage:</b>	Substantial
<b>Defining Event:</b>	Fuel starvation	<b>Injuries:</b>	1 Serious
<b>Flight Conducted Under:</b>	Part 91: General aviation - Personal

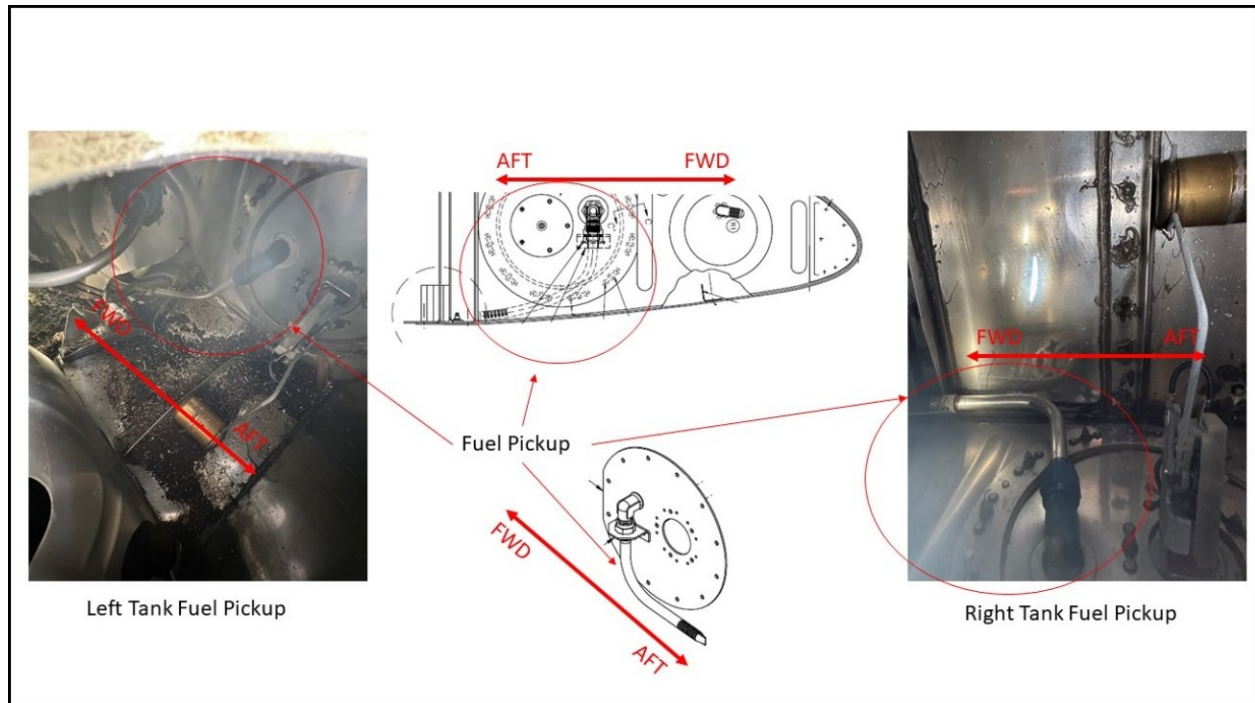
Postaccident examination of the engine found no evidence of a preimpact mechanical malfunction or failure that would have precluded normal operation. Examination of the wing fuel tanks revealed that the fuel pickups in both wing fuel tanks were installed incorrectly as compared to the kit manufacturer's plans; both lines were facing forward instead of aft. The incorrect positioning of the pickup lines made it likely that the amount of unusable fuel was greatly increased, especially at nose high pitch attitudes, such as during takeoff and initial climb, due to the fuel's movement toward the aft portion of the tank. The pilot reported that he was not provided documentation when he bought the airplane as to the quantity of unusable fuel, nor had the unusable fuel amounts been calculated since he purchased the airplane.

Although the amount of unusable fuel in the selected tank selected could not be determined (given the damage sustained to the tank during the accident), it is likely that during initial climb the engine was starved for fuel due to the incorrect installation of the pickup lines, resulting in a loss of engine power.

The incorrect installation of the fuel pickups, which resulted in a total loss of engine power due to fuel starvation. Contributing was the lack of documentation of the airplane’s unusable fuel.

The fuel pickup in both wing tanks were not installed correctly when compared to the plans for a Van's Aircraft RV-6. The plans called for the fuel pickups to be routed down towards the bottom of the fuel tank and then bend toward the aft bulkhead of the fuel tank, under the fuel sending unit. The fuel pickups on the accident airplane were routed down and then bent forward toward the leading edge (see figure 1). The kit manufacturer reported that if the fuel pickups were bent forward toward the leading edge instead of aft, as the plans called for, then the amount of unusable fuel would greatly increase. The pilot (who was the third owner of the airplane and not the original builder) reported that there was no documentation stating the amount of unusable fuel, only that the fuel tanks had a total capacity of 38 gallons. The investigation was not able to determine the amount of unusable fuel due to the selected fuel tank being compromised in the accident sequence. A "Flying Lessons" article published by the FAA on May 26, 2011, discussed how fuel moving away from the fuel tank pickups could result in fuel starvation and a loss of engine power.

Figure 1 - Fuel pickup position on accident airplane with RV-6 plan schematic showing the proper configuration.

A review of maintenance records showed that service bulletin SB 06-2-23 and a service notification letter issued June 12, 2000, from the kit manufacturer, relating to the fuel pickups, had not been complied with. The publication *Service Bulletins and the Aircraft Owner*, published by the FAA, states, "Manufacturers issue aircraft Service Bulletins to inform owners and operators about critical and useful information on aircraft safety, maintenance, or product improvement," and, "If you are operating your aircraft under 14 CFR part 91, a service bulletin is advisory, and compliance is not mandatory unless it is included in an Airworthiness Directive." A search of the FAA Dynamic Regulatory System found no airworthiness directives for the Van's Aircraft Inc. RV-6.
