Aviation Investigation Final Report

Location:	Conroe, Texas	Accident Number:	CEN23LA081
Date & Time:	January 14, 2023, 14:25 Local	Registration:	N512P
Aircraft:	Pitts Model 12	Aircraft Damage:	Substantial
Defining Event:	Sys/Comp malf/fail (non-power)	Injuries:	1 Serious, 1 Minor
Flight Conducted Under:	Part 91: General aviation - Personal

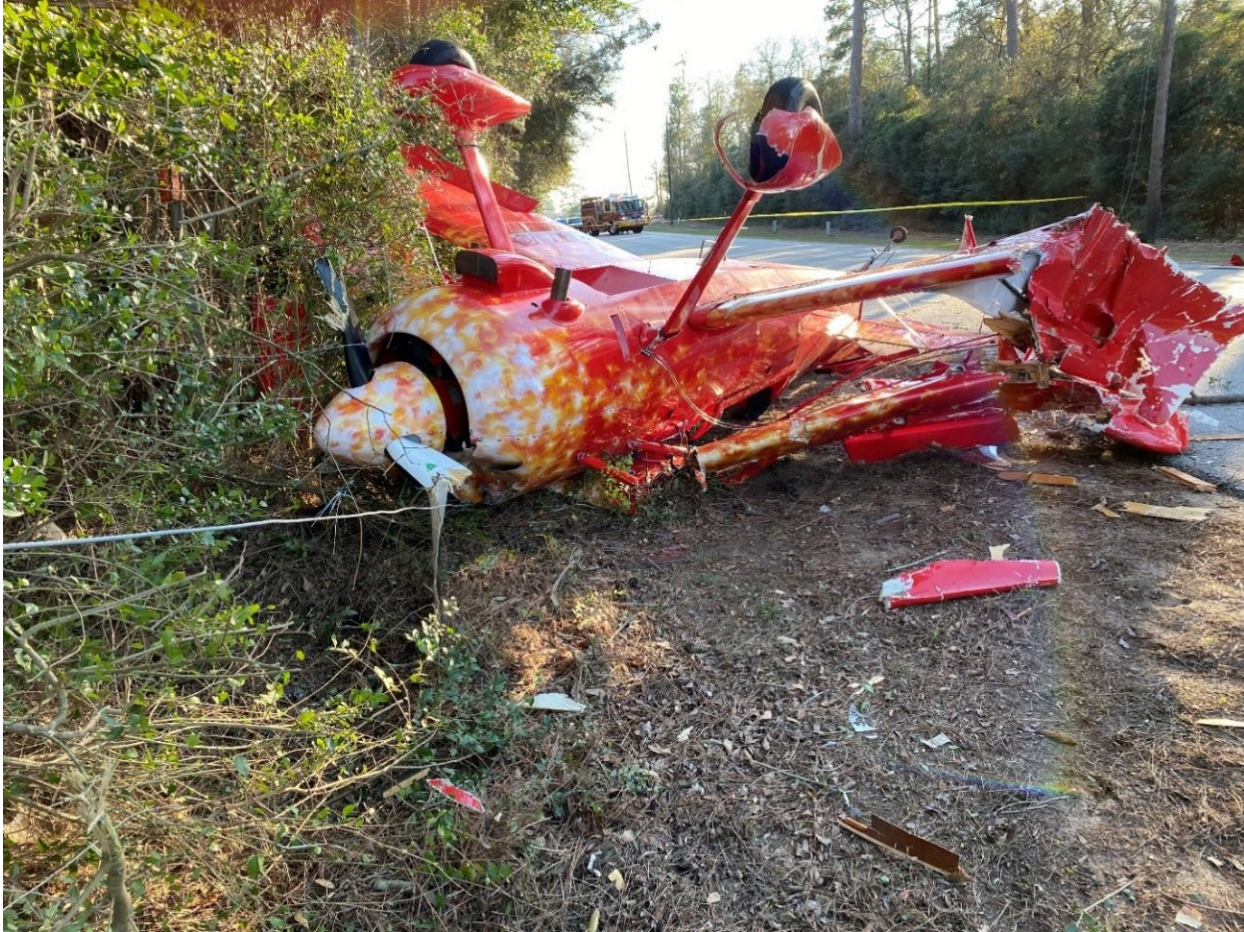
Figure 1. Accident airplane as it came to rest (Source: Federal Aviation Administration)

The pilot stated that, about 1 minute later, the engine sustained a series of power fluctuations; “like someone was turning the [magnetos] off and on.” When the pilot turned on the fuel boost pump, the engine produced a burst of power, and then lost power. The pilot switched from the main fuel tank to the auxiliary tank with no change noted to engine power, then switched back to the main fuel tank. Unable to reach the airport or a field due to a high descent rate, the pilot performed a forced landing to a nearby roadway. During the landing, the airplane impacted a powerline and terrain before coming to rest inverted. The airplane sustained substantial damage to the wings, fuselage, and empennage (see Figure 1).

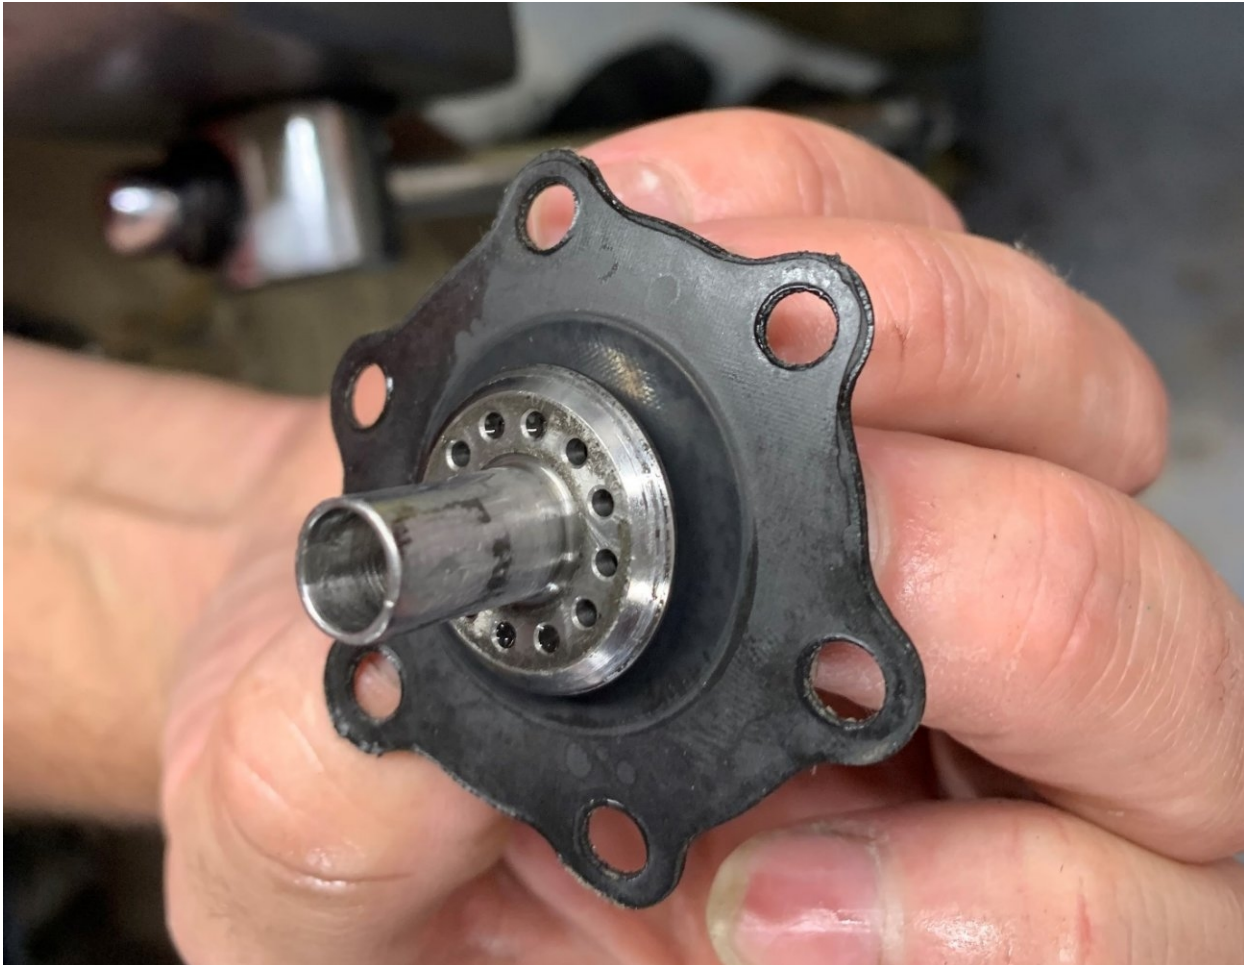
Figure 2. Engine fuel pump pressure relief valve with diaphragm

Postaccident examination of the airplane revealed non-ferrous metallic debris throughout the entire fuel system; the source of the debris was unable to be determined. Due to a leak noted during a functional test, the engine-driven fuel pump was disassembled. Scratches and scoring marks were noted on the pressure relief valve seat, which allowed fuel into the air side cavity of the fuel pump. It is likely the fuel pump air cavity filled with fuel, which equalized the pump pressure and restricted fuel flow to the engine. The restricted fuel flow resulted in a total loss of engine power.

The failure of the engine-driven fuel pump, which resulted in a total loss of engine power. Contributing to the failure of the fuel pump was an unknown non-ferrous metallic debris that was noted throughout the airplane's fuel system.

the pump was removed and replaced with a slave pump. The accident fuel pump was disassembled; scratches and scoring marks were noted on the pressure relief valve seat, which allowed fuel into the air side cavity of the fuel pump (see Figure 2). The diaphragm was pliable and undamaged. Blue stains, consistent with aviation fuel, were noted on the external pump housing.
