Aviation Investigation Final Report

Location:	North Charleston, South Carolina	Accident Number:	ERA23LA319
Date & Time:	August 1, 2023, 15:30 Local	Registration:	N31PB
Aircraft:	BELL HELICOPTER TEXTRON CANADA 407	Aircraft Damage:	Substantial
Defining Event:	Flight control sys malf/fail	Injuries:	1 Minor
Flight Conducted Under:	Public aircraft

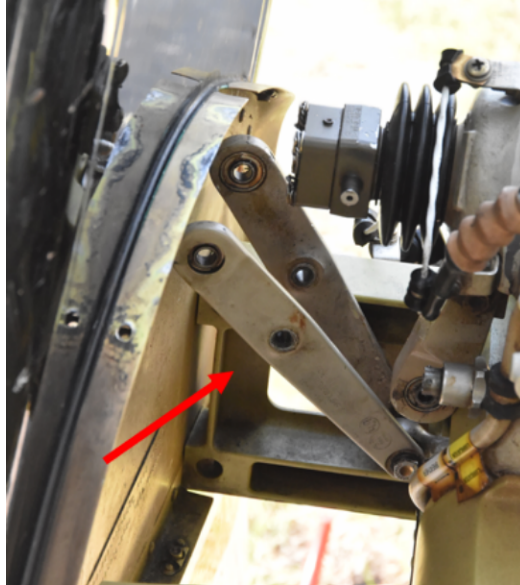
A postaccident examination of the helicopter found one of the two bolts that secured the tail rotor pitch change lever assembly was missing. The lever assembly was disconnected from the trunnion, resulting in the loss of tail rotor control. The other bolt that connected the levers to the rod assembly was in place, but loose; the cotter pin for its attachment nut was missing.

A failure of the tail rotor pitch change lever assembly due to incorrectly installed bolts and maintenance personnel's inadequate inspection of the tail rotor control system.

Photo 1: Tail rotor Pitch Change Lever Assembly. Red arrow points to area of missing bolt.
