# Aviation Investigation Final Report

<b>Location:</b>	Pellston, Michigan	<b>Accident Number:</b>	CEN23LA217
<b>Date &amp; Time:</b>	June 1, 2023, 13:30 Local	<b>Registration:</b>	N4376H
<b>Aircraft:</b>	Piper PA-28-181	<b>Aircraft Damage:</b>	Substantial
<b>Defining Event:</b>	Sys/Comp malf/fail (non-power)	<b>Injuries:</b>	2 None
<b>Flight Conducted Under:</b>	Part 91: General aviation - Instructional

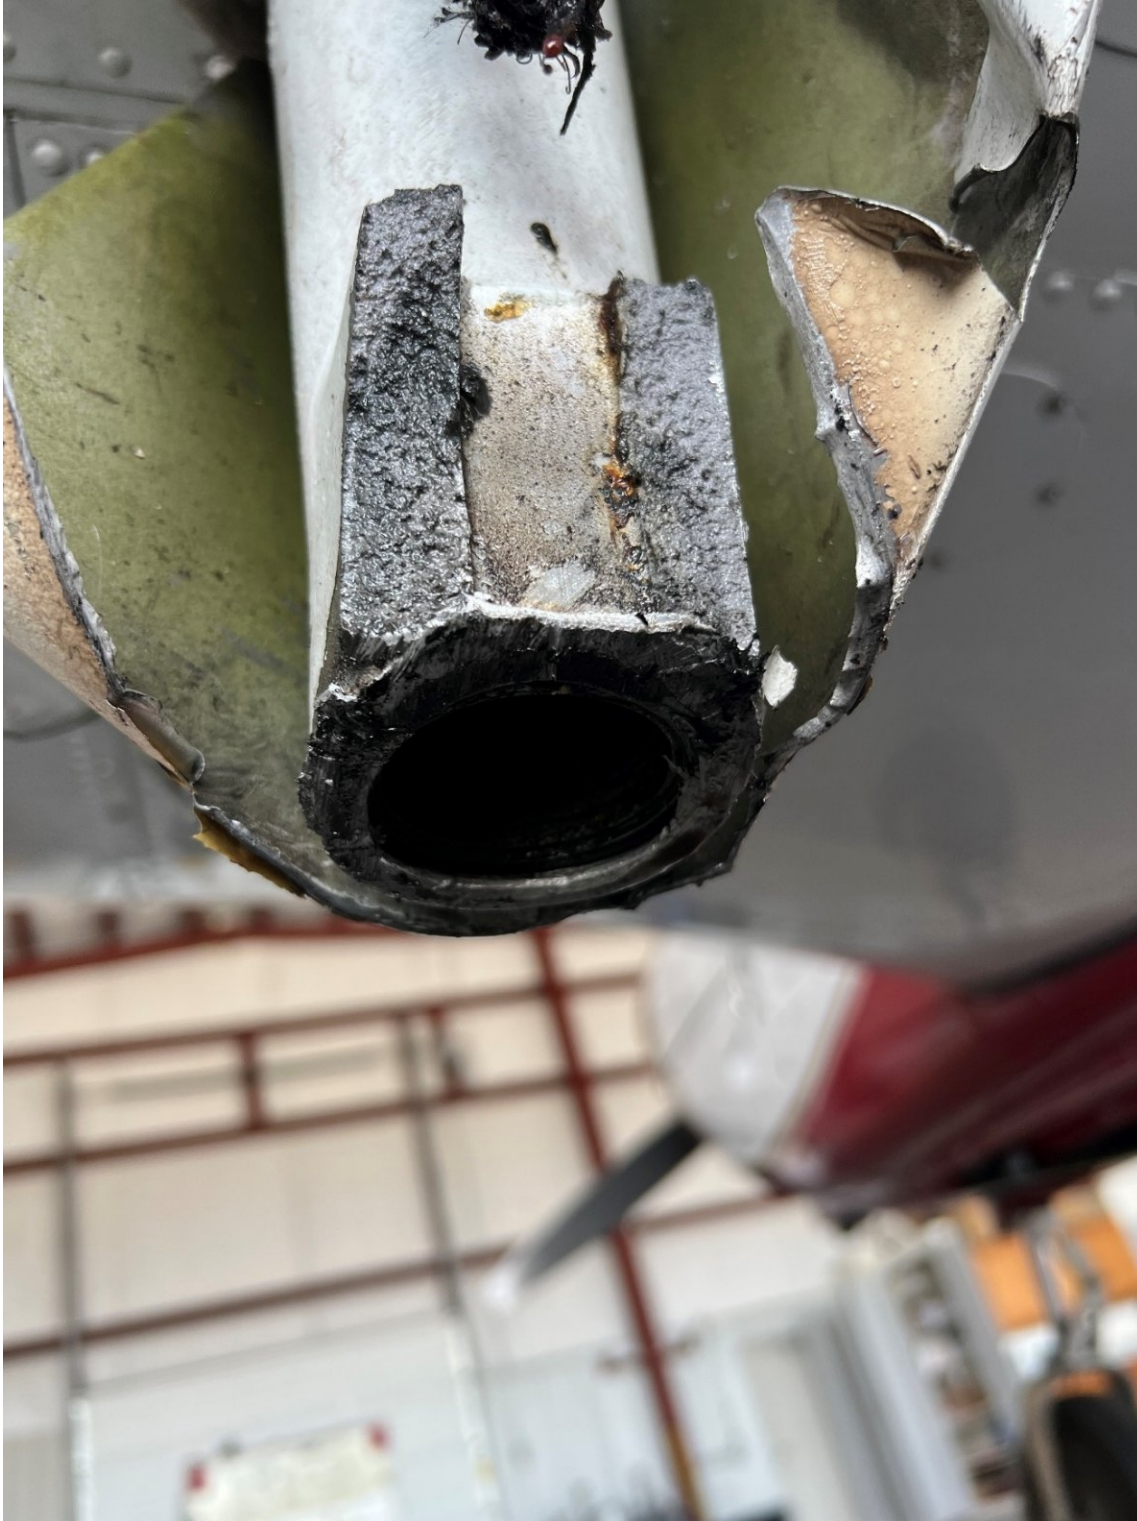
The failure of the left main landing gear strut and clevises due to fatigue cracks that initiated at multiple casting solidification voids.

The airplane landed on the runway centerline with the partially separated left main landing gear assembly and sustained substantial damage to the left wing. Postaccident examination revealed the landing gear strut housing clevis was fractured at the upper torque link connection (see figure 1). The wheel assembly remained attached via the brake line hose. The airplane and strut housing were retained for further examination.

*Figure 1. Fractured left main landing gear strut housing clevis (Source: Federal Aviation Administration).*

The National Transportation Safety Board's Materials Laboratory examined the remnants of the landing gear strut, which included a sectioned portion of the cylinder, and the torque link assembly arm attached to the broken cylinder clevis via the attachment bolt. The chemical composition of the fractured cylinder was consistent with A356 aluminum-silicon casting alloy. The cylinder side fracture surfaces exhibited crack arrest marks, consistent with progressive fracture, and ratchet marks, indicative of multiple crack initiation sites. The crack features were consistent with initiation along the interior surface between the clevises, which was machined smoother than the exterior surfaces. Outside of the cracks, the fracture surface exhibited dimpled rupture, consistent with subsequent overstress fracture.

Several initiation sites were examined along the radius with the machined surface. One initiation site exhibited a flat, faceted region from which river patterns and striations emanated. Closer examination revealed layered hackles typical of localized brittle fracture and consistent with a silicon-rich phase, typical in many aluminum-silicon castings.

A smooth surface feature adjacent to the fracture edge exhibited a spherical, dendritic morphology which consisted of a solidification void from the casting of the part. Fatigue striations were found propagating from the void rather than from the fracture edge. The features were consistent with crack initiation from the solidification void. Another solidification void, exhibiting smooth, rounded dendritic shapes along the fracture surface edge, contained a secondary crack running through the feature. Fatigue striations were found propagating parallel to the edge, consistent with initiation along the secondary crack from the solidification void.

The strut assembly fractured from fatigue cracks that had initiated along the radius of the clevis arms within the inner machined surface. These cracks initiated at multiple casting solidification voids and silicon-rich phases. The cracks propagated through the clevis cross-sections until the remaining cross-sections fractured from overstress.
