Aviation Investigation Final Report

Location:	Santa Monica, California	Accident Number:	WPR23LA216
Date & Time:	June 5, 2023, 15:17 Local	Registration:	N819KS
Aircraft:	Cessna 172R	Aircraft Damage:	Substantial
Defining Event:	Sys/Comp malf/fail (non-power)	Injuries:	1 None
Flight Conducted Under:	Part 91: General aviation - Flight test

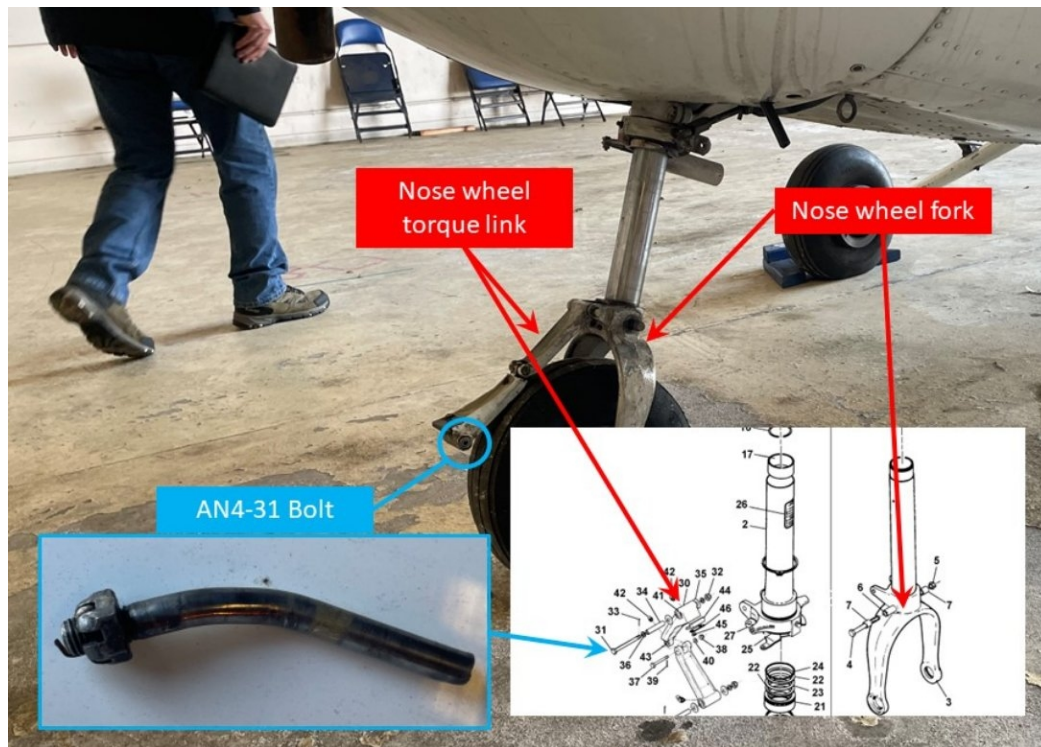
A bolt from the upper portion of the nose torque link was found on the runway and a postaccident material analysis revealed that the bolt had separated from shear overstress. The investigation also found that the bolt had been damaged and was not replaced as part of the repairs made to prepare the airplane for the ferry flight following the previous collision with the fuel truck.

A bolt from the nose wheel torque link assembly was found on the runway during a sweep for foreign object debris following the accident. In addition, the torque link had separated from the nose wheel steering arm assembly at the upper bolt (see Figure 1). According to the airplane maintenance manual,

Figure 1: Nose wheel torque link and bolt from accident

A National Transportation Safety Board Materials Laboratory examination found that both the upper and lower torque link bolt measurements and thread profiles were consistent with the proper bolt for the installation. The bolthead had separated from the bolt shank, but the corresponding castellated nut and cotter pin were secure in place. The fracture surface had directional dimples consistent with shear overstress.

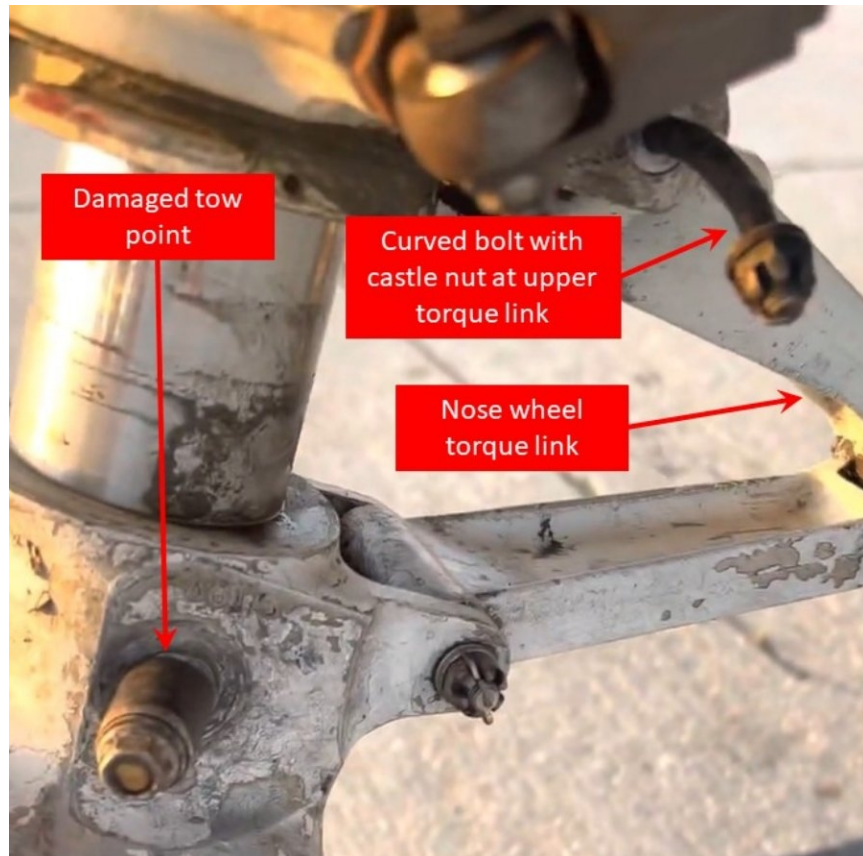
The accident was the result of a failure of the upper torque link during landing. The link failed due to a bolt that had unaddressed fractures originating from when the airplane collided with the truck. This resulted in a loss of steering control and a subsequent loss of directional control on the ground. A video provided by the airplane owner of the airplane showing the damage on the airplane following the collision with the fuel truck clearly shows the bent upper torque link bolt.

In May 2023 the airplane collided with a fuel truck as it was being towed by the operator. The airplane owner videotaped the damage to the airplane, which showed a bent tow point and a curved bolt with a castellated nut protruding from the upper torque link to nose gear steering arm assembly connection. According to an invoice, the damage was inspected and 10 shock mounts on the cowling were replaced to prepare the airplane for a ferry flight as the damage, including the strut, was going to be repaired by another maintenance facility. The operator stated that the instructor was then asked to complete the maintenance flight (accident flight) after the airplane was serviced to ensure it was airworthy before the ferry flight.

Figure 2: Damage to nose gear after collision with truck (May 2023)
