Aviation Investigation Final Report

Location:	Skwentna, Alaska	Accident Number:	ANC23FA061
Date & Time:	August 9, 2023, 12:15 Local	Registration:	N4481Z
Aircraft:	Piper PA-18-150	Aircraft Damage:	Destroyed
Defining Event:	Unknown or undetermined	Injuries:	2 Fatal
Flight Conducted Under:	Part 135: Air taxi & commuter - Non-scheduled

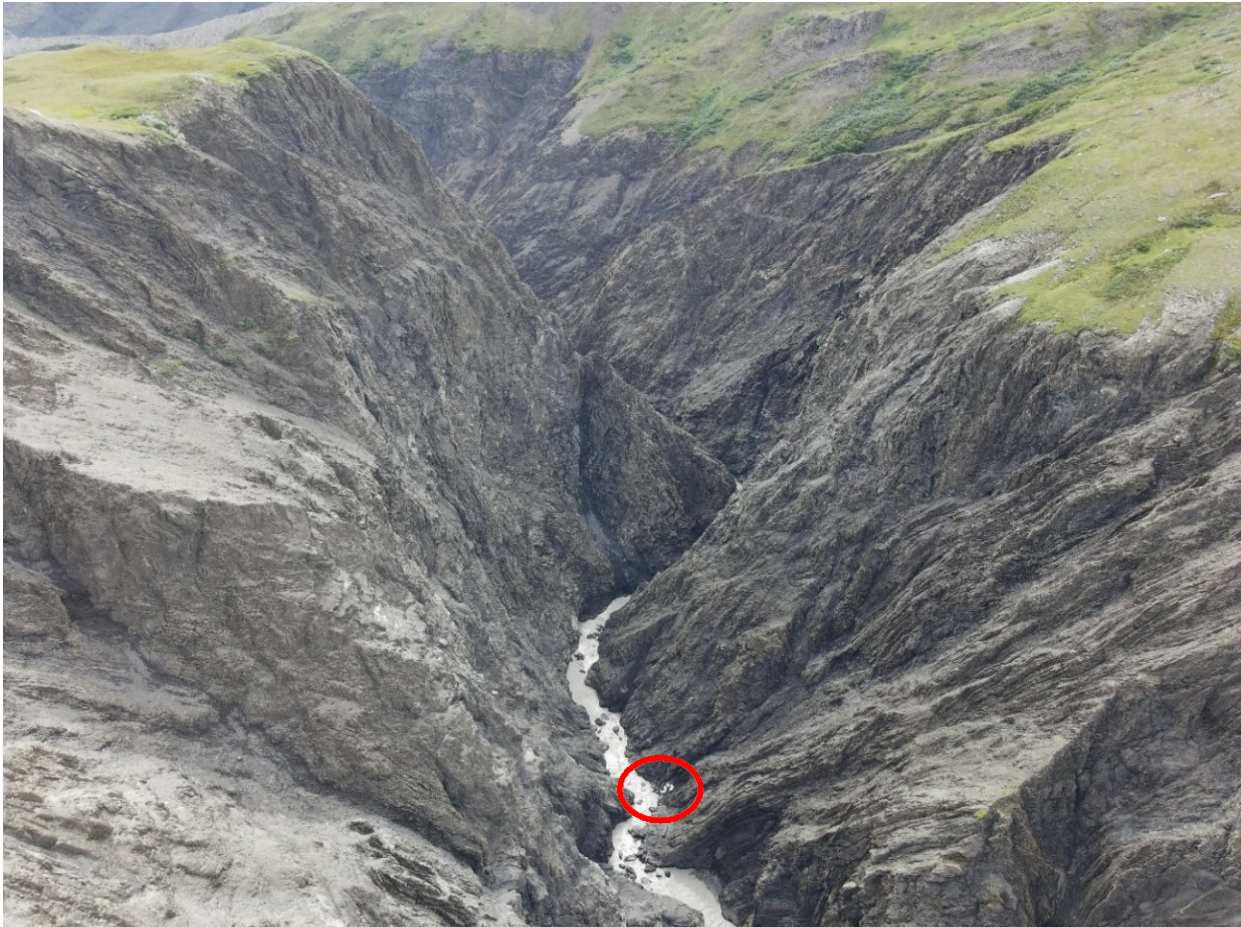
Figure

Search and rescue operations began that evening by the Alaska Air National Guard Rescue Coordination Center (AKRCC). Initial search flights were then suspended due to poor weather in the identified search area. On August 10th, about 0930, the airplane wreckage was located by the AKRCC at the bottom of an estimated 500 to 600 ft deep narrow ravine of the West Fork of the Yentna River, also known as Shellabarger Pass in Denali National Park and Preserve (see Figures 2 and 3).

2. Accident site location (airplane circled in red)

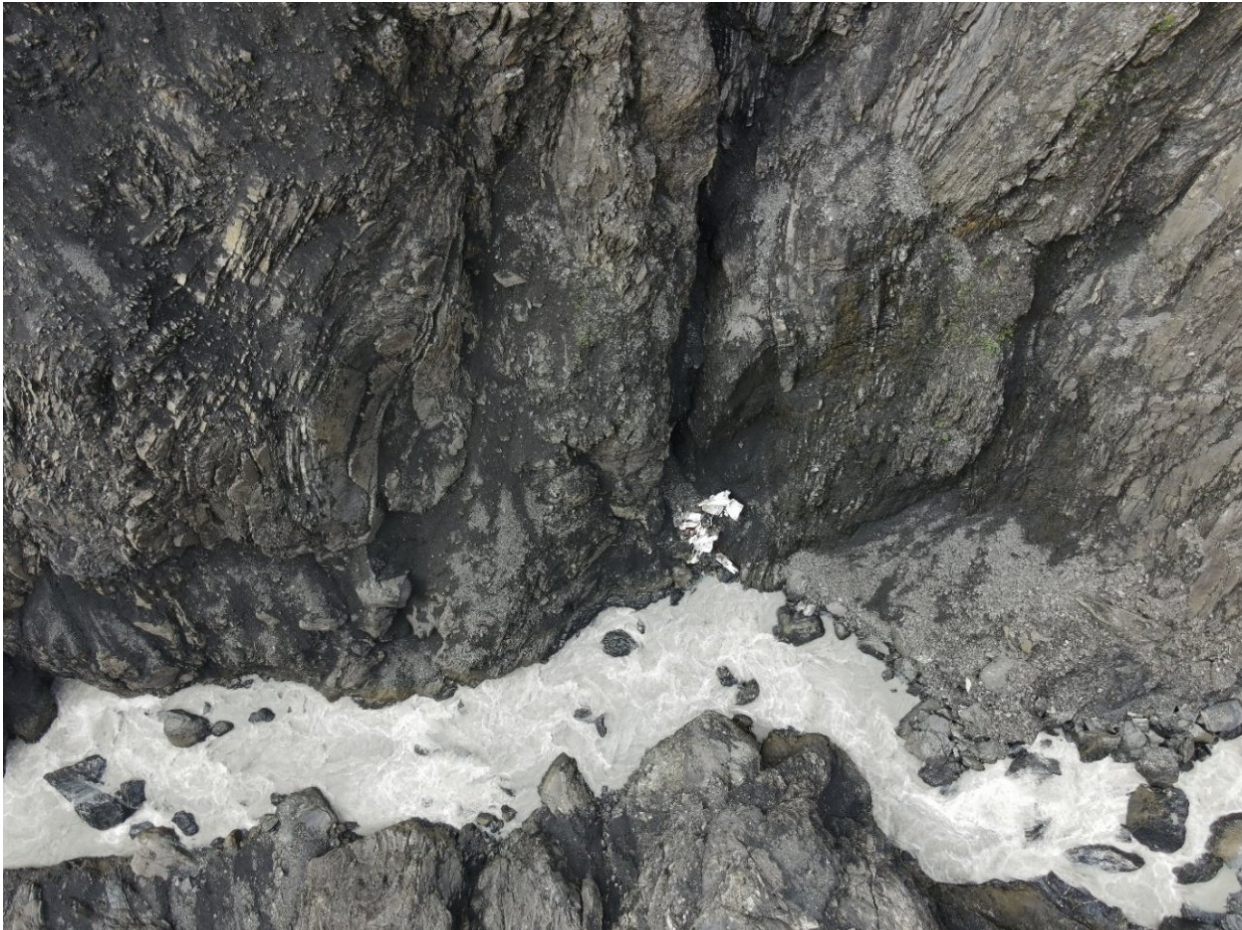
Figure

3. Airplane wreckage in bottom of ravine

On August 11th, the day after the wreckage was discovered, the National Transportation Safety Board (NTSB) investigator-in-charge and Denali National Park rangers traveled to the accident site location but were unable to access the accident site due to steep and unstable terrain conditions. The airplane wreckage was photographed by helicopter, and an NTSB drone was deployed to descend into the canyon to document the accident site and airplane wreckage. Airplane debris and non-aircraft gear were located on the canyon wall about 400 ft above the main wreckage.
