Aviation Investigation Final Report

Location:	Carrington, North Dakota	Accident Number:	CEN23LA233
Date & Time:	June 3, 2023, 09:00 Local	Registration:	N8843L
Aircraft:	Piper PA-25-235	Aircraft Damage:	Substantial
Defining Event:	Fuel related	Injuries:	1 None
Flight Conducted Under:	Part 137: Agricultural

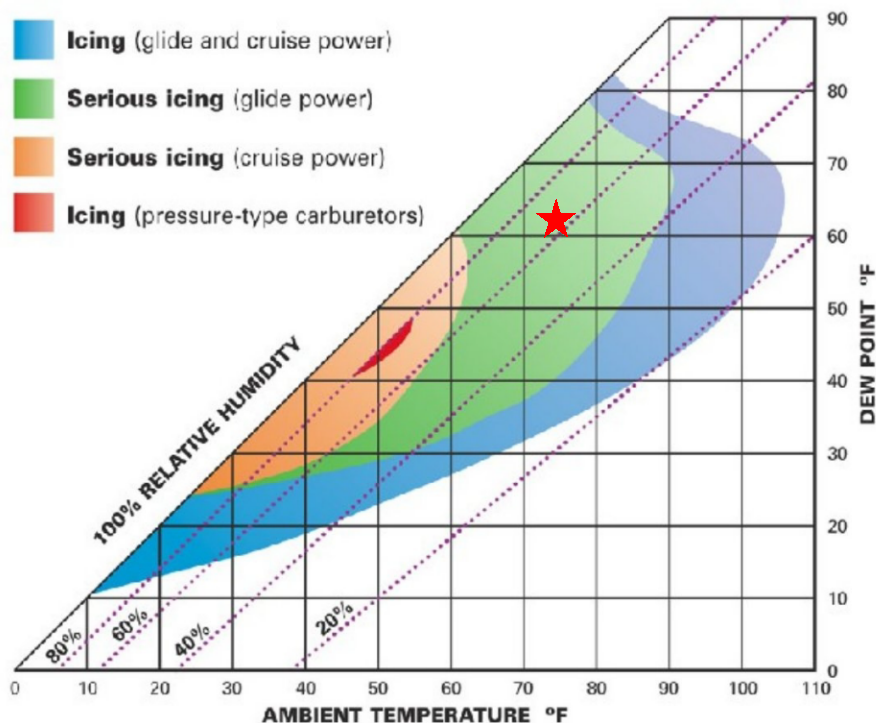
Figure. Carburetor Icing Probability Chart. Reference: FAA Special Airworthiness Information Bulletin CE-09-35

With no anomalies noted from the postaccident examination and the weather conditions present at the time of the accident, it is likely that carburetor ice formed during the extended ground run at idle power while the pilot waited for the oil temperature to rise.

A total loss of engine power as a result of carburetor ice that formed while the engine was operating at a low power setting for an extended period of time before departure.

The temperature (75°F) and dewpoint (62°F) about the time of the accident were plotted on a carburetor icing probability chart, which showed that the airplane was operating in an environment conducive for serious carburetor icing at a glide power setting. (See figure.)
