# Aviation Investigation Final Report

<b>Location:</b>	Casa Grande, Arizona	<b>Accident Number:</b>	WPR23LA199
<b>Date &amp; Time:</b>	May 24, 2023, 09:00 Local	<b>Registration:</b>	N60372
<b>Aircraft:</b>	Cessna 172S	<b>Aircraft Damage:</b>	Substantial
<b>Defining Event:</b>	Powerplant sys/comp malf/fail	<b>Injuries:</b>	2 None
<b>Flight Conducted Under:</b>	Part 91: General aviation - Personal

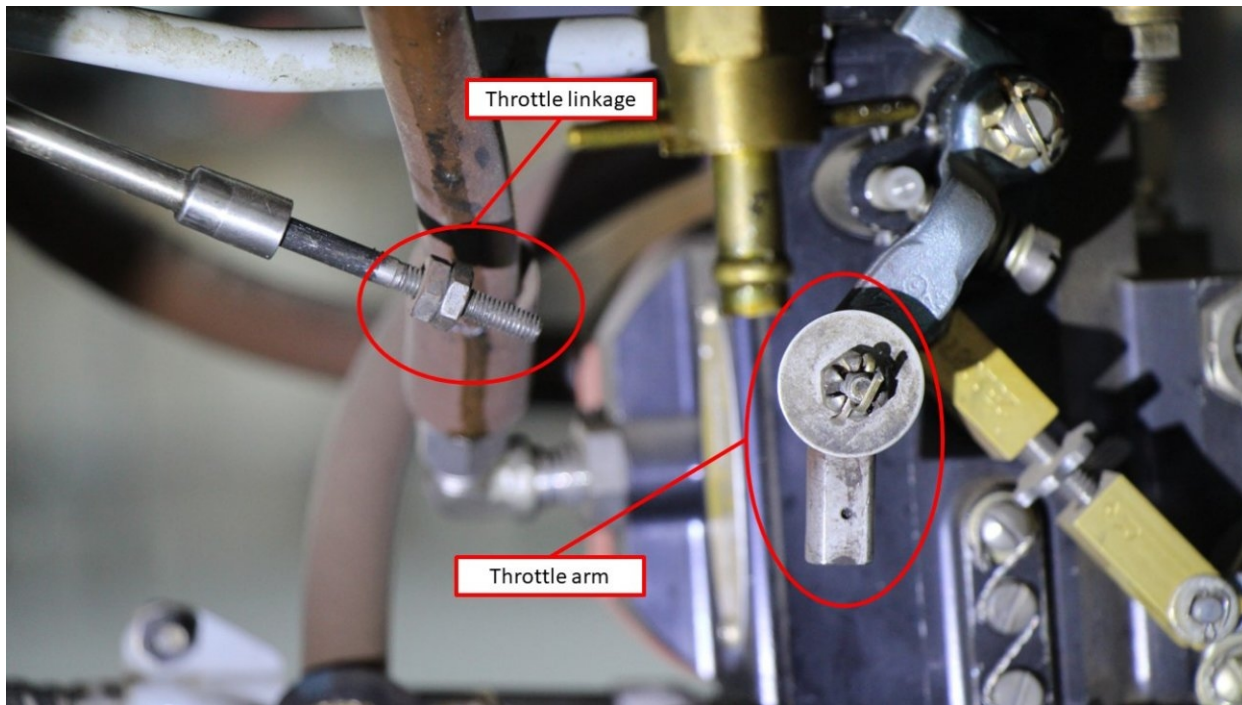
*Figure 1: Throttle linkage and throttle arm*

Postaccident examination of the airplane revealed that the throttle linkage had separated from the throttle arm. The threads on both the linkage and threaded section of the arm were intact and both jamnuts were loosely threaded to the linkage. The absence of any damage to the throttle assembly suggests that the linkage likely unthreaded itself from the throttle arm during the accident flight, which resulted in a loss of throttle control.

The separation likely developed over the course of the airplane's 680 flight hours since the throttle linkage was installed and should have been discovered during one of the subsequent required 50-hour inspection intervals or the airplane's most recent 100-hour inspection. However, none of these inspections were accomplished in the 680 hours of operation.

An in-flight separation of the throttle linkage, which resulted in a loss of throttle control.

Contributing to the accident was maintenance personnel's failure to follow the maintenance manual inspection procedure for the throttle cable assembly.

Postaccident examination of the engine revealed that the throttle linkage had separated from the throttle arm at the fuel servo.

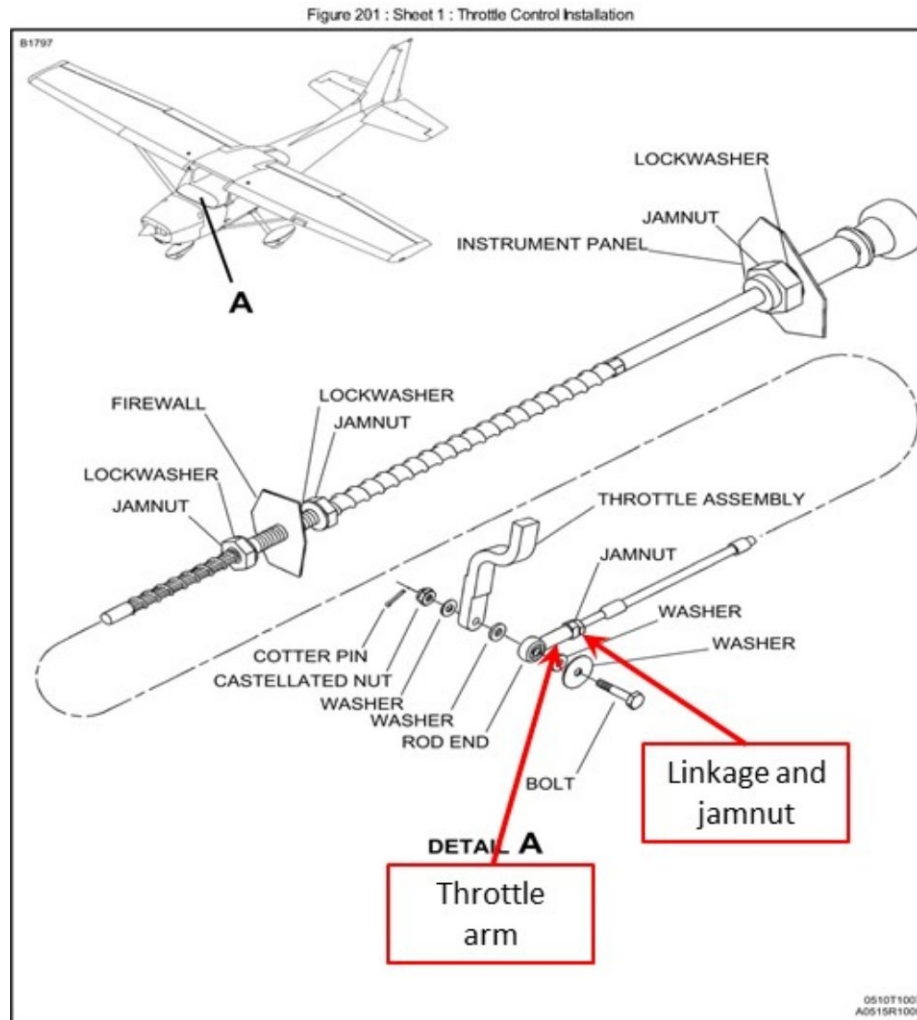
Figure 2: Throttle linkage installation from maintenance manual

The throttle system can be advanced and retarded for power adjustments. Throttle action is achieved through a cable that connects the throttle lever to the throttle arm of the fuel servo mounted at a plenum below the oil sump. The throttle linkage is threaded into the rod end attached to the throttle arm. (See figures 1 and 2).

The airplane maintenance manual includes inspection criteria for the throttle control. According to the manual, the engine throttle assembly should be inspected every 50 hours.

*“Engine Controls and Linkage – Examine the general condition and freedom of movement through the full range. Complete a check for the proper travel, security of attachment, and for evidence of wear. Complete a check of the friction lock and vernier adjustment for proper operation. Complete a check to make sure the throttle, fuel mixture, and propeller governor arms operate through their full arc of travel. The maximum linear freeplay is 0.050 inch.”*
