Aviation Investigation Final Report

Location:	Lakewood, Washington	Accident Number:	WPR23LA186
Date & Time:	May 9, 2023, 12:15 Local	Registration:	N416AG
Aircraft:	AVIAT AIRCRAFT INC A-1C-180 Husky	Aircraft Damage:	Destroyed
Defining Event:	Collision during takeoff/land	Injuries:	2 Serious
Flight Conducted Under:	Part 91: General aviation - Personal

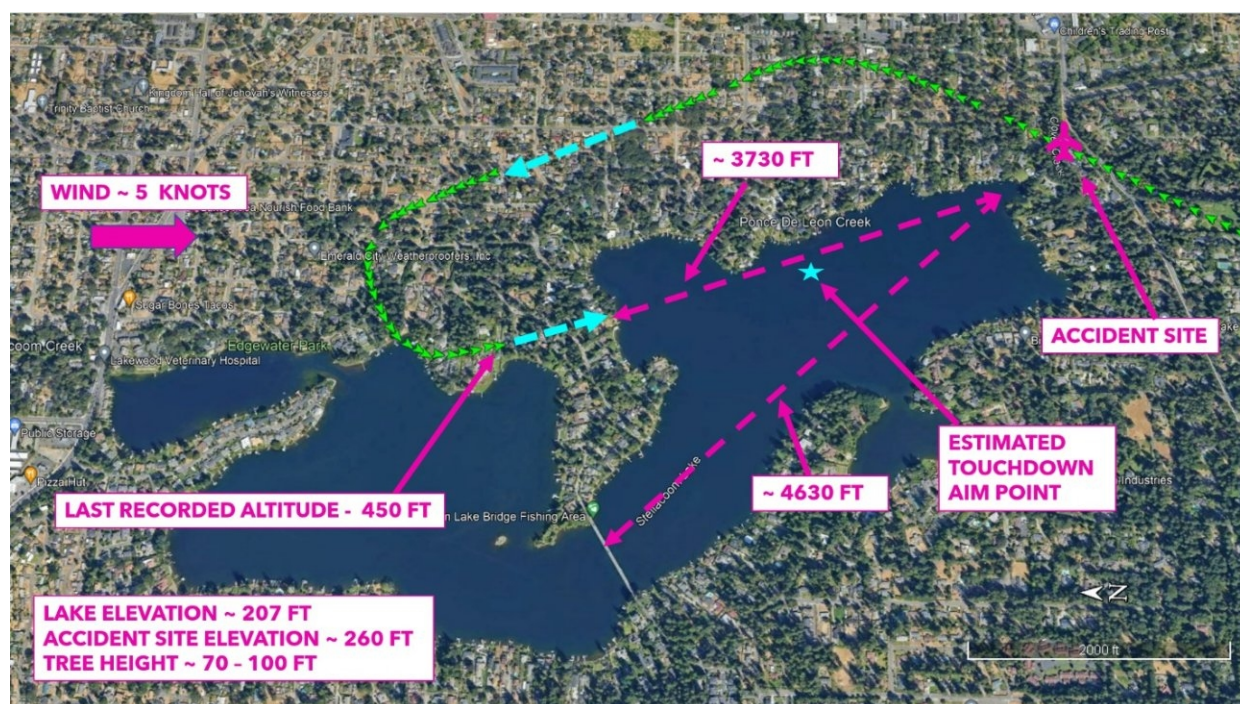
Figure 1 – ADS-B landing track (green)

The lake was about 1.5 miles long from the north to south. However, it was dissected in the middle by a peninsula and a roadway bridge. The landing area chosen by the pilot took him over his house and would have given him an available water distance of about 3,370 ft, with rising terrain and tall trees directly at the end. An approach slightly south over the bridge had a water distance of about 4,630 ft (Figure 1).

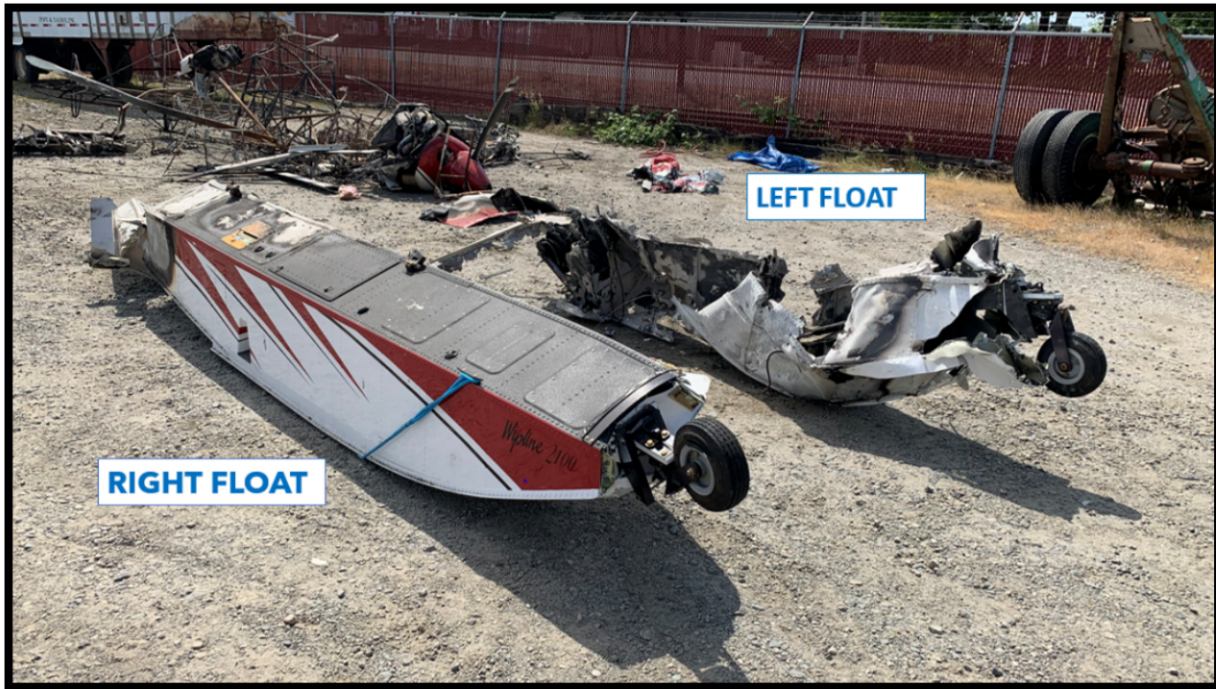
Examination of the floats and landing gear revealed all 4-landing gear were in the retracted (UP) position.

The left and right nose gear assembly remained intact on the left and right tracks. Both nose gear wheel tire assemblies could free castor.

The right main gear visual indicator rod and gear actuator indicated the right main was retracted in the up (water) position. The left main gear visual indicator rod was thermally damaged; however, the left gear actuator indicated that the left main wheel was retracted, in the up (water) position.
